Alameda-North Bay Farm Island Crossings Master Plan

*East Bay Municipal
Utility District*

November 2014

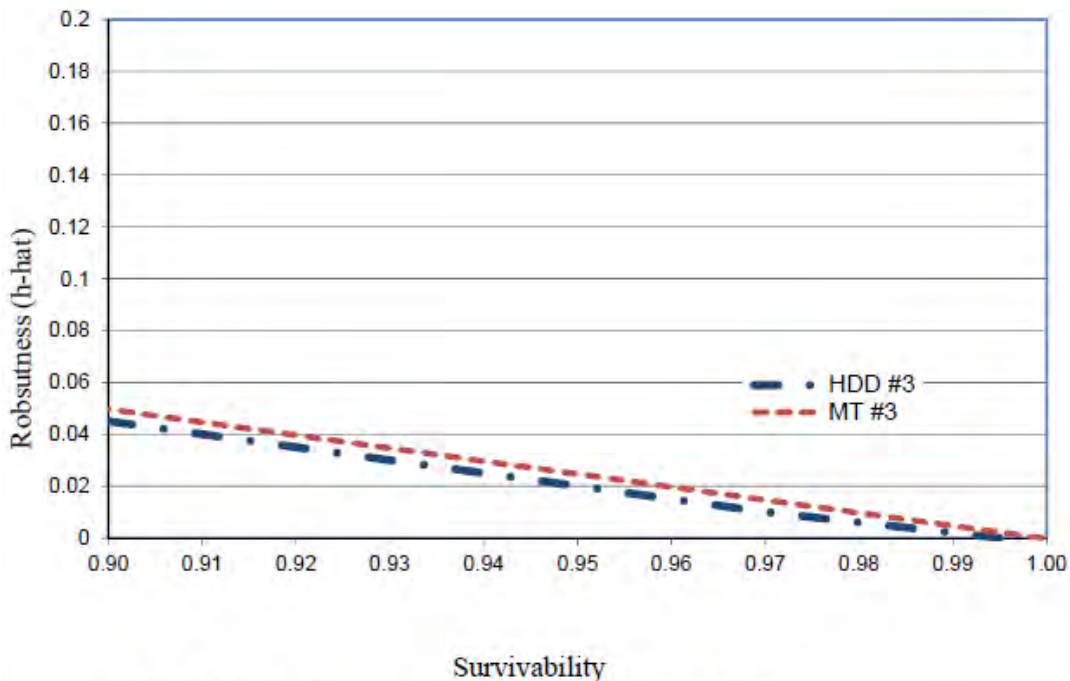
**GRAPH 5-1
Survivability Model Results**

Graph 5-1 shows a comparison of robustness curves for two designs: one HDD alternative and one MT alternative. The horizontal axis represents the critical survivability, while the vertical axis is the corresponding robustness.

HDD #3: 20-foot conductor casing left in place plus jet-grouting
 MT #3: Riser encased in concrete, shaft backfilled

The MT alternative has higher robustness at every point along the curve. Since the probability of failures of the MT alternative is estimated as extremely low, the higher robustness leads to extremely large tolerance to uncertainty relative to those estimated probabilities of failures. The tolerance to uncertainty on the HDD alternative, on the other hand, is not only smaller but much smaller in relative comparison to the estimated probabilities.

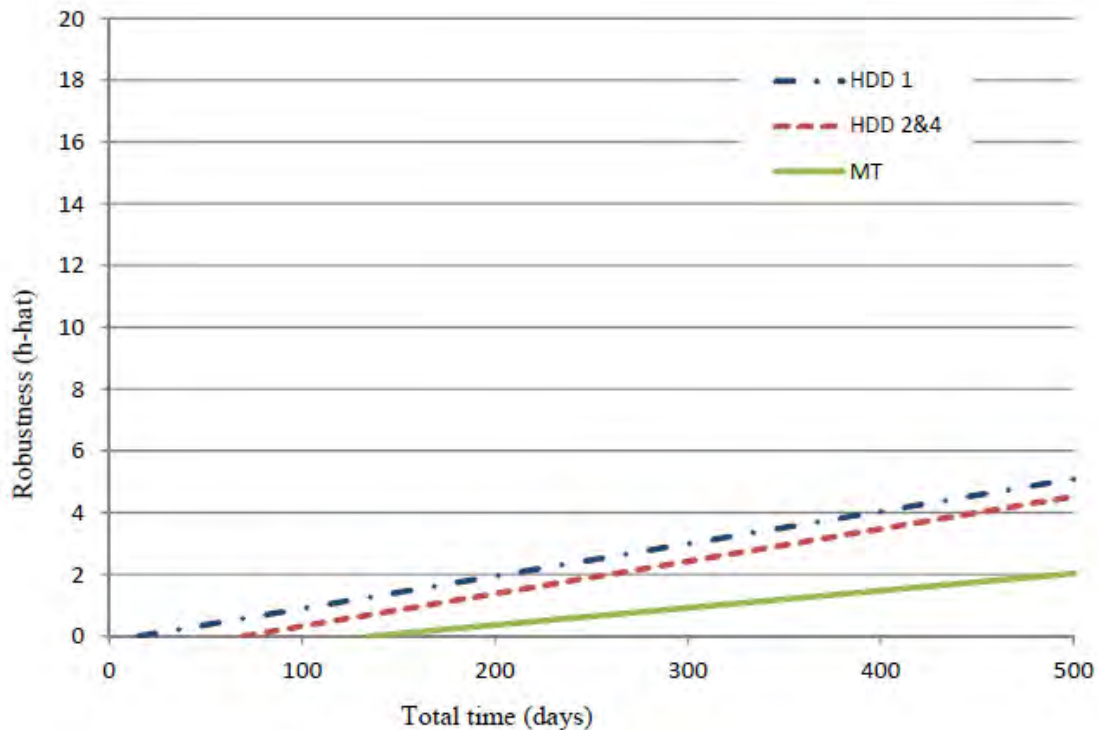
GRAPH 5-2
Reparability Model Results

Graph 5-2 shows a comparison of three robustness curves. HDD #1 represents a directly drilled crossing with no conductor casing. This design would be *expected* to fail near the surface in the liquefiable soils and therefore has a lower *expected* estimate. HDD 2 and 3 represent alternatives with a conductor casing which are expected to require a submarine repair. The microtunnel alternative is based on a general estimate for all microtunnel designs. The horizontal axis represents the critical time to repair, while the vertical axis is the corresponding robustness.

As shown in Graph 5-2, the HDD alternatives have higher robustness at every point on the curve. But no amount of reparability was deemed “good enough” to be counted on for restoring service to Alameda and Bay Farm Islands after a seismic event. Therefore the project team chose to provide redundancy (another model of robustness) in the number and location of crossings, as stated in the Survivability Model section.

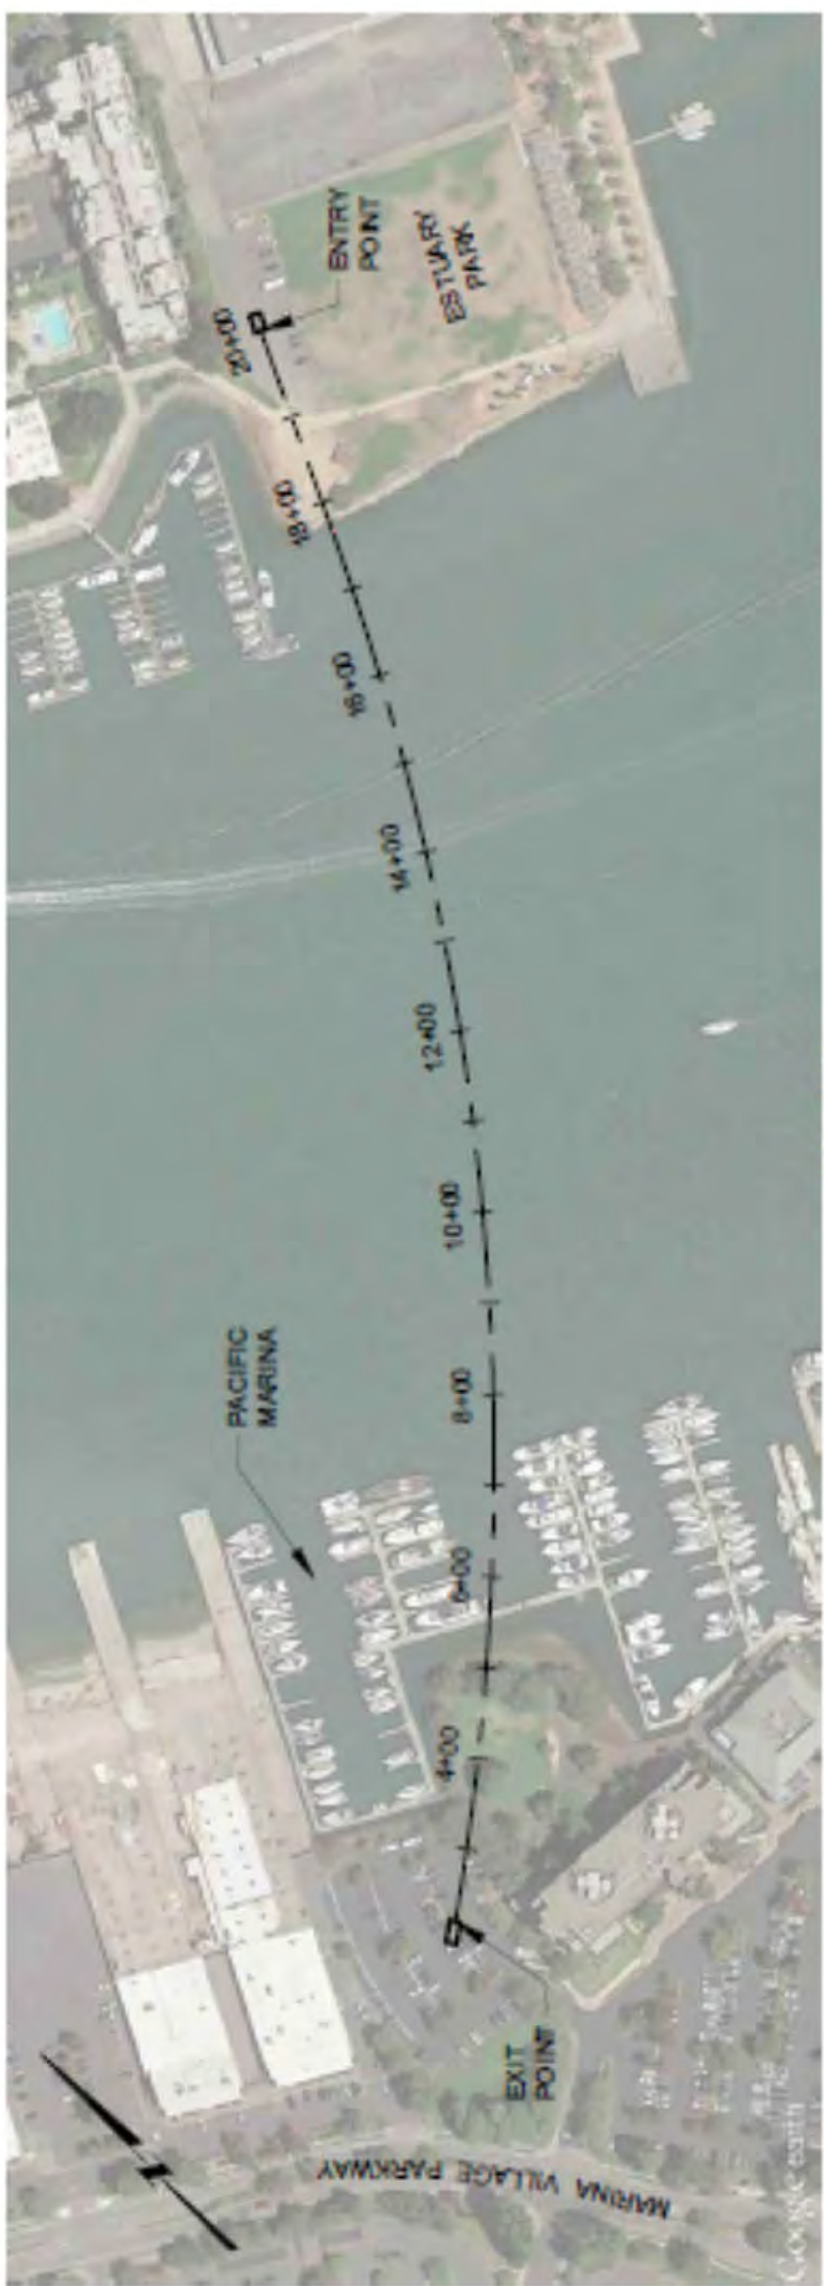
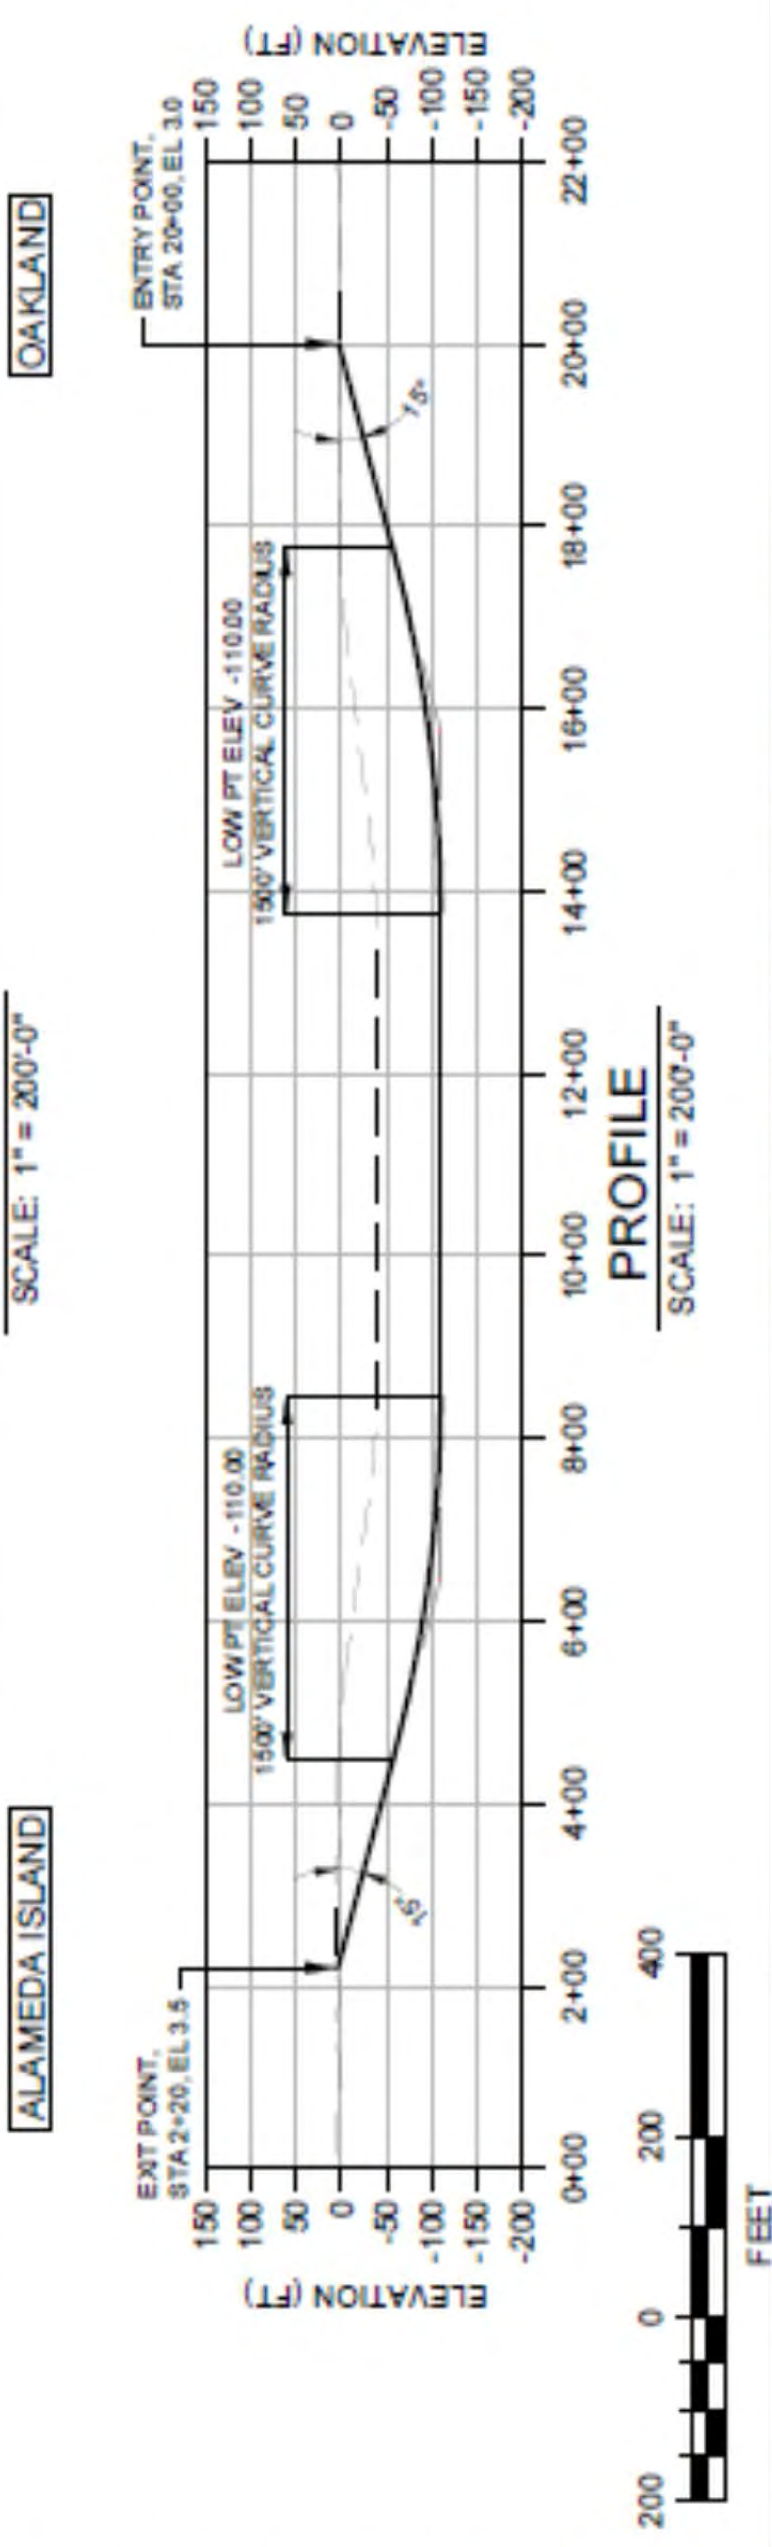
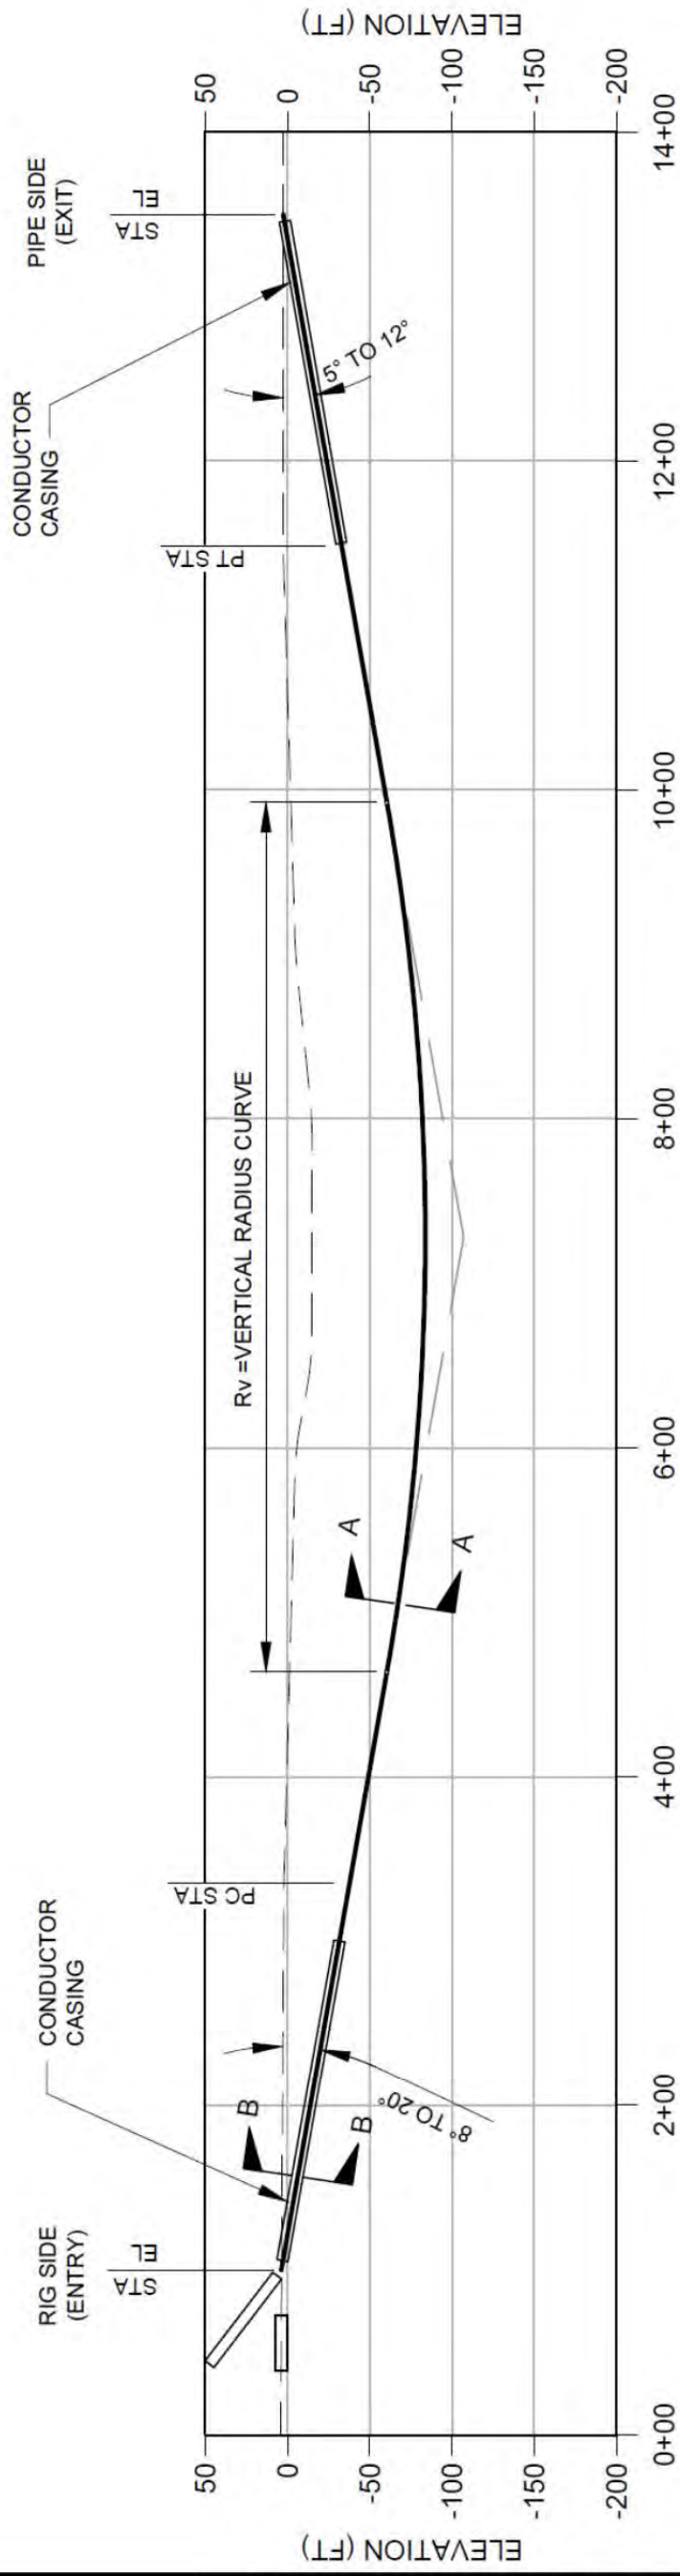
Figure 2-2
HDD Alternative 1D Plan and Profile

ALAMEDA-NORTH BAY FARM ISLAND CROSSINGS ALAMEDA, CALIFORNIA		PROJECT# 9033.0
HDD ALTERNATIVE 1D PLAN AND PROFILE		MARCH 2014
JACOBS ASSOCIATES Engineers/Consultants		F-9

PROFILE

The selected project includes the installation of a new 24-inch diameter underwater crossing at the Alternative 1D alignment along with new in-ground and street pipeline installation on the Oakland and Alameda side of the estuary; see Figure 2-1. A plan and profile drawing of the new 24-inch high density polyethylene (HDPE) pipeline crossing installation is shown in Figure 2-2. In addition, approximately 10,000 feet of new 24-inch steel pipeline will be needed to connect to Lincoln Avenue on the Alameda side and to 9th Street on the Oakland side, also shown in Figure 2-1. The new HDD drilling profile and the jet-grouted soil improvements are shown respectively in Figures 2-3 and 2-4. Jet grout supports are intended to strengthen the conductor casing through the young bay mud (YBM) into the less liquefiable older bay mud (OBM).

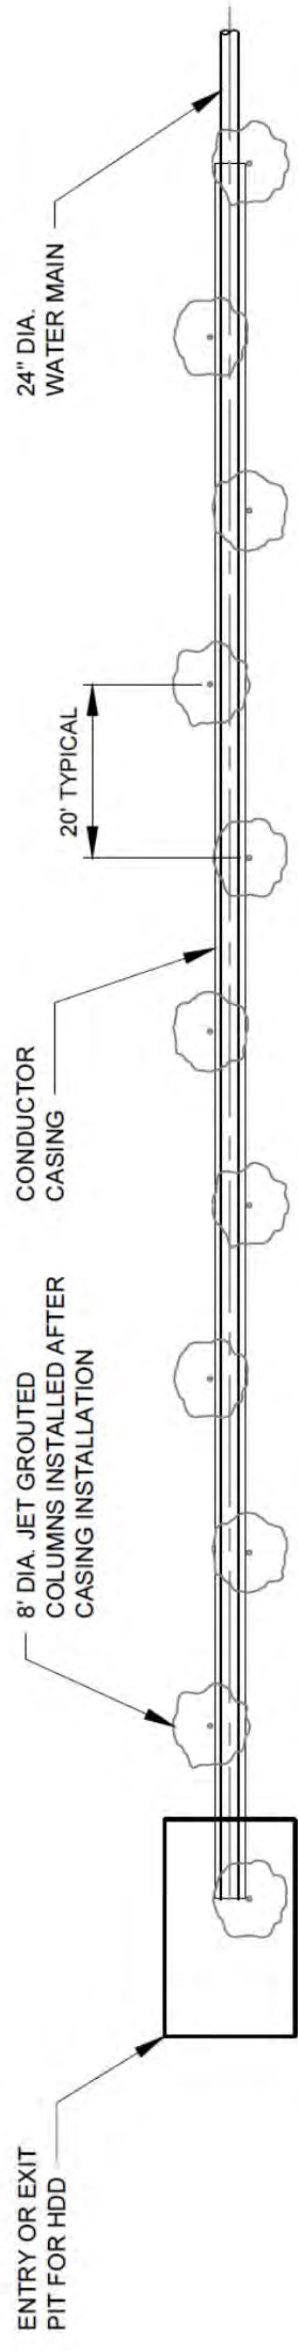
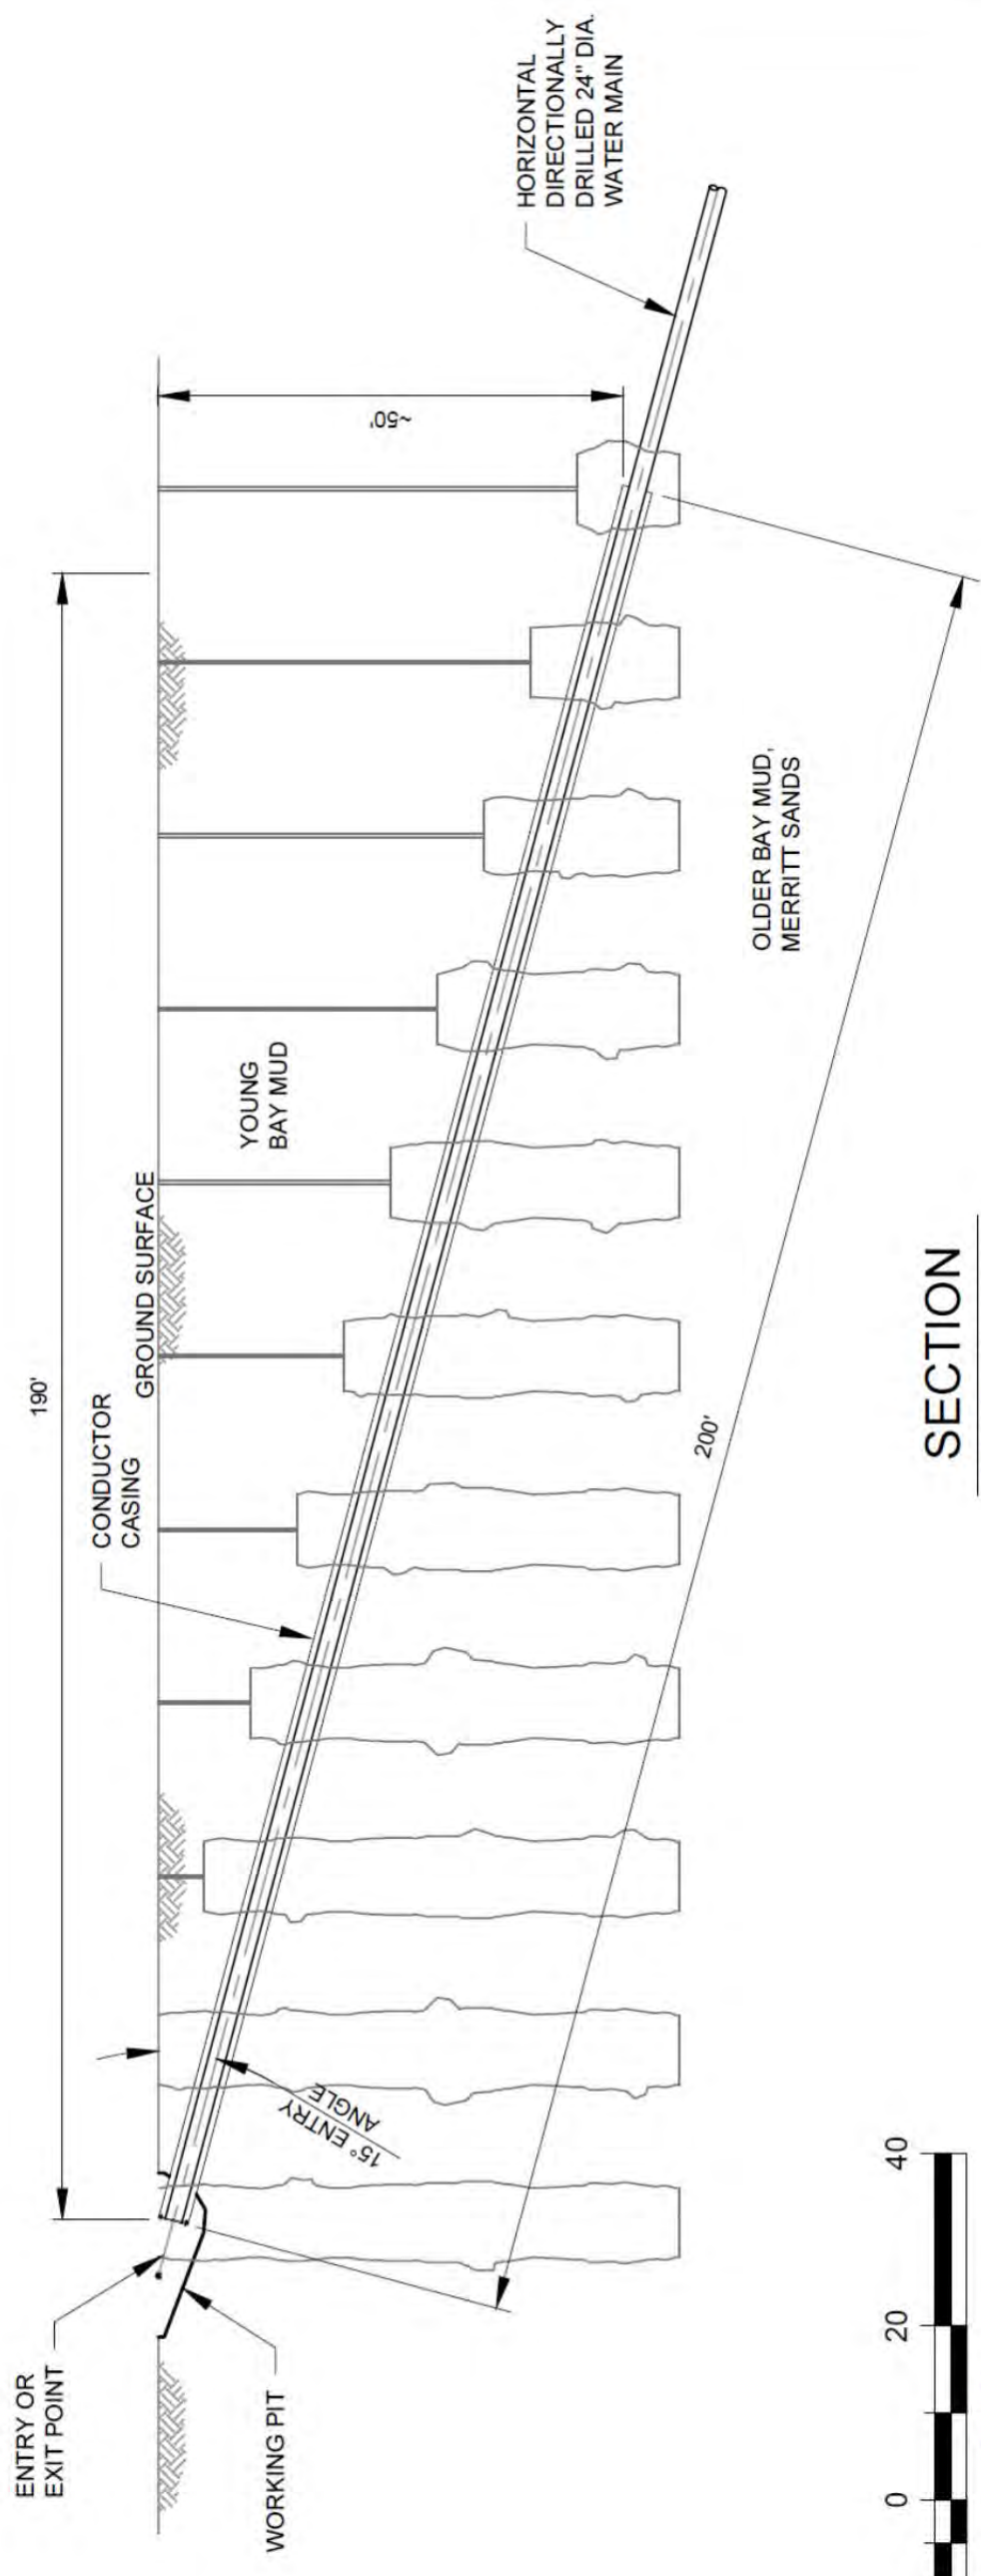
Extended Casing with Jet Grout Support

PLAN

SECTION

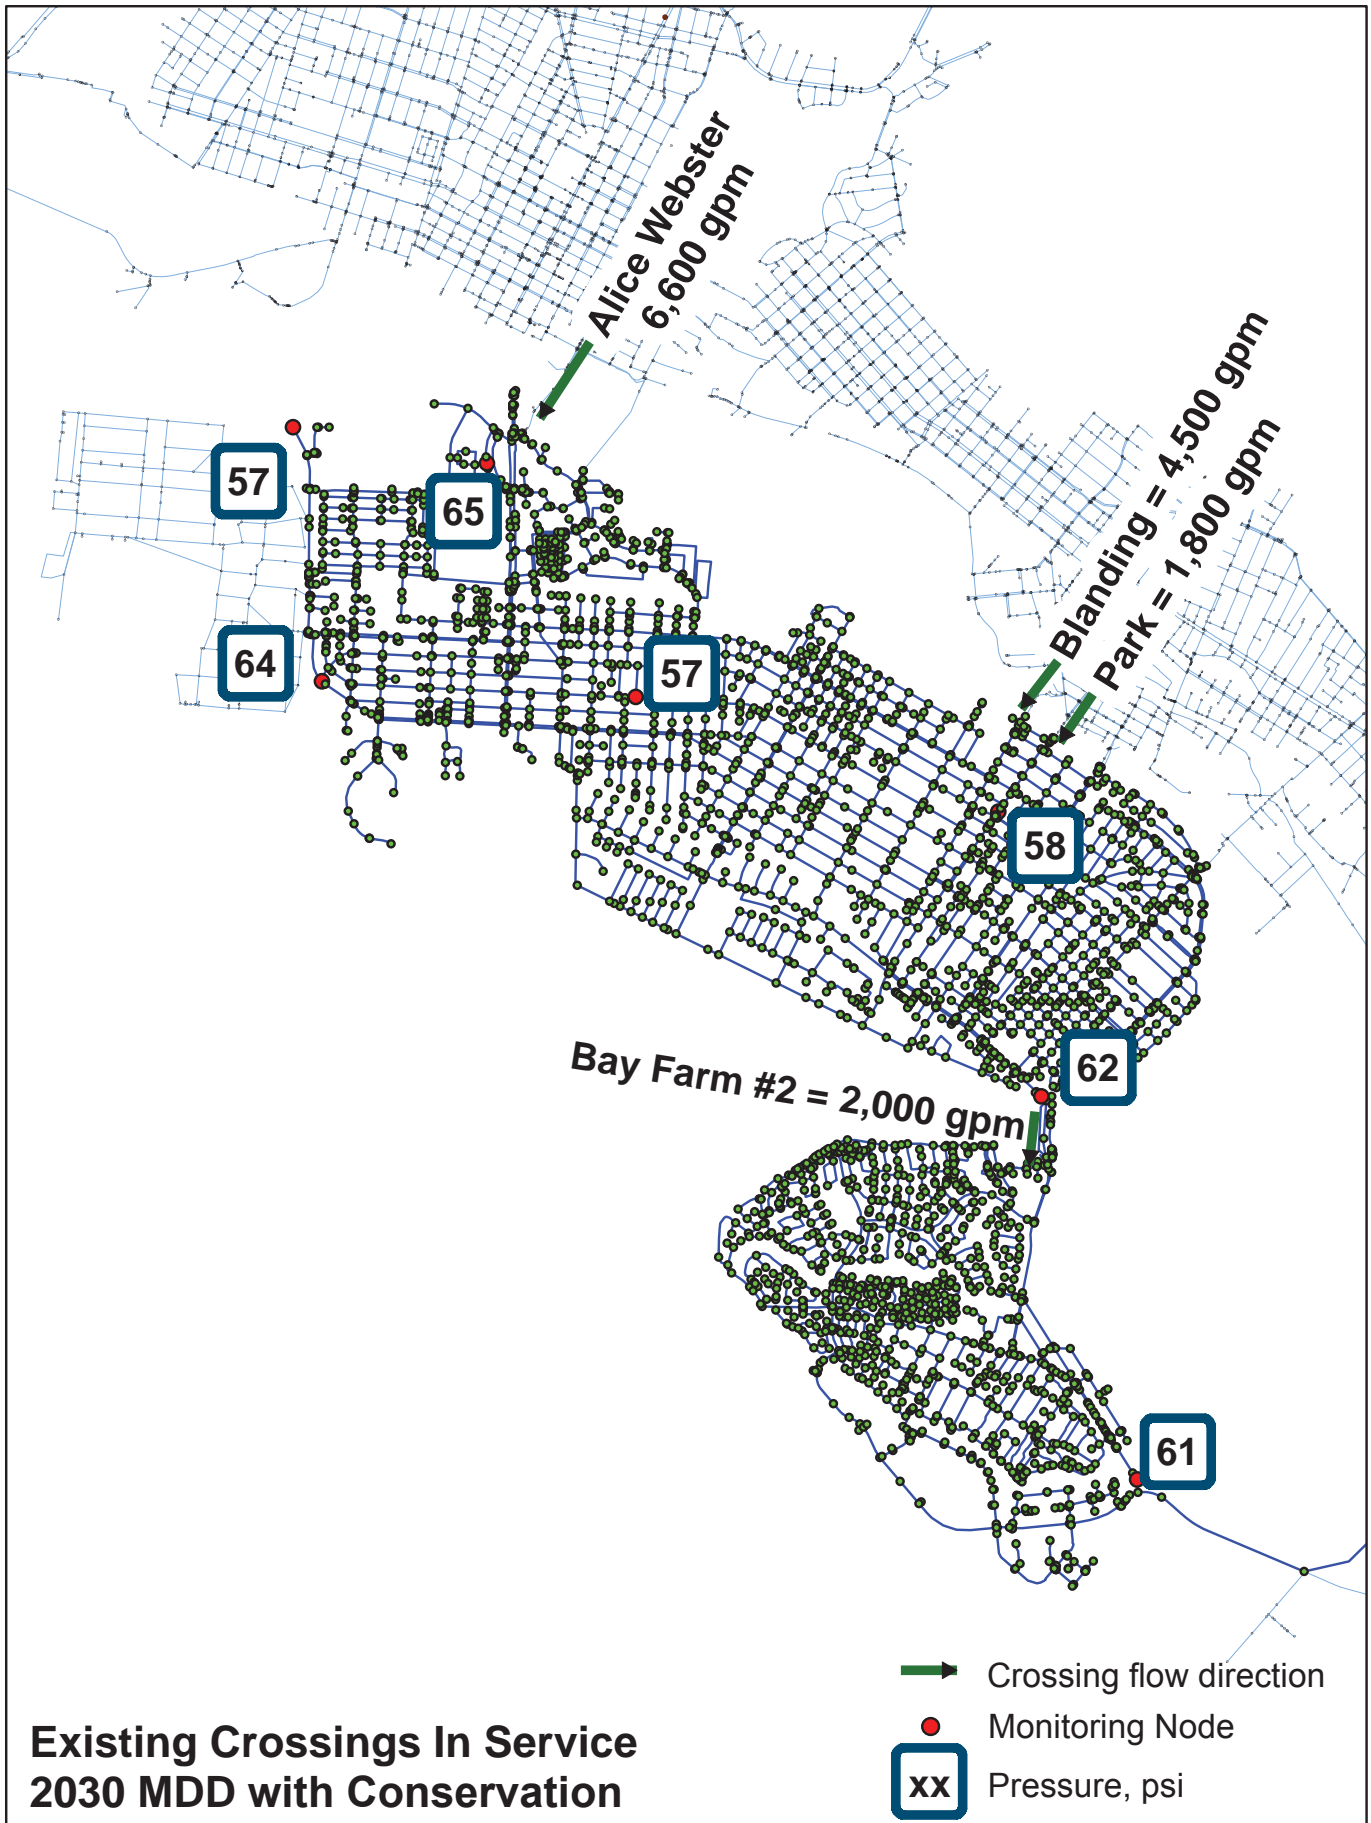
Existing Crossing in Service, 2030 Crossing Flows and Pressures (with Conservation)

Based on 2006 MDD in the Central-Central Pressure Zone, Alameda and Bay Farm Islands typically see pressures of 68-76 psi across Alameda Island. Typical flows through the four active crossings as well as pressures at select nodes on Alameda and Bay Farm Islands are shown in Figure 4-3 reflecting existing conditions. Positive numbers reflect flow into Alameda while negative (bracketed) values denote flows leaving Alameda Island. As shown in Figure 4-4, pressures are expected to drop to about 57-65 psi across the study area under adjusted 2030 maximum day demands with the same four existing crossings in service.

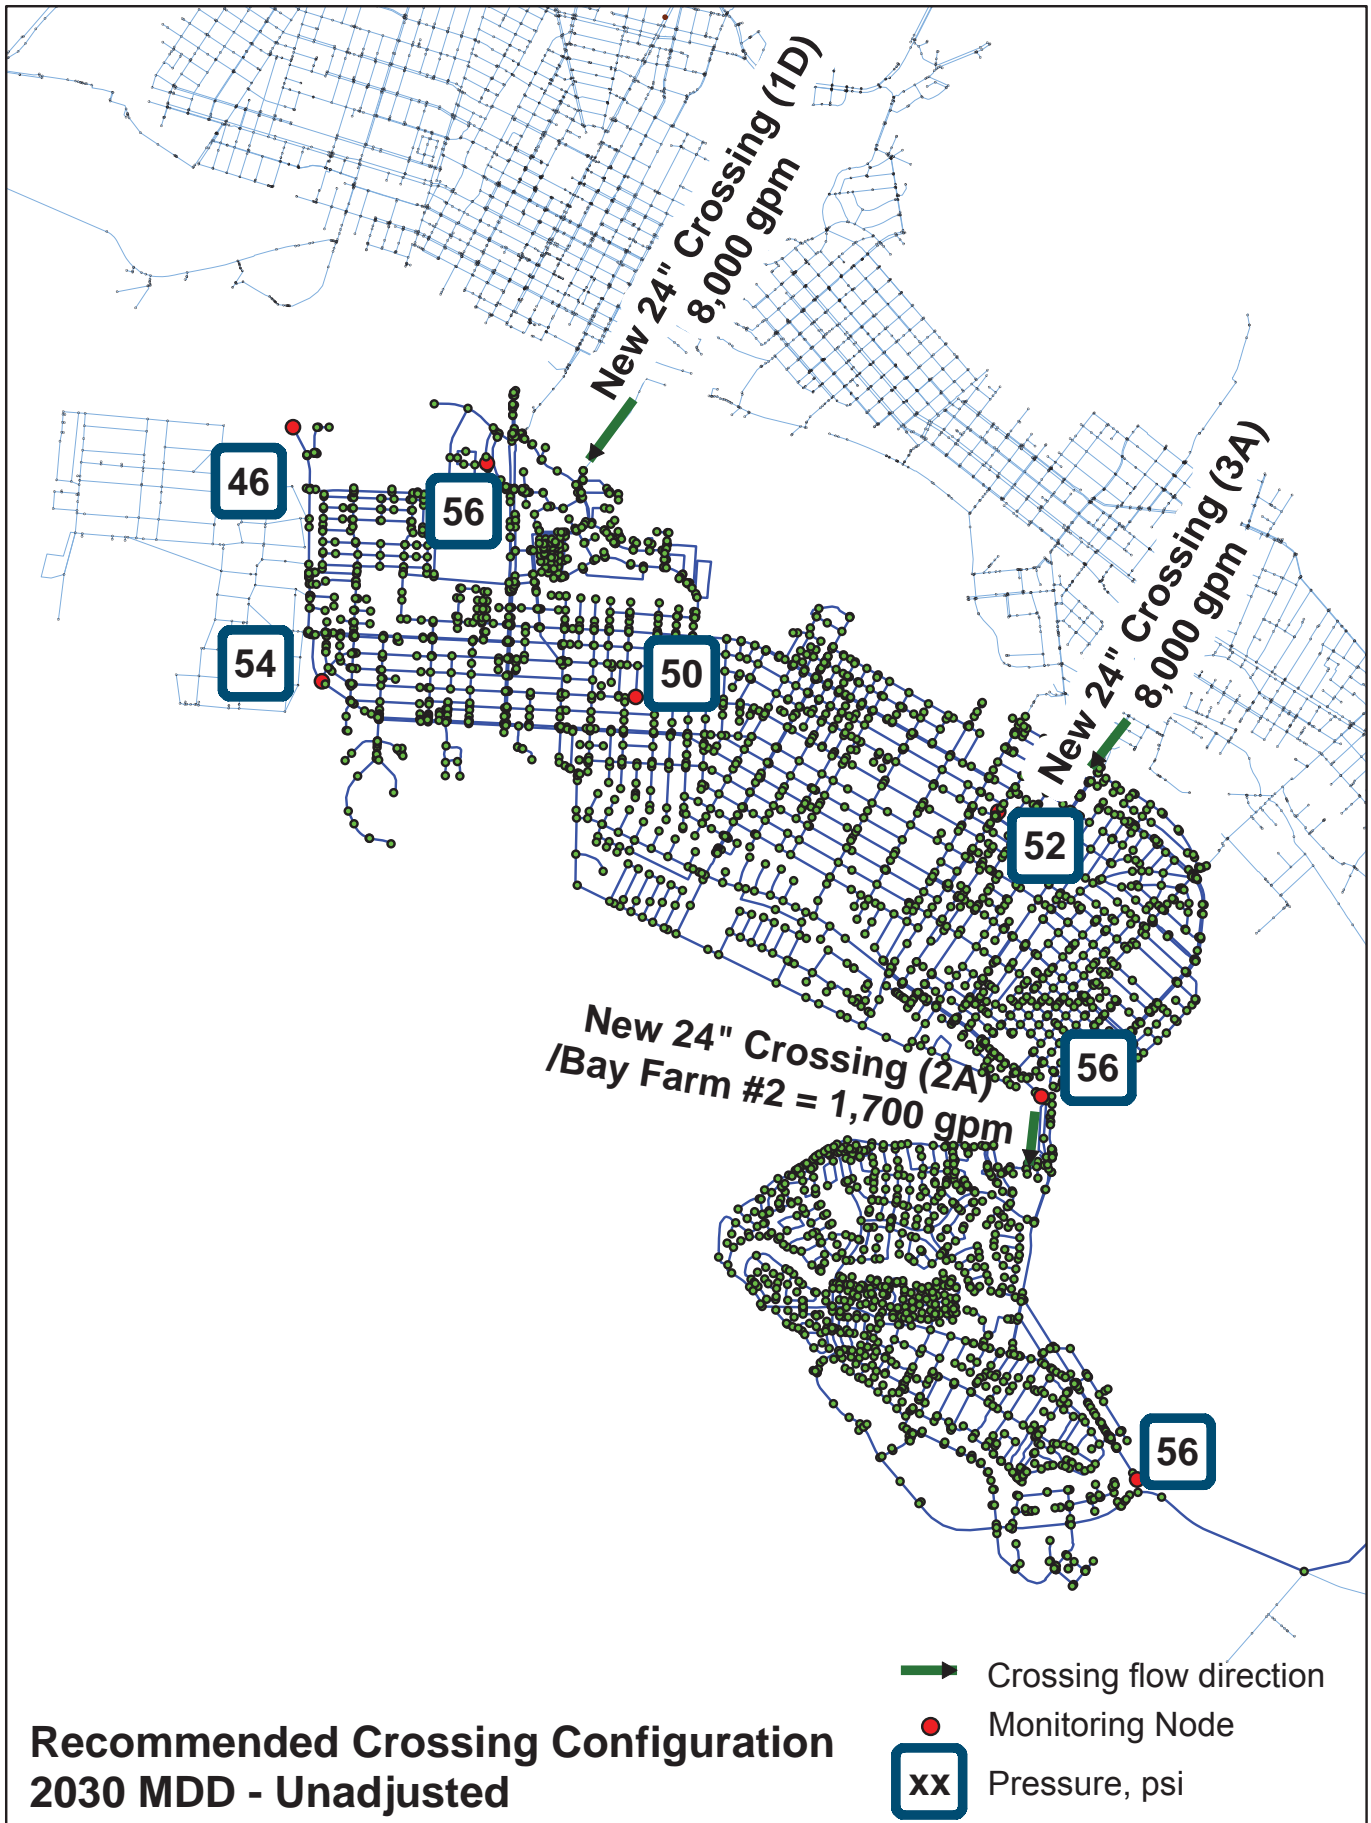
Recommended Crossing Configuration 2030 Flows and Pressures (unadjusted)

B	2030 MDD- <i>Unadjusted, Full Central Model</i> , New 24" Alice-Webster @ 1D, Replace Derby @ 3A (24")	7400		7000		48	57	58	52	55	61	28	see Figure 4-9
C ⁴	2030 MDD- <i>Unadjusted, Full Central Model</i> , New 24" Alice-Webster @ 1D, Replace Derby @ 3A (24"), New 24" crossing @ 2A/BF#2	8000		8000	-1700	46	54	56	50	52	56	56	see Figure 4-5

If water conservation does not significantly reduce demand on the maximum day, unadjusted 2030 maximum day demands with the recommended configuration cause pressures to drop up to 10 psi to 46-56 psi as shown in Figure 4-5. As these reduced pressures are unacceptable given customer plumbing, fire sprinklers, and current fire hydrant flows, upsizing some of the supply pipelines from Oakland will be critical to maintaining service pressures closer to the “existing conditions”. Figure 4-6 shows the general location critical pipes serving Alameda. These transmission mains must eventually be upsized to maintain the existing level of service for Alameda and Bay Farm Island.

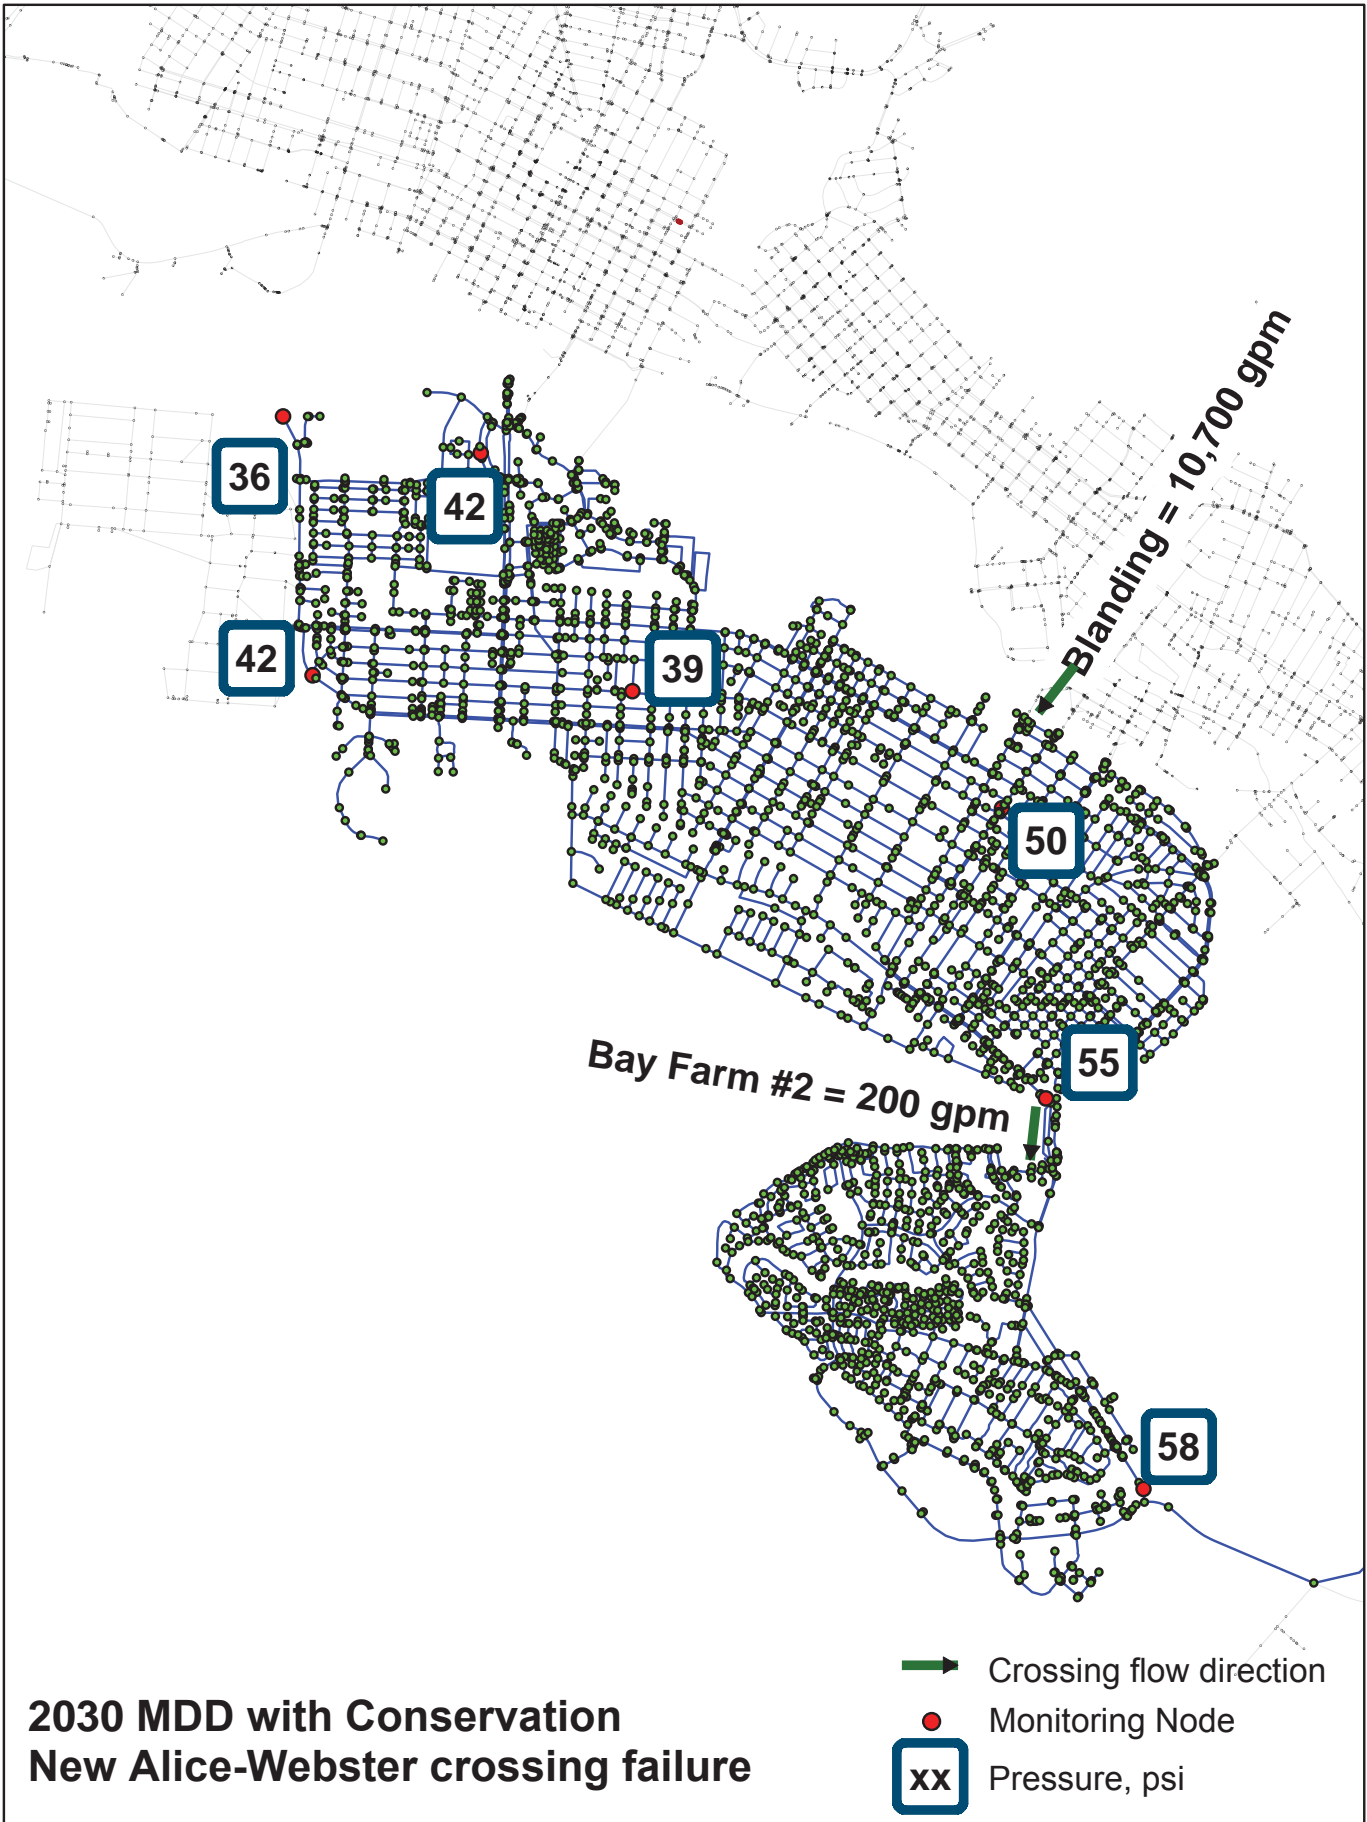
Alice-Webster Crossing Failure, 2030 Crossing Flows and Pressures

In case of a failure of the Alice-Webster crossing (or the new Estuary Park crossing), pressures drop to the levels shown in Figure 4-7. In this case, Blanding (or the new Derby crossing if in service) provides all the flow to Alameda and Bay Farm Island. The most significant pressure reduction is seen in the Alameda Point area (modeled as one node) where pressures fall below 40 psi to 36 psi.

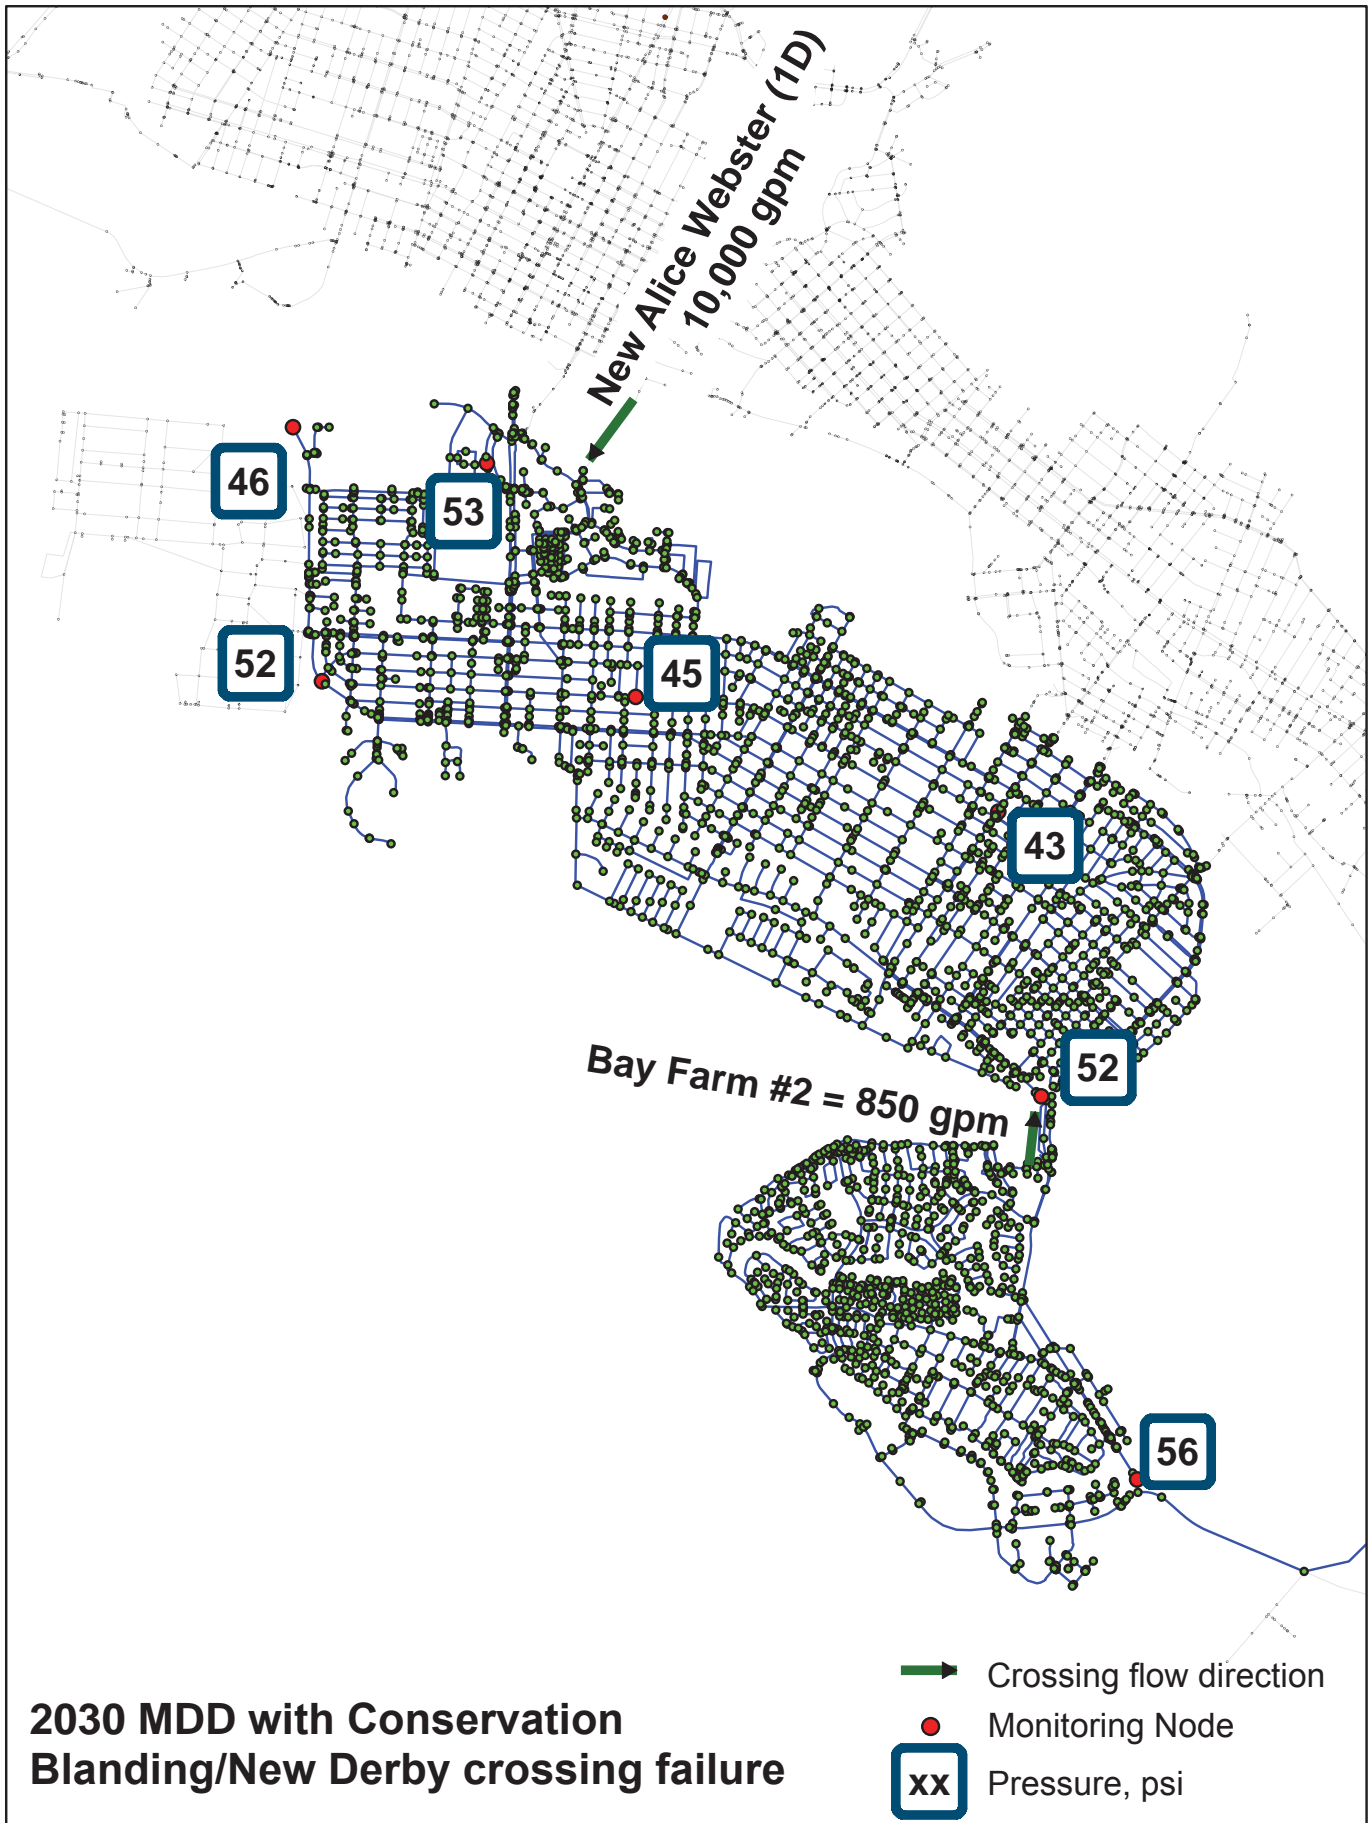
Blanding Crossing Failure, 2030 Existing Crossing Flows and Pressures

5	2030 MDD, New 24" Alice-Webster @ 1D, After Blanding Failure	7300		4800	-1200	53	60	60	54	54	60	60	
6	2030 MDD, New 24" Alice-Webster @ 1D, After Blanding and Park Street Failures	10000			850	46	52	53	45	43	52	56	see Figure 4-8
7	2030 MDD, New 24" Alice-Webster @ 1D and New 24" Derby @ 3A, After Blanding and Park Failures	6500		6200	-1800	55	61	62	55	57	62	61	
8	2030 MDD, New 24" Alice-Webster @ 1D, After BF#2 Failure	5500	3900	1500		57	63	64	58	59	66	58	
9	2030 MDD, New 24" Alice-Webster @ 1D and New 27" Derby @ 3A, After Blanding & Park Failures	6300		6500	-1900	55	62	62	56	58	62	61	
10	2030 MDD, New 24" Alice-Webster @ 1D and New 36" Derby @ 3A, After Blanding & Park Failure	6100		6900	-2100	55	62	63	56	58	62	61	
11	2030 MDD, New 24" Alice-Webster @ 1D and New 24" Derby @ 3A; no other crossings in service	5800		5000		56	63	63	57	58	66	58	
A	2030 MDD- <i>Unadjusted, Full Central Model</i> , New 24" Alice-Webster @ 1D, existing Blanding and Park	7500	6100	2500	-1800	47	56	58	51	54	57	57
