Alameda-North Bay Farm Island Crossings Master Plan

*East Bay Municipal
Utility District*

November 2014

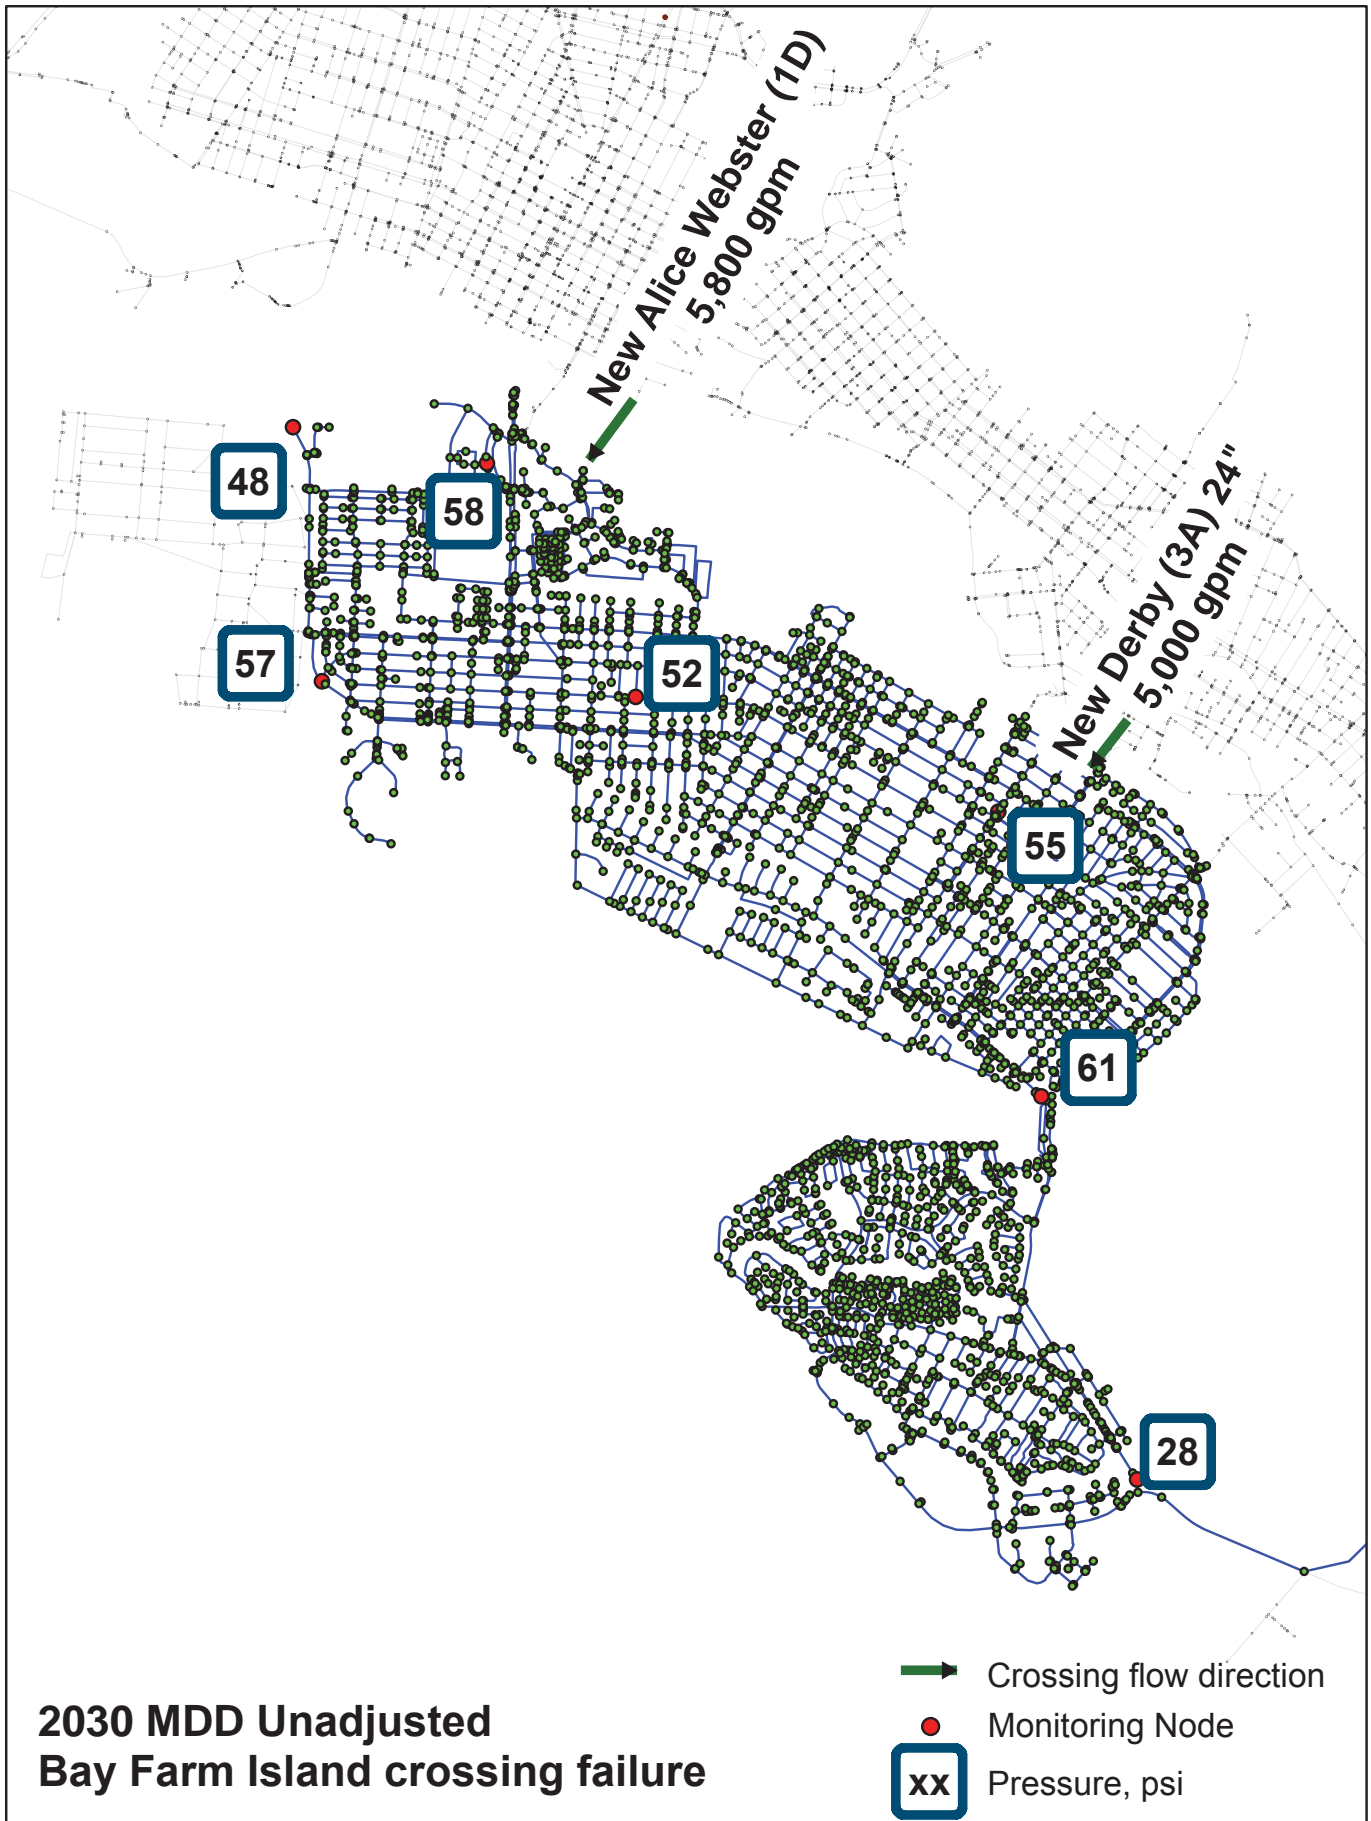
Bay Farm Island Crossing Failure, 2030 Existing Crossing Flows and Pressures

B	2030 MDD- <i>Unadjusted, Full Central Model</i> , New 24" Alice-Webster @ 1D, Replace Derby @ 3A (24")	7400		7000		48	57	58	52	55	61	28	see Figure 4-9
C ⁴	2030 MDD- <i>Unadjusted, Full Central Model</i> , New 24" Alice-Webster @ 1D, Replace Derby @ 3A (24"), New 24" crossing @ 2A/BF#2	8000		8000	-1700	46	54	56	50	52	56	56	see Figure 4-5

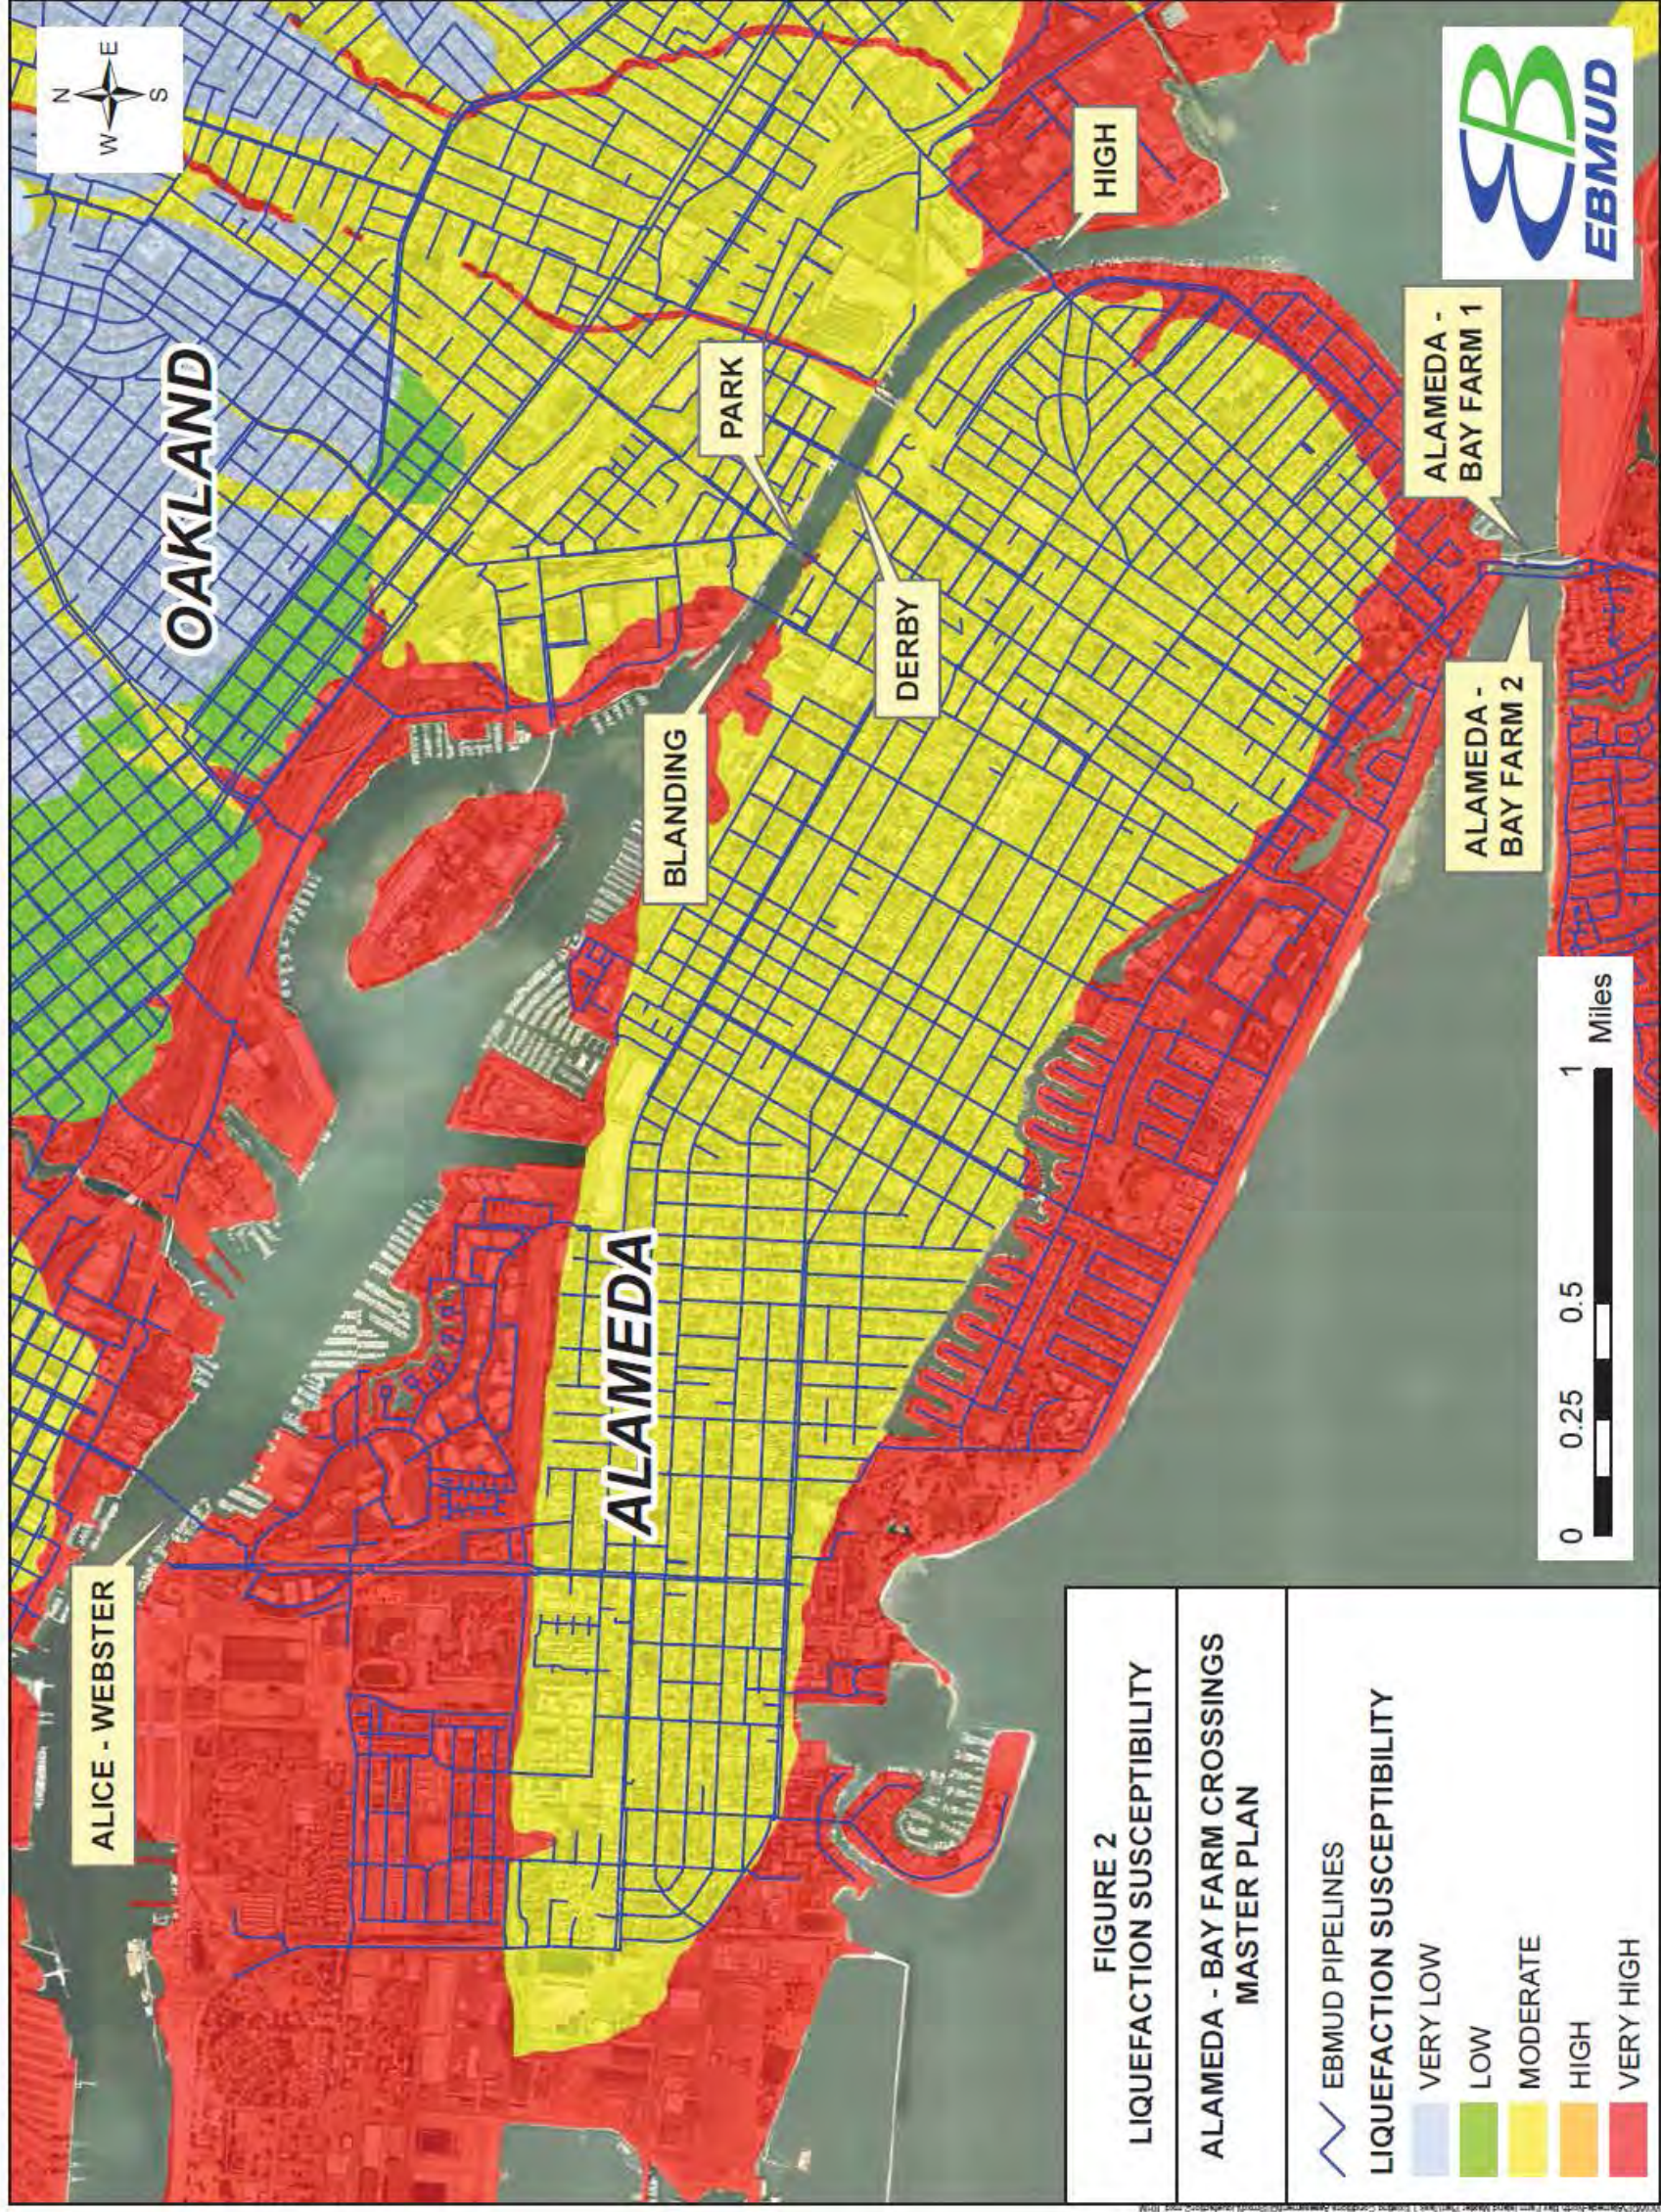
Soil Susceptibility to Liquefaction

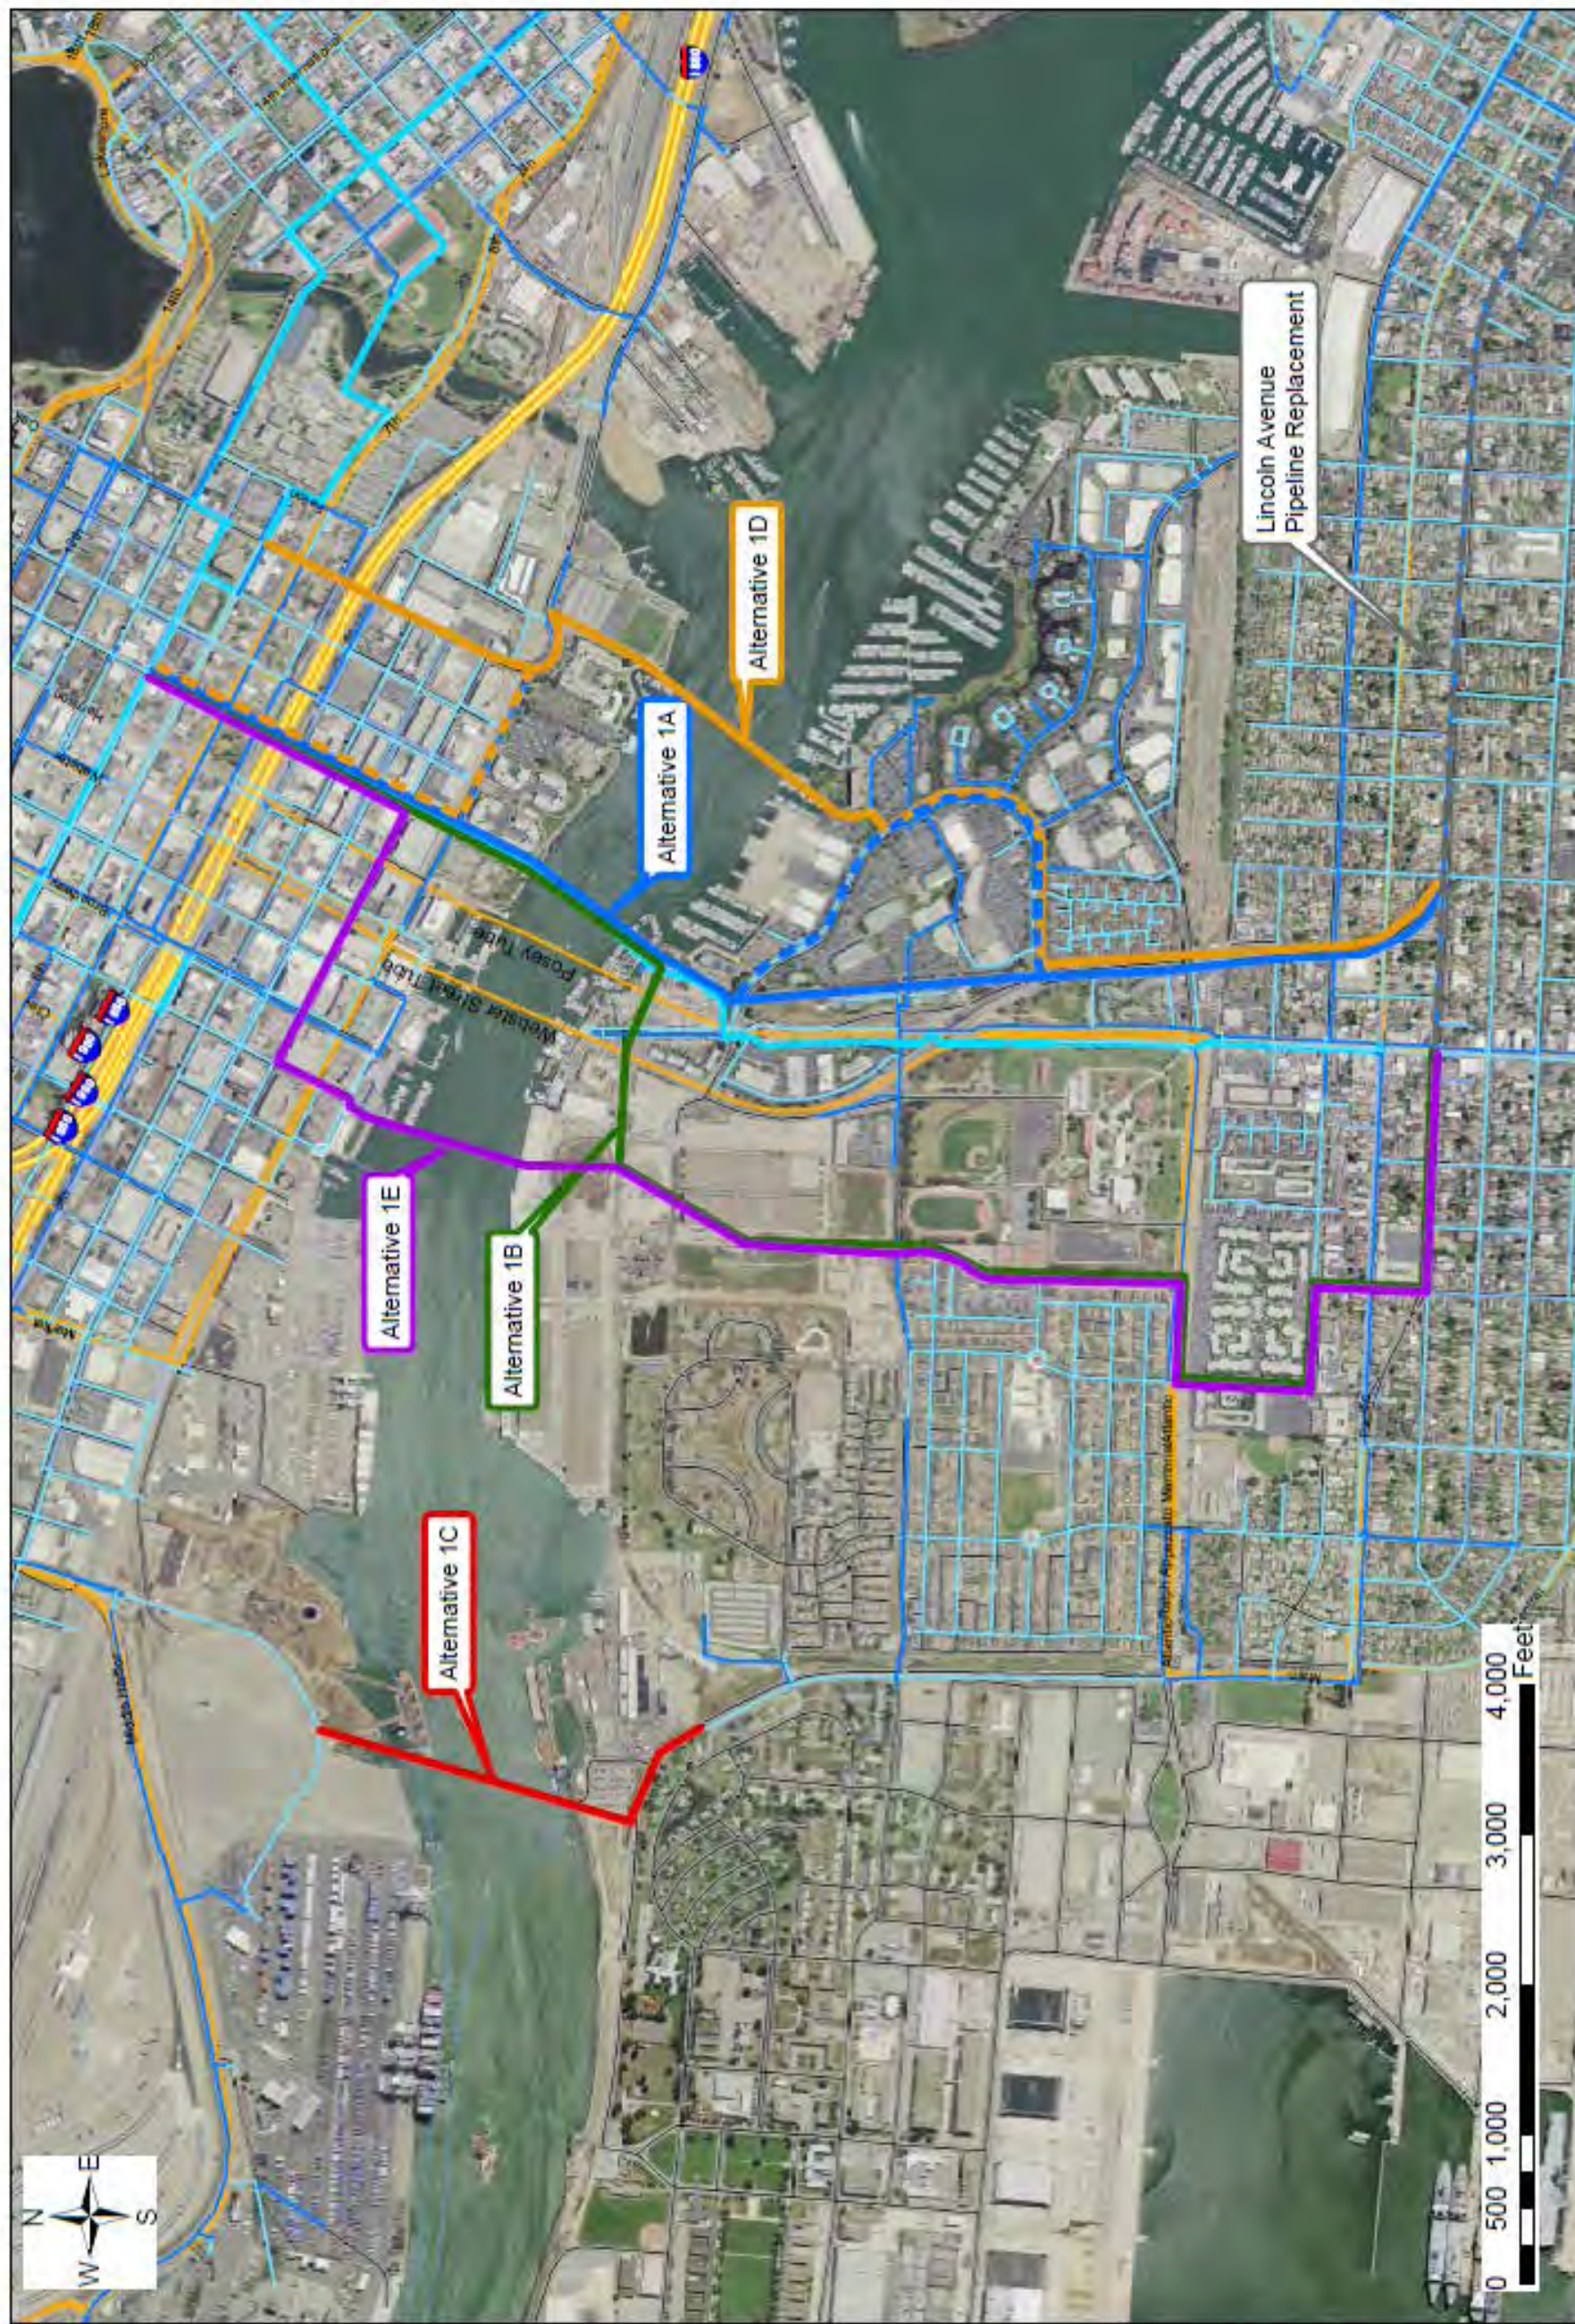
Alternative Alignments in Alice-Webster Vicinity

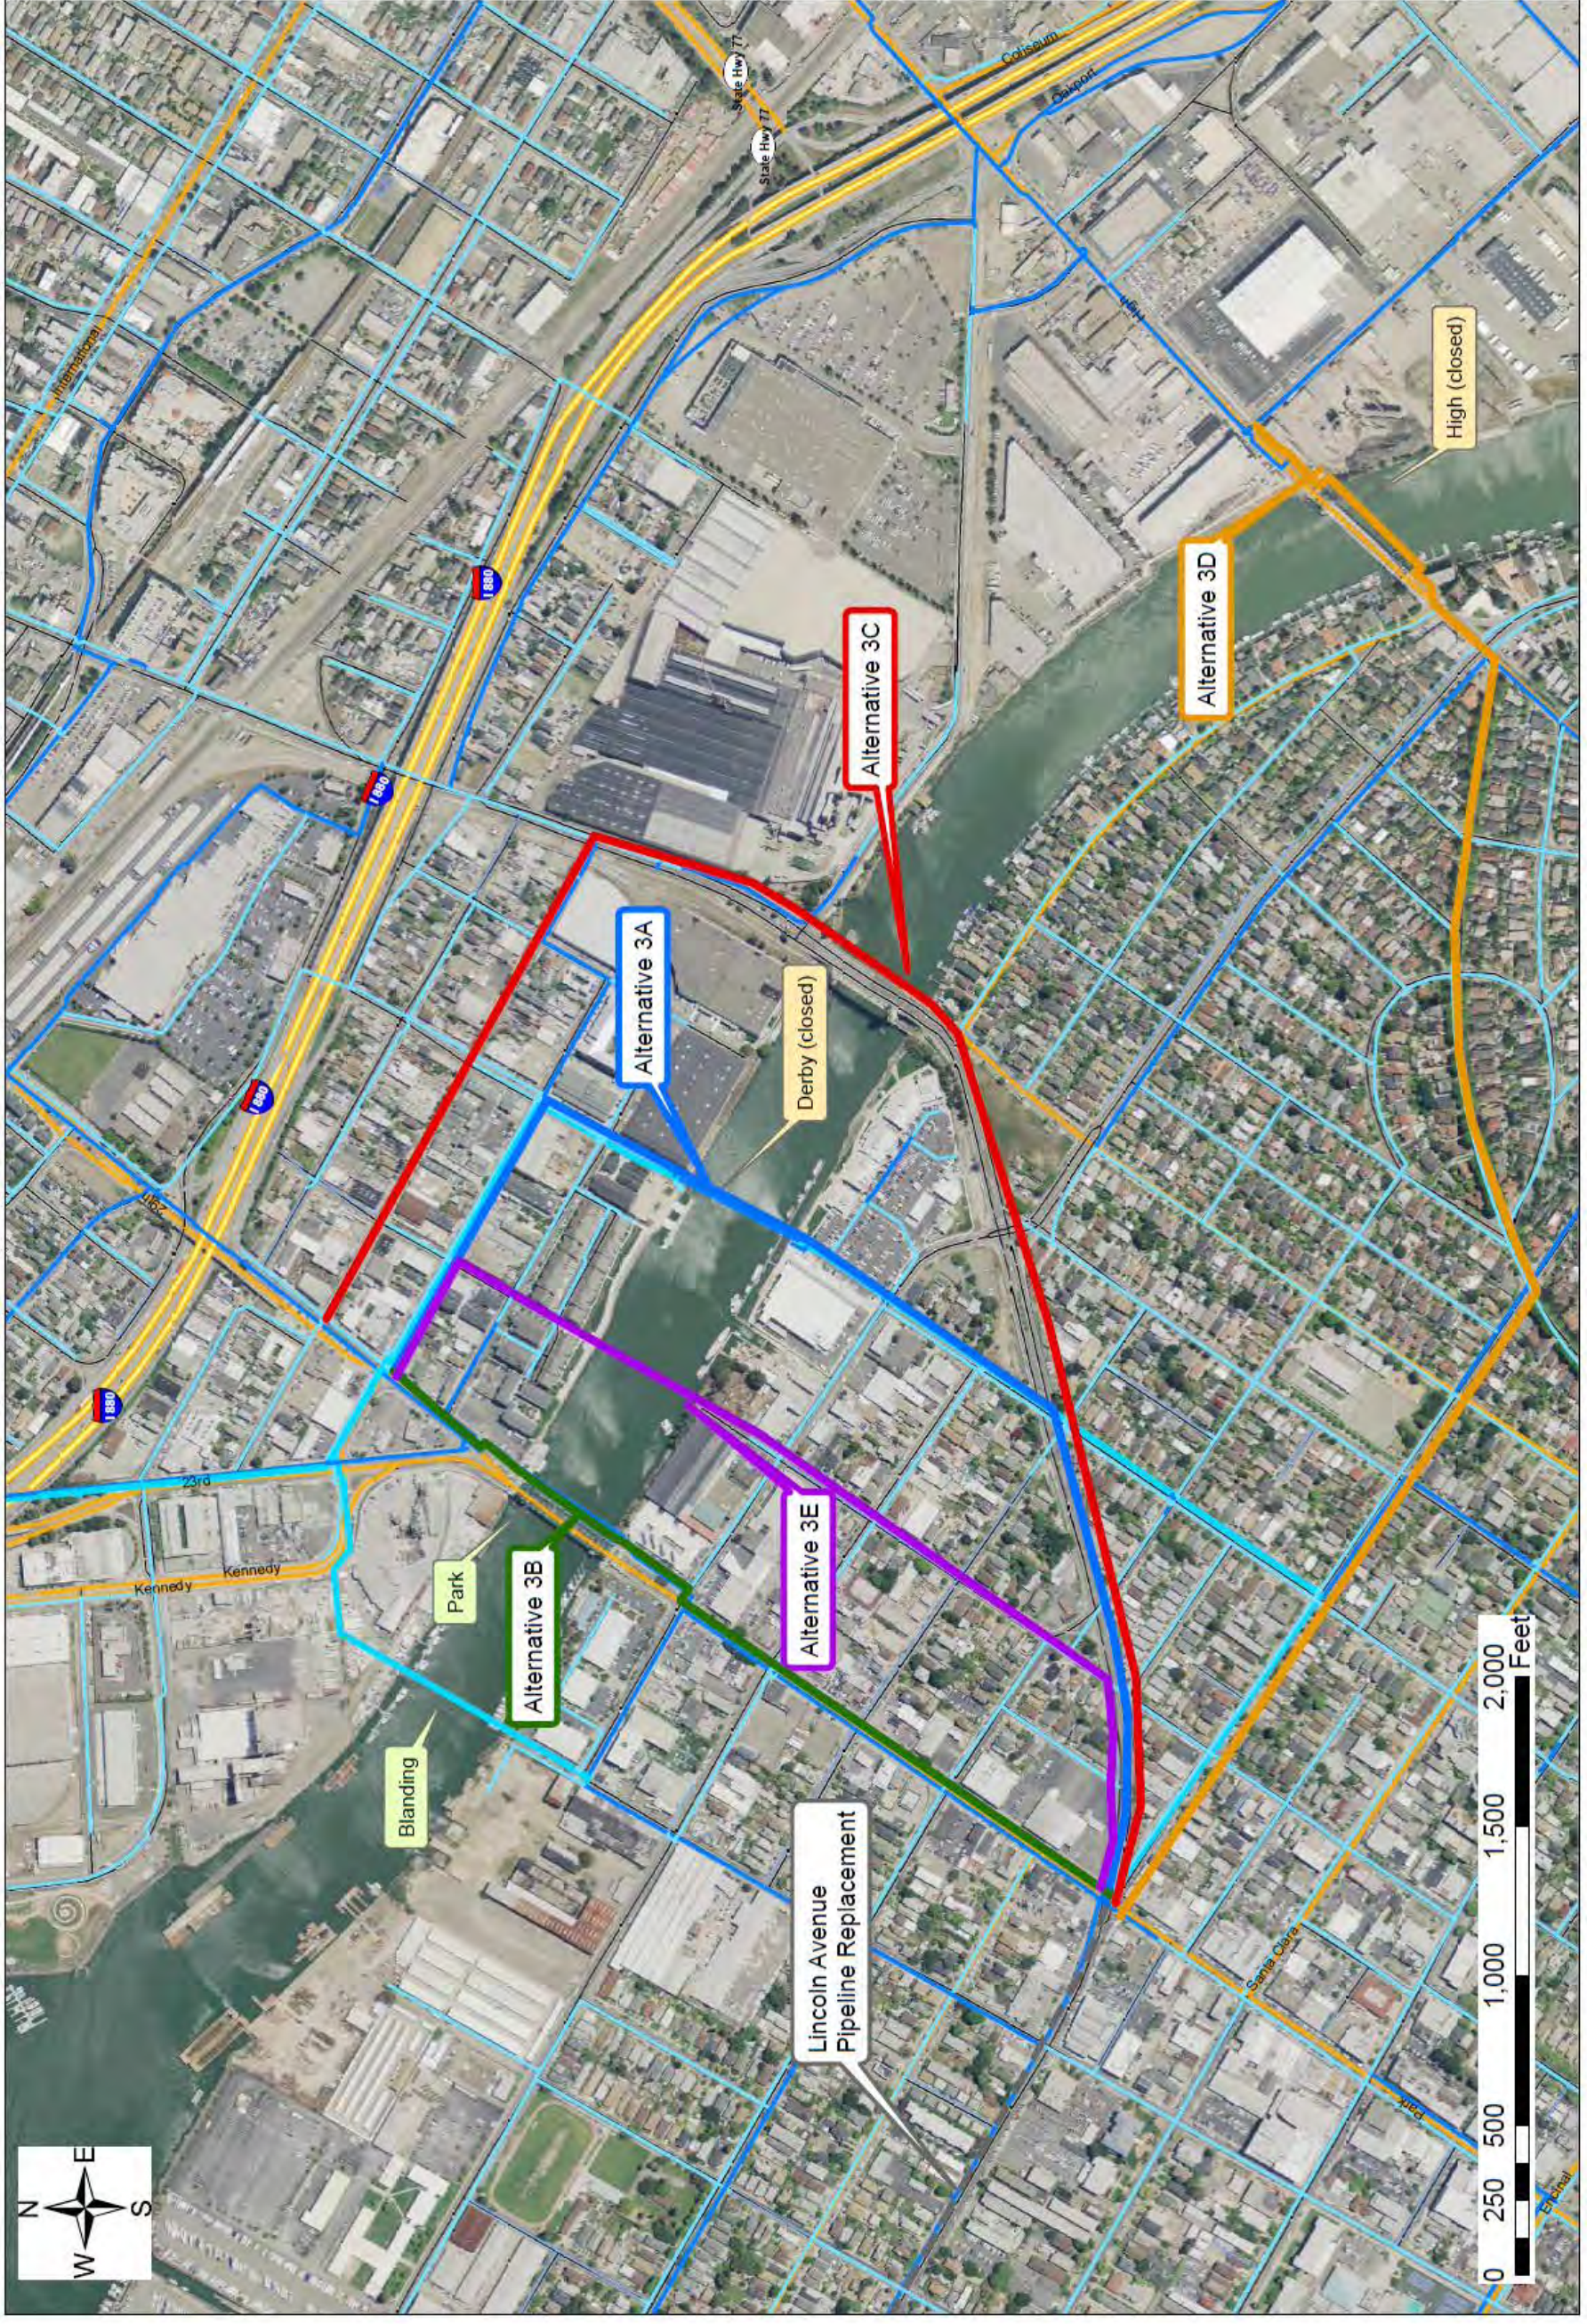
Alternative Alignments in Northeast Corridor Vicinity

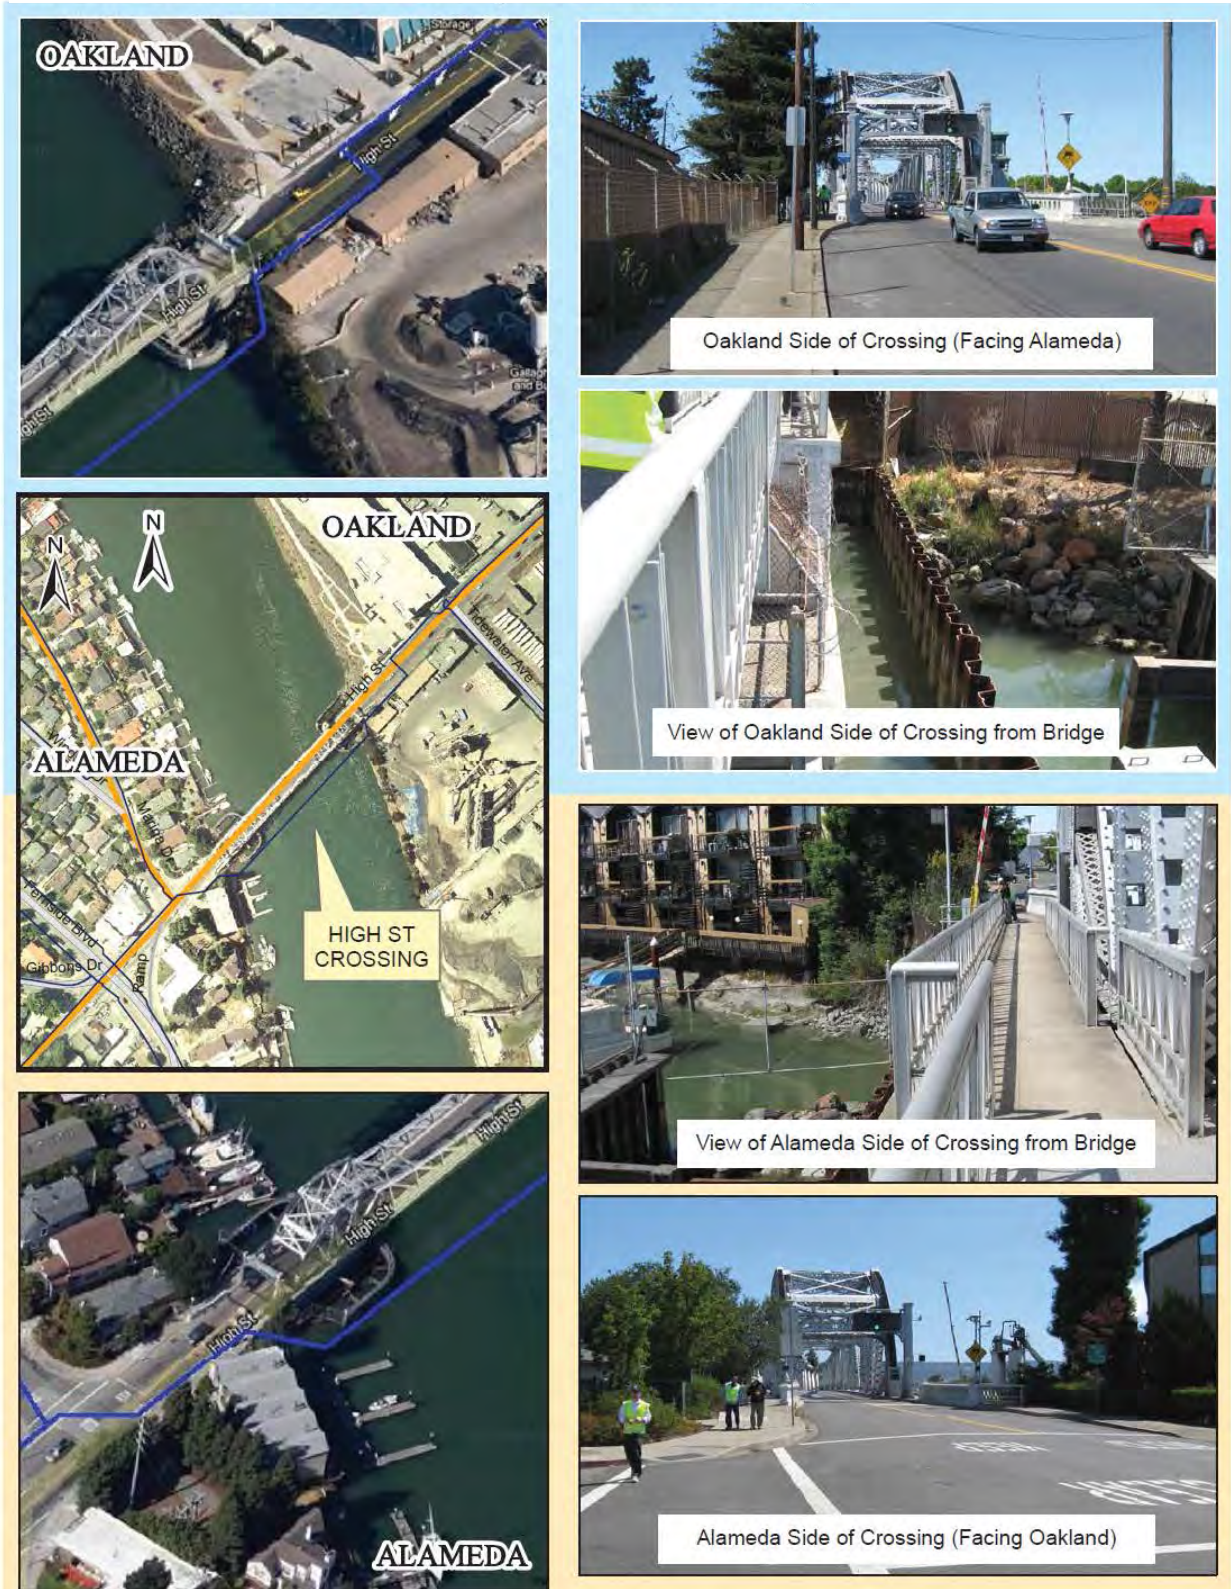
Figure 5-14

Alternative Alignment 3D Photos and Aerial

On the Oakland side of the crossing, the landing located in High Street in a narrow roadway (Figure 5-14). On the Alameda side of the crossing, the landing is located in High Street as well, in a busy intersection with high traffic.

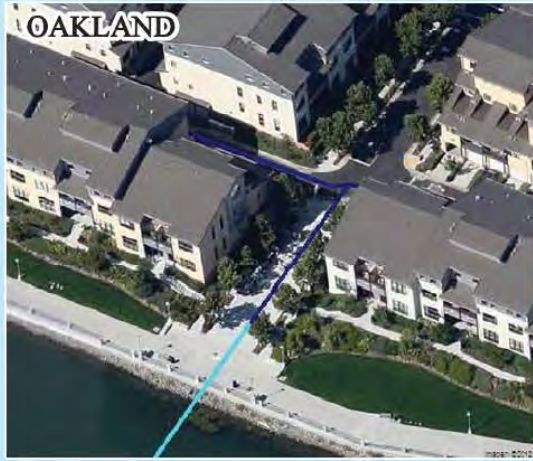
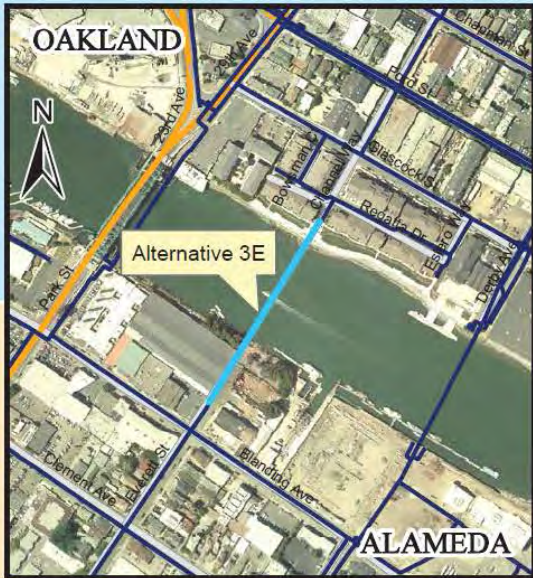
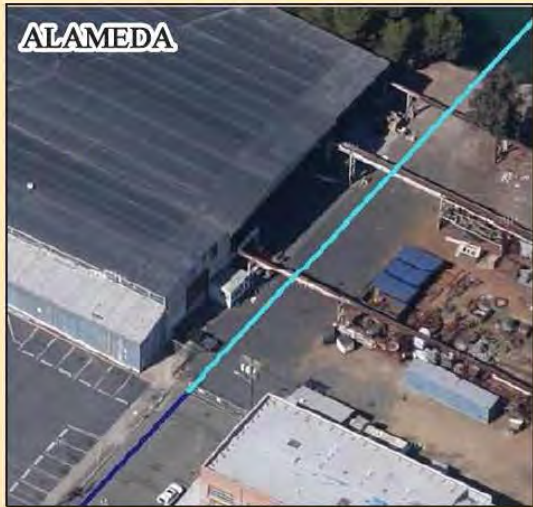
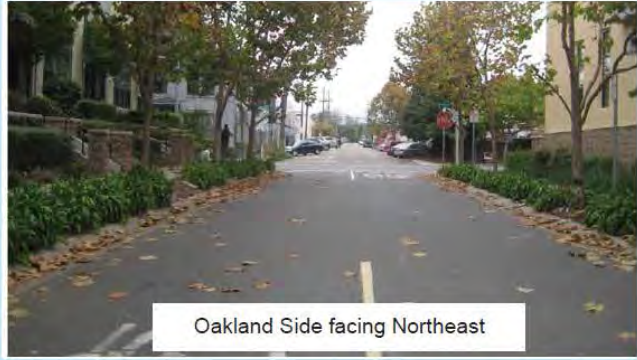
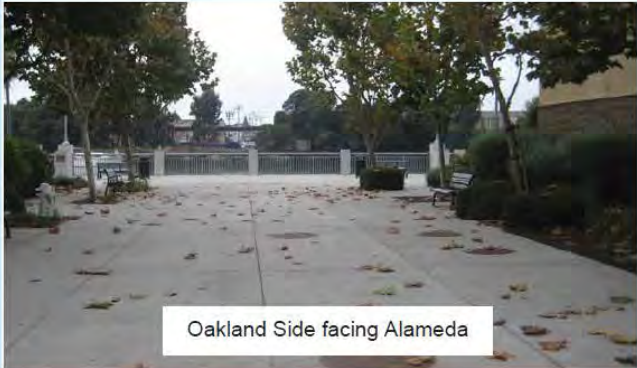
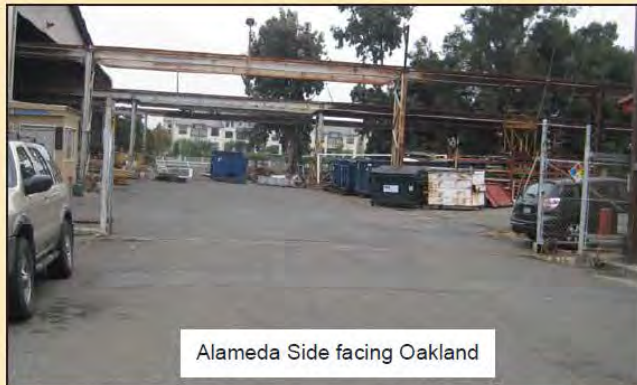
Figure 5-15

Alternative Alignment 3E Photos and Aerial

On the Oakland side of the crossing, the landing is located within narrow private streets, surrounded by multi-story condominium units (Figure 5-15). However, there is an existing 20-foot R/W through the multi-unit housing. On the Alameda side of the crossing, the landing is located in a private steel fabrication yard, which would require an easement. Overall, both of these landing locations are on private property, in congested areas, and do not provide much room for construction access.

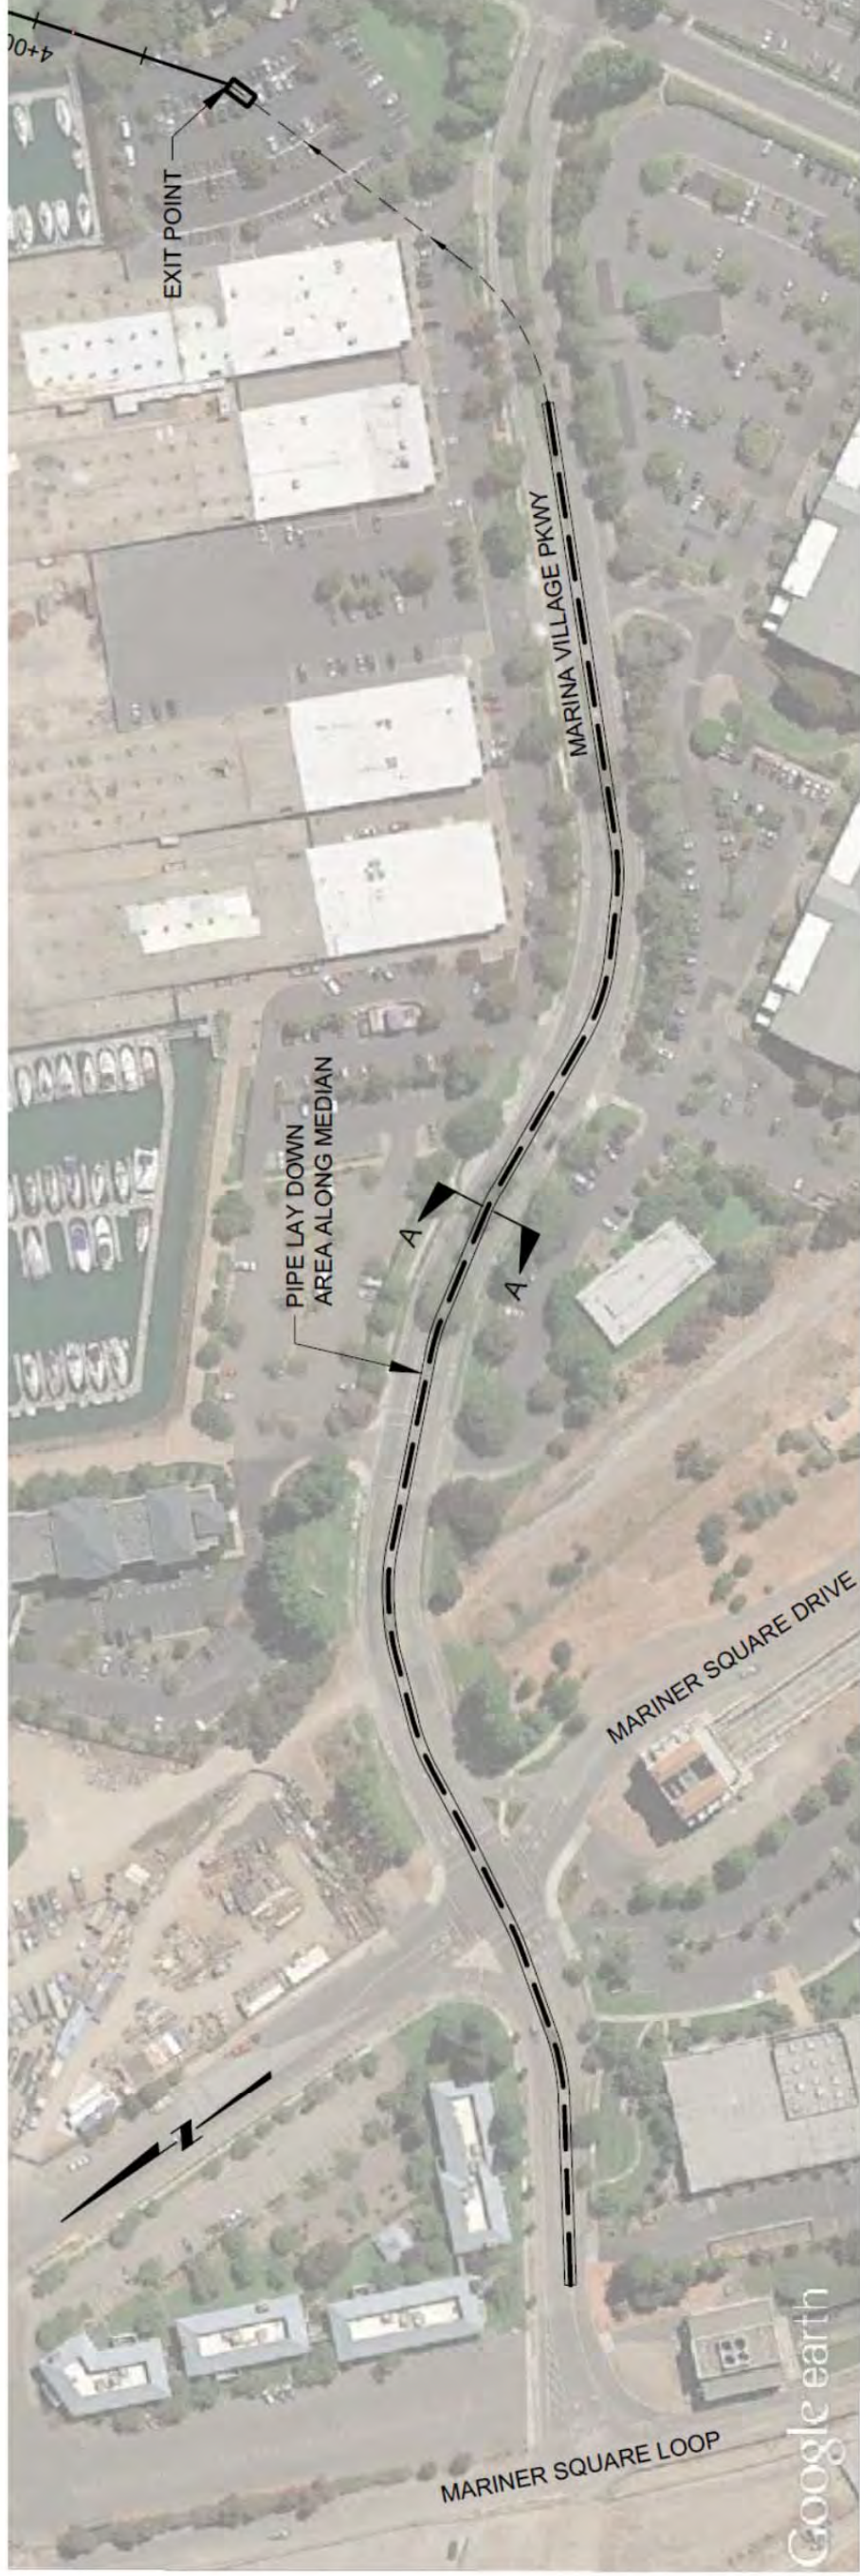
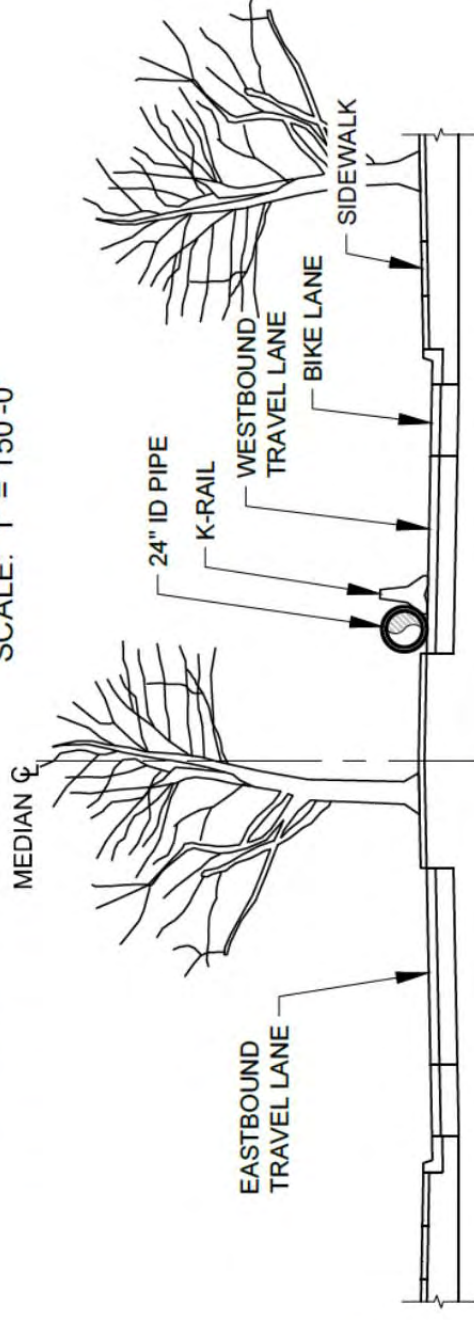
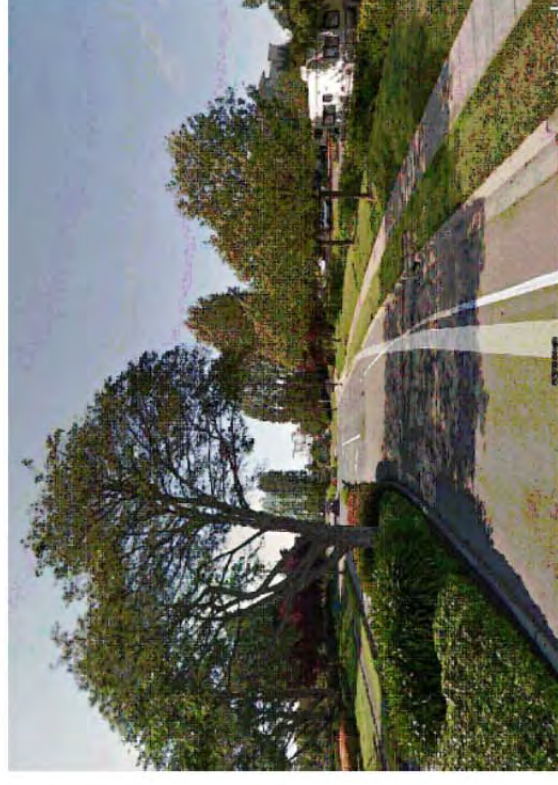
Figure 6-1

PLAN

SECTION A-A

HDD Alternative 1D Pipe Laydown Area

Alignment 1D is the recommended new crossing alignment in the Alice-Webster crossing area and detailed planning, design, and construction should proceed. The HDD alignment crosses the Alameda Channel from a gated parking lot at Estuary Park in Oakland to a private parking lot between 1080 and 1100 Marina Village on Alameda Island and is approximately 1,780 feet in length (Figure 2-2). The laydown area for the pipe fusion is along the east side of the median strip of Marina Village Parkway on the Alameda side (Figure 6-1).
