Alameda-North Bay Farm Island Crossings Master Plan

*East Bay Municipal
Utility District*

November 2014

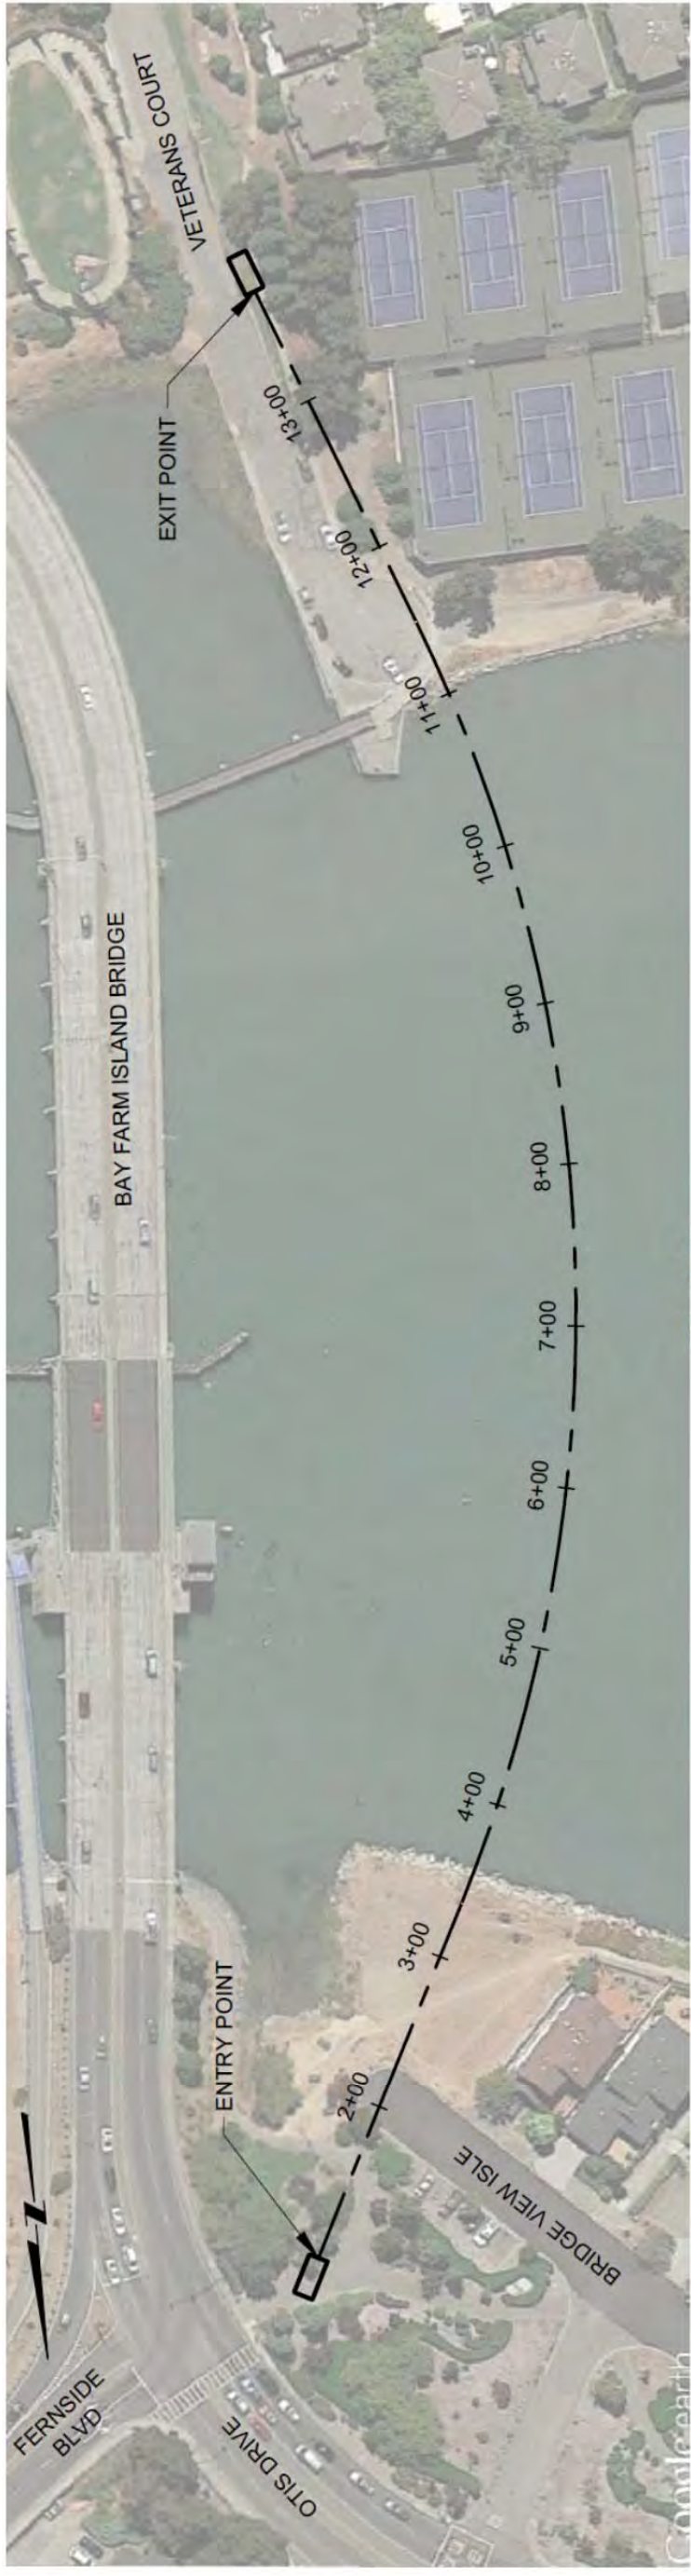
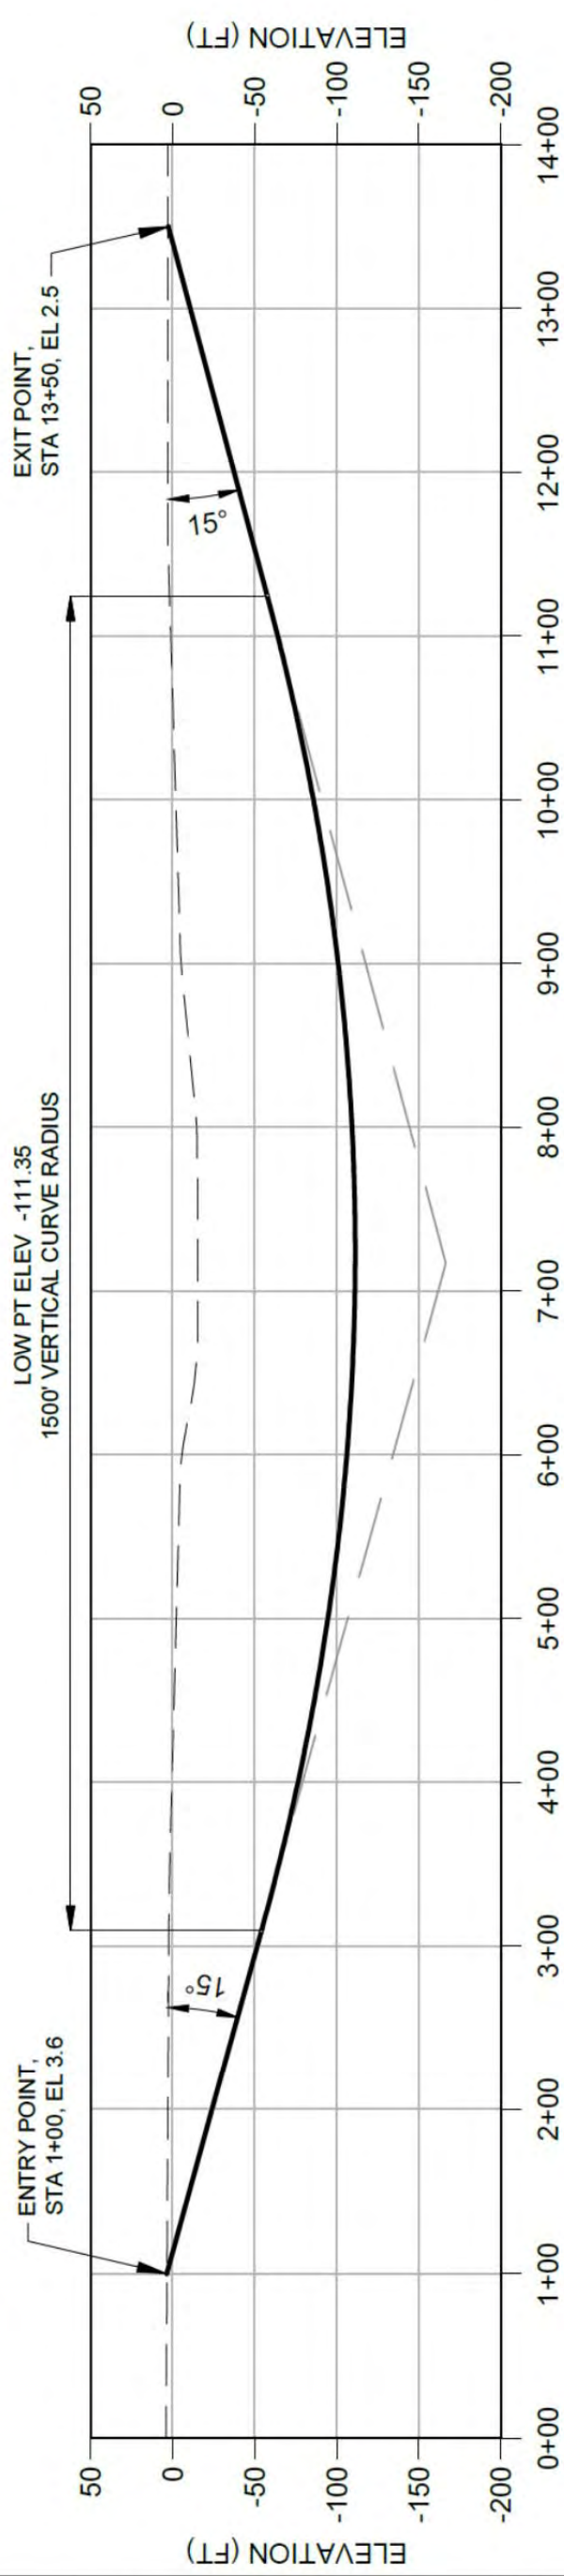
LOW PT ELEV. -111.35
1500' VERTICAL CURVE RADIUS

Figure 6-2
HDD Alternative 2A Plan and Profile

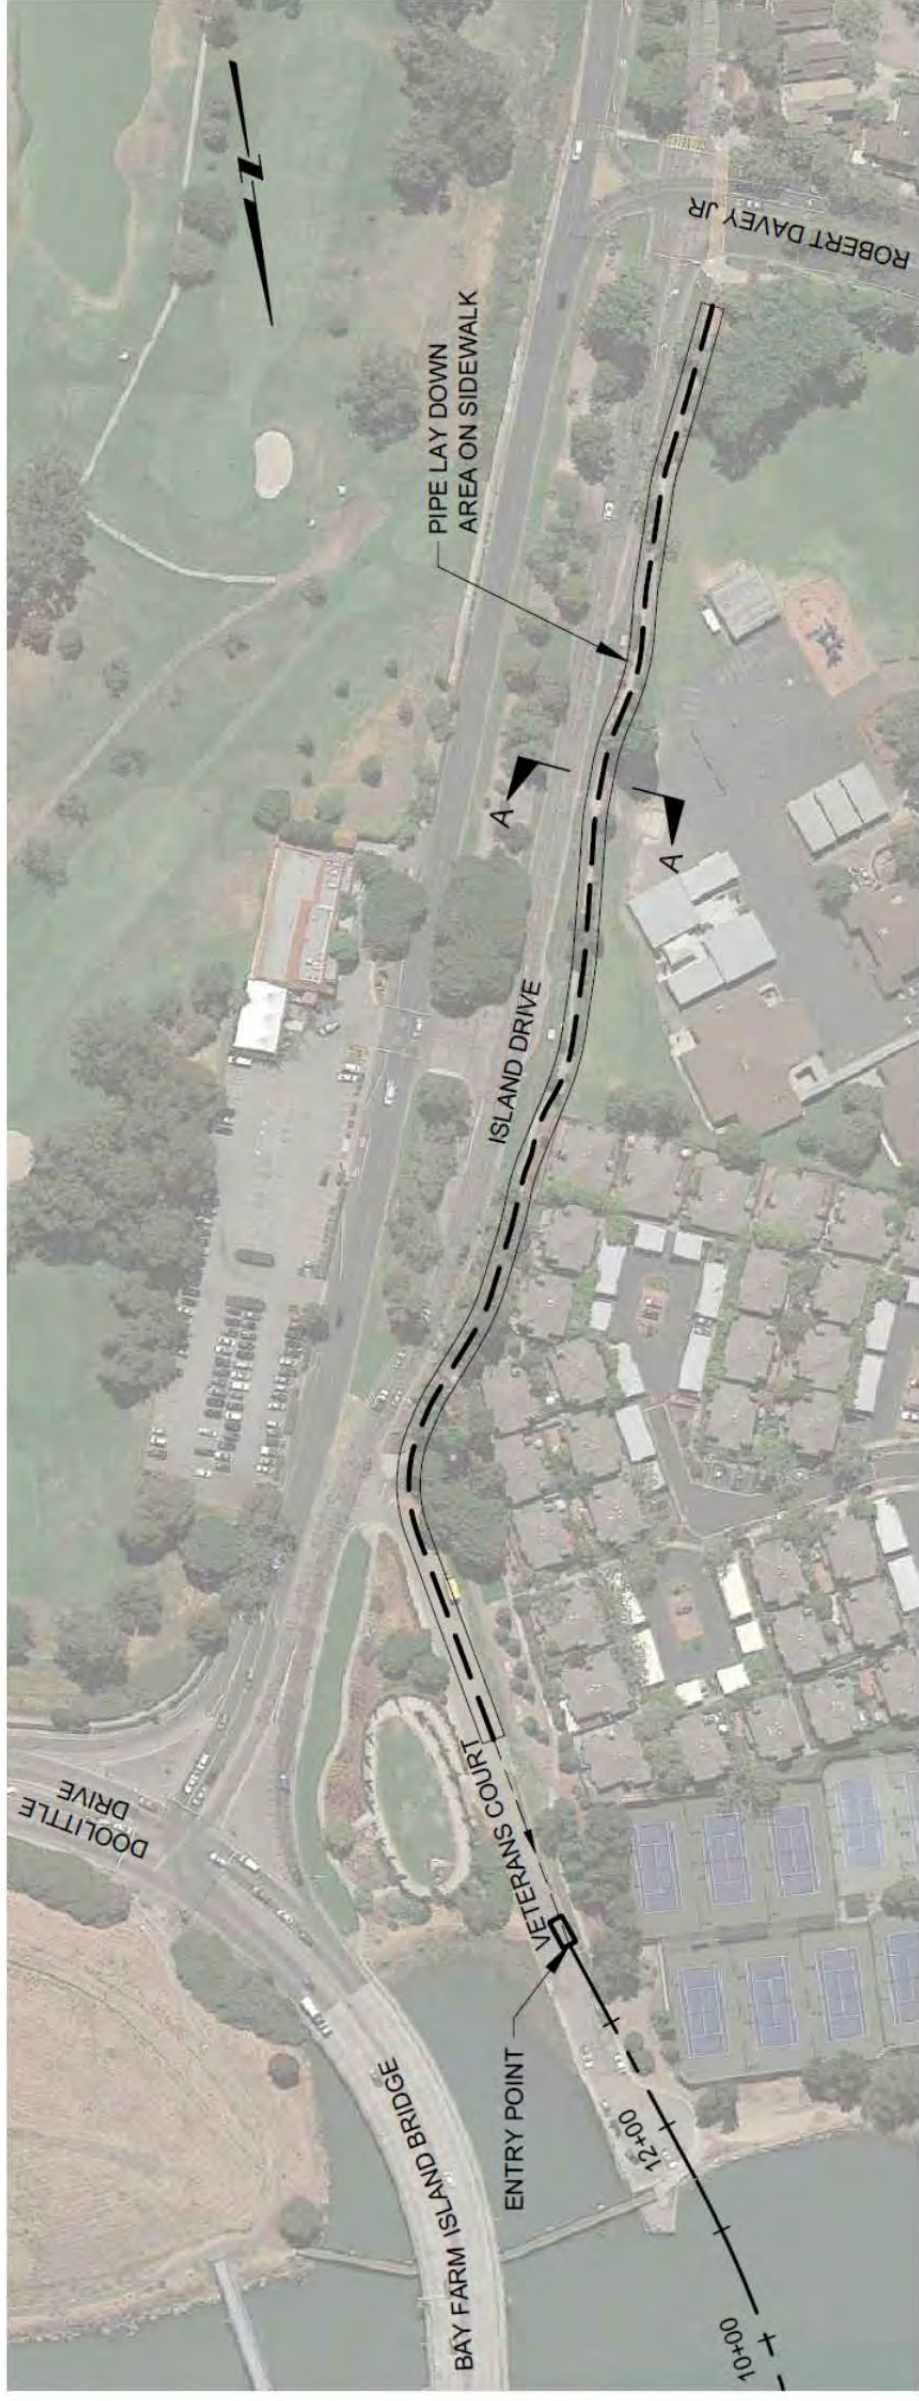
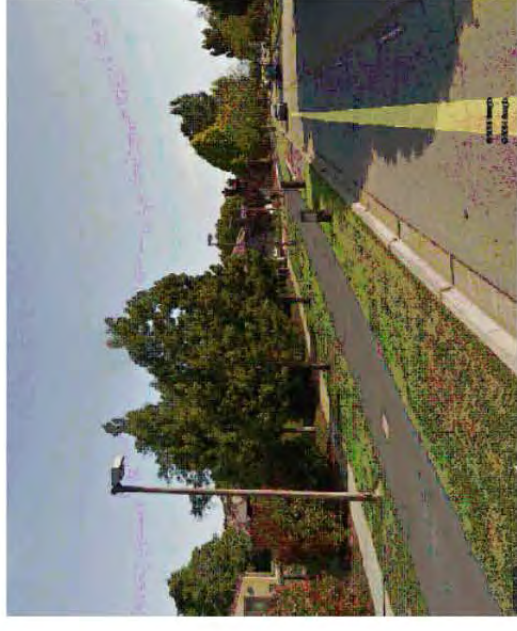
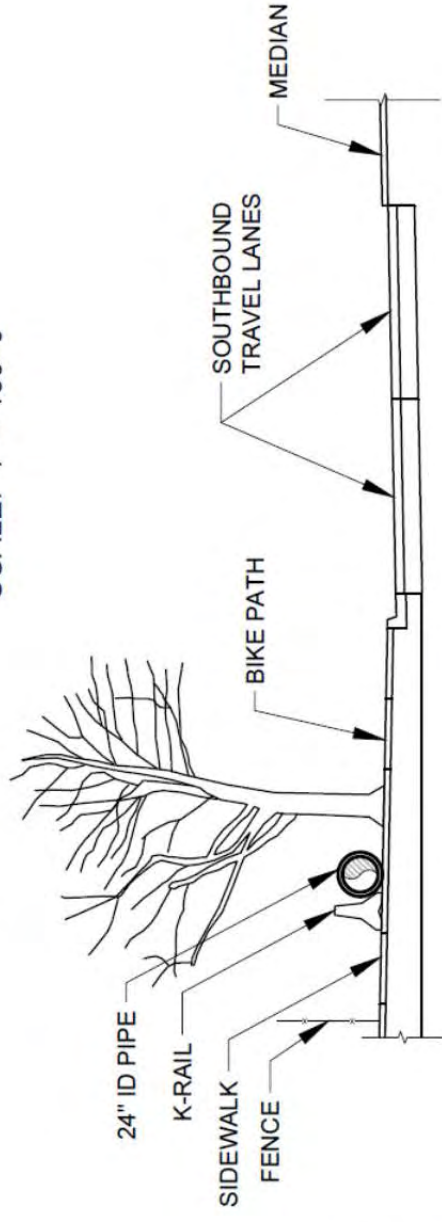
PLAN

SECTION A-A

Figure 6-3
HDD Alternative 2A Pipe Laydown Area

Upon sign of failure of the existing Alameda Bay Farm Island #2 crossing, a new crossing at this same location is recommended. Alignment 2A crosses the Alameda Channel from Veterans Court on North Bay Farm Island to Towata Park, just beyond Bridgeview Isle, on the Alameda side and is approximately 1,250-feet in length (Figure 6-2). The laydown area for the pipe fusion would be along Veterans Court and then turning south along Island Drive

on Bay Farm Island (Figure 6-3). For an assessment of recommended in-ground pipeline improvements associated with this alignment, see Appendix C.

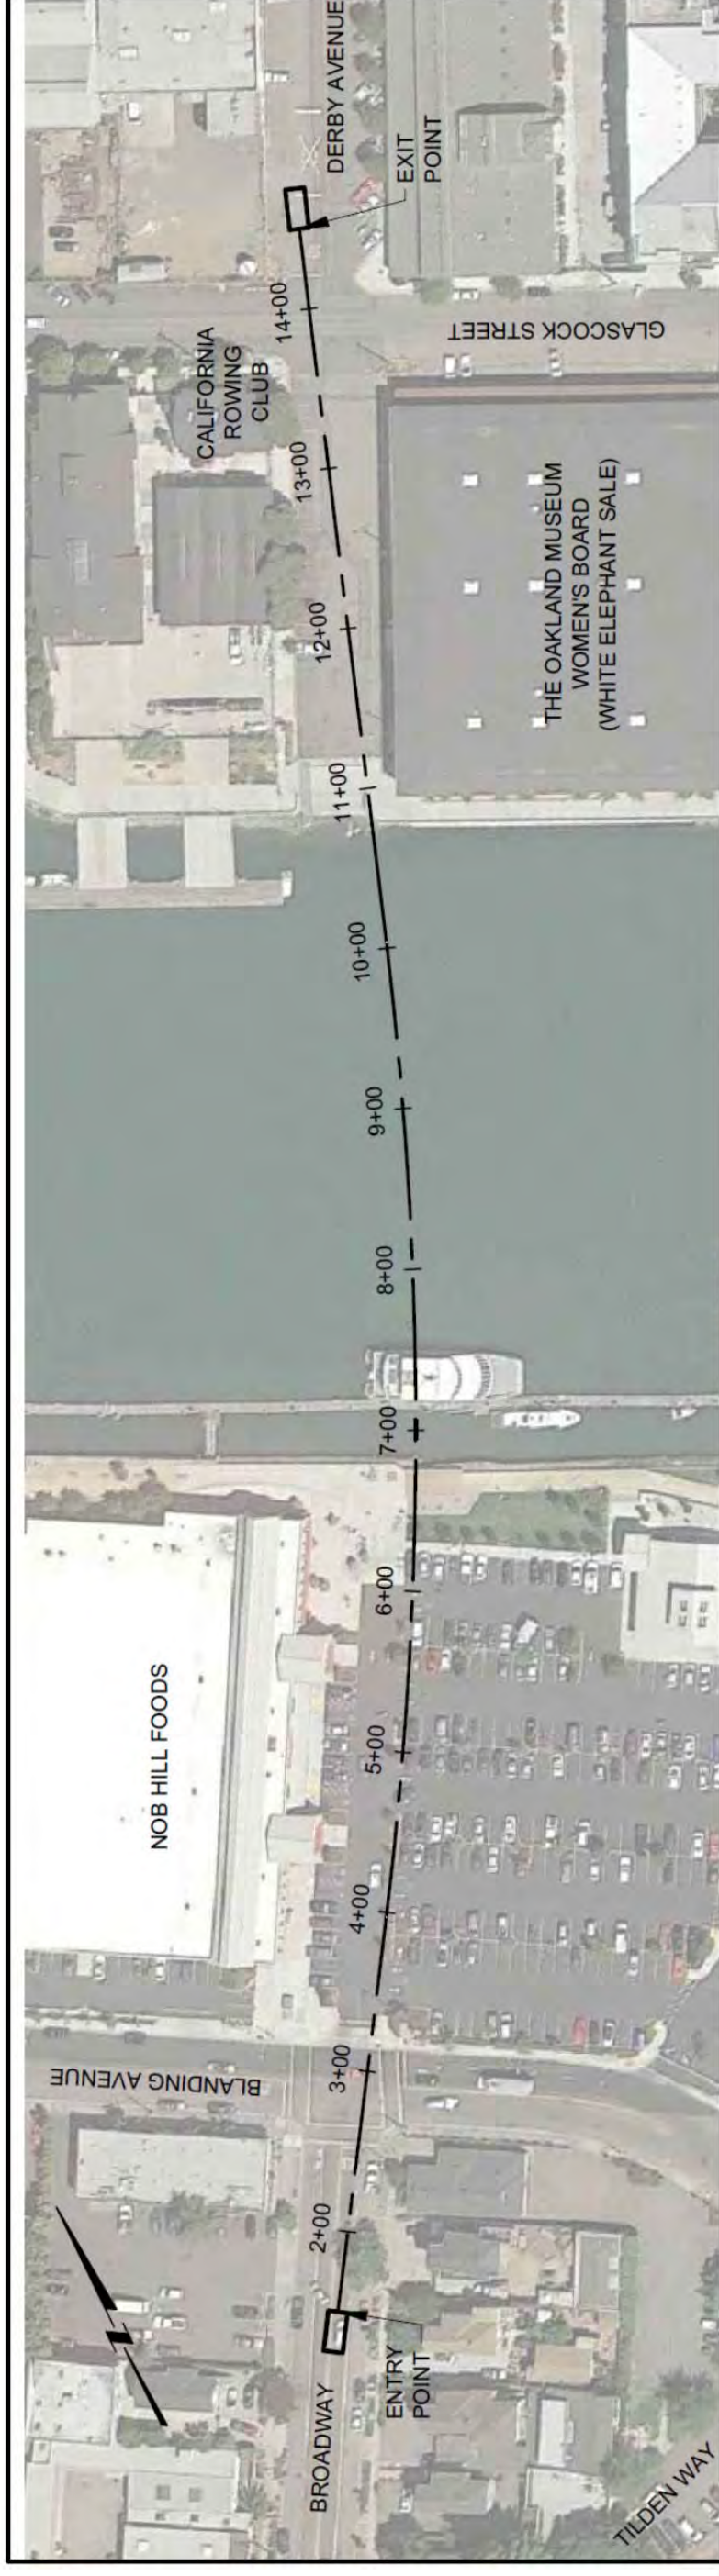
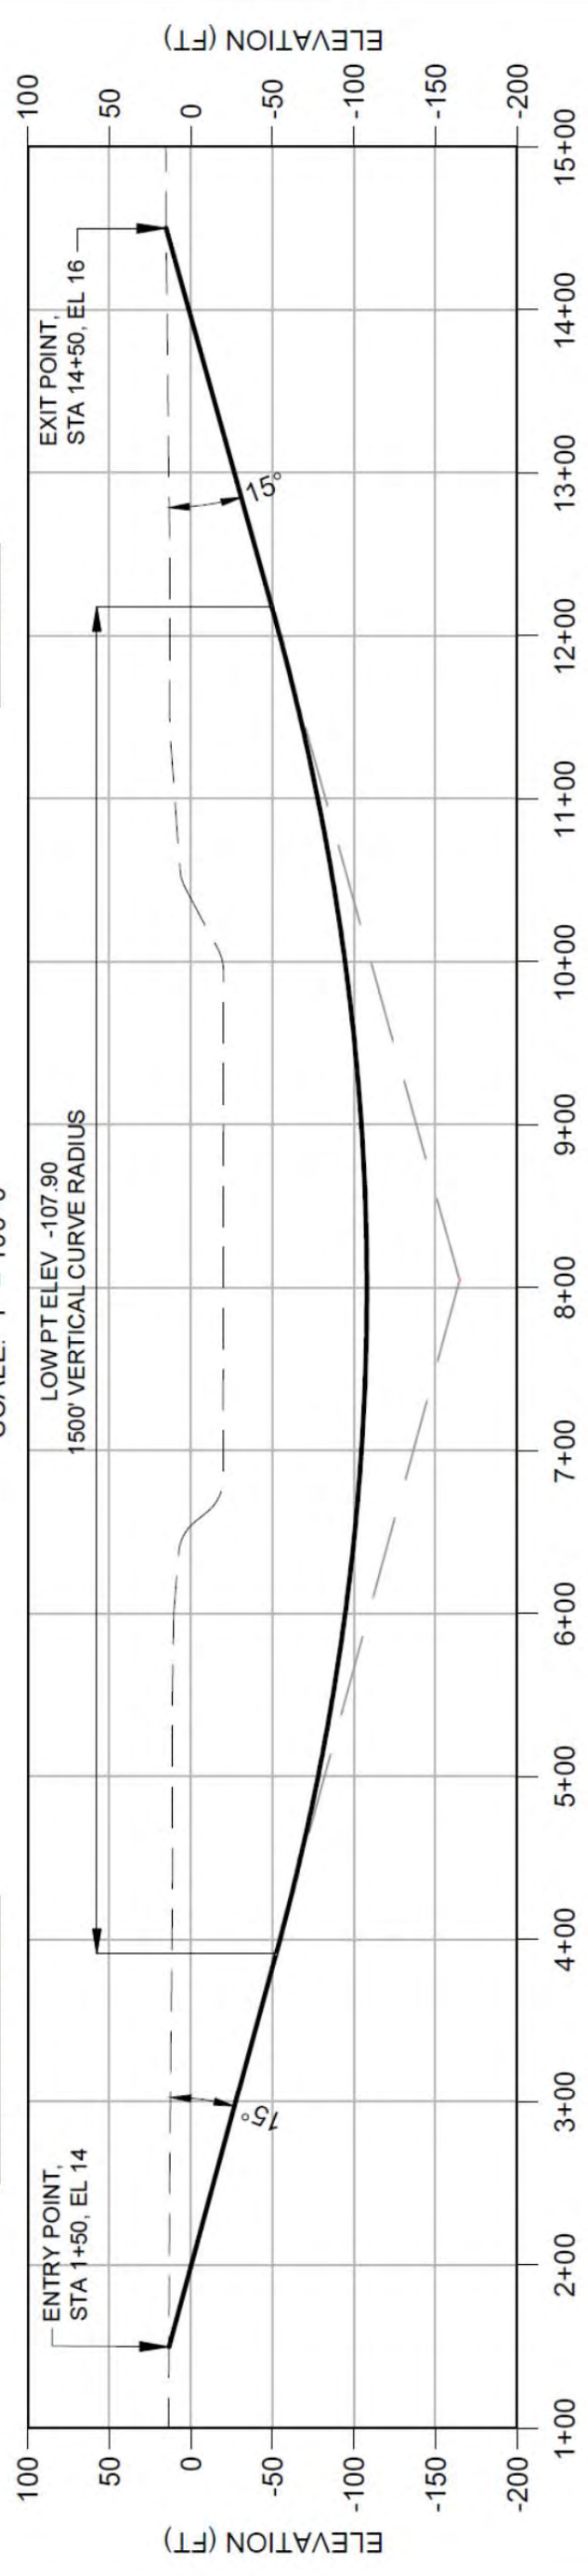
Figure 6-4

PLAN

PROFILE

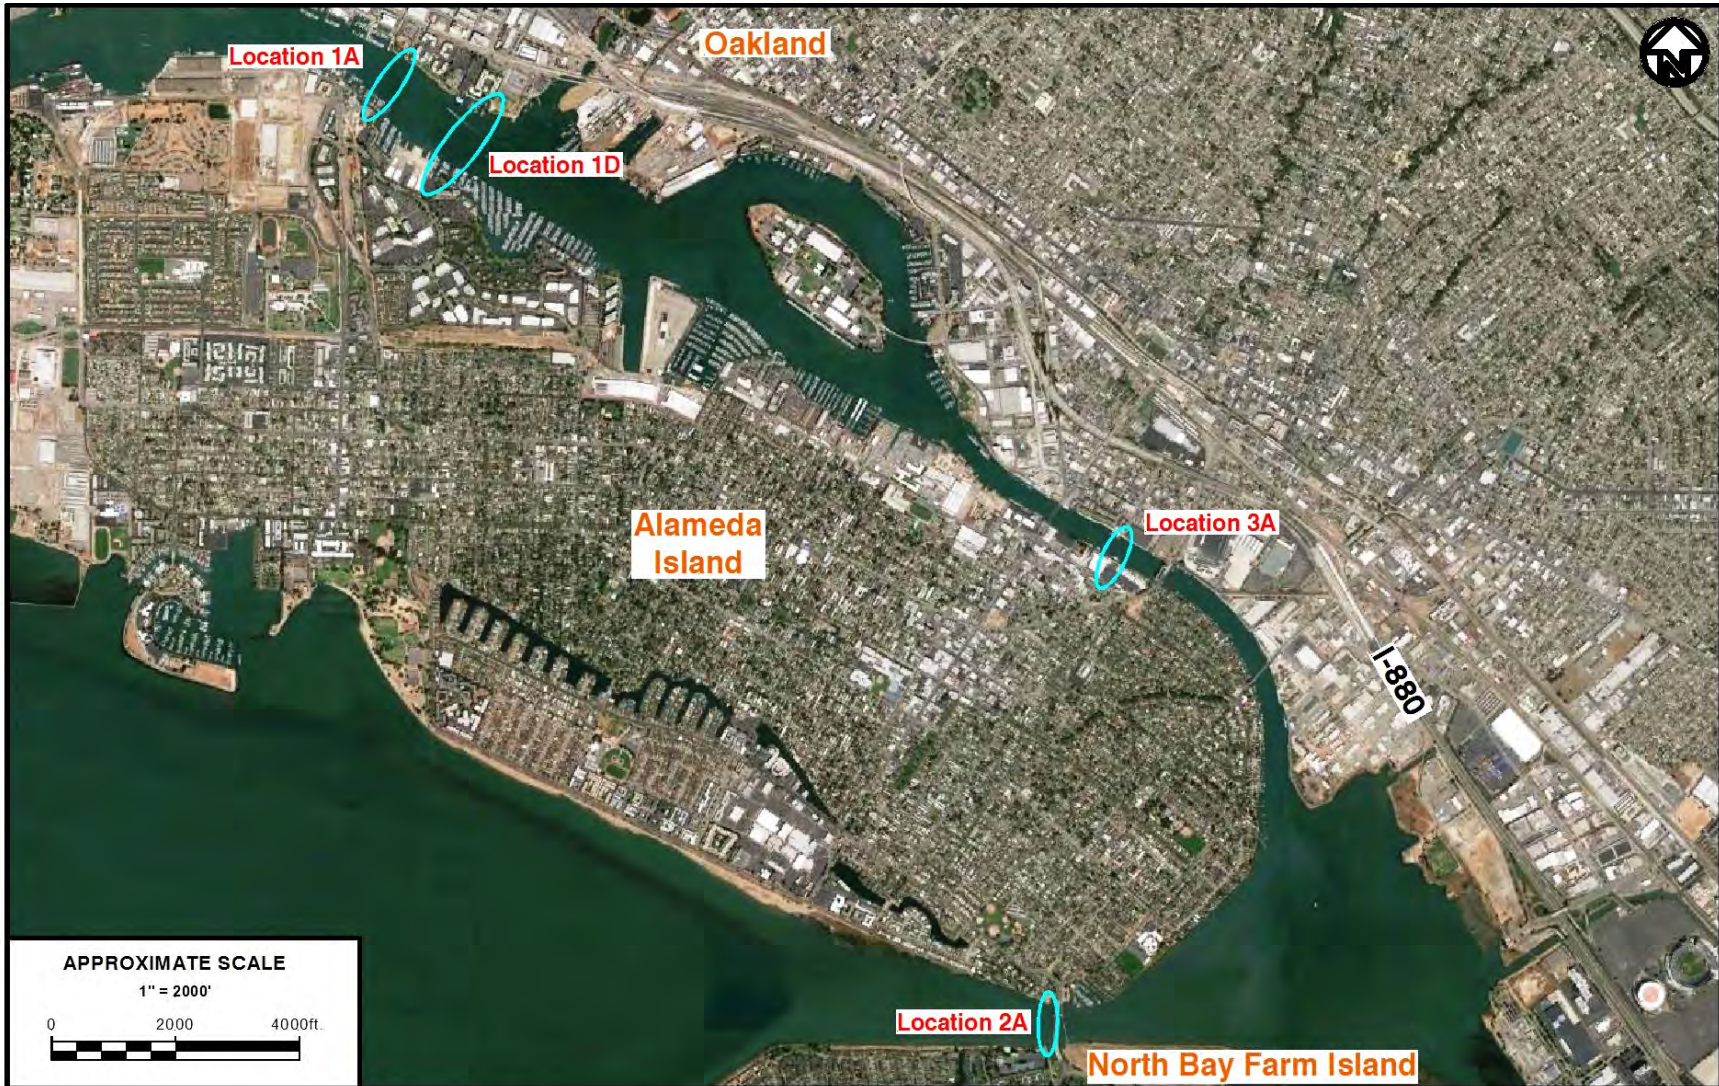
Figure 1-1. Proposed Pipeline Crossing Alternatives 1A and 1D (Oakland Inner Harbor), 2A (Bay Farm Crossing), and 3A (Derby Avenue)

The District has identified four preferred alignment alternatives at the three crossing areas shown in Figure 1-1: Alternatives 1A and 1D (Oakland Inner Harbor), 2A (Crossing to North Bay Farm Island), and 3A (Derby Avenue Crossing). This report presents the results of the feasibility study that examines the four proposed pipelines in terms of:

This section summarizes conditions for the new pipeline crossings at Alternative 1A, 1D, 2A, and 3A locations (Figures 1-1 and F-1). Information provided in this section is based on the (1) District-Jacobs Associates-G&E Engineering Systems’ site visit on May 28, 2013, (2) background information provided by the District, and (3) references cited herein. Copies of the photographs taken during the May 28, 2013 site visit are provided in Appendix I.

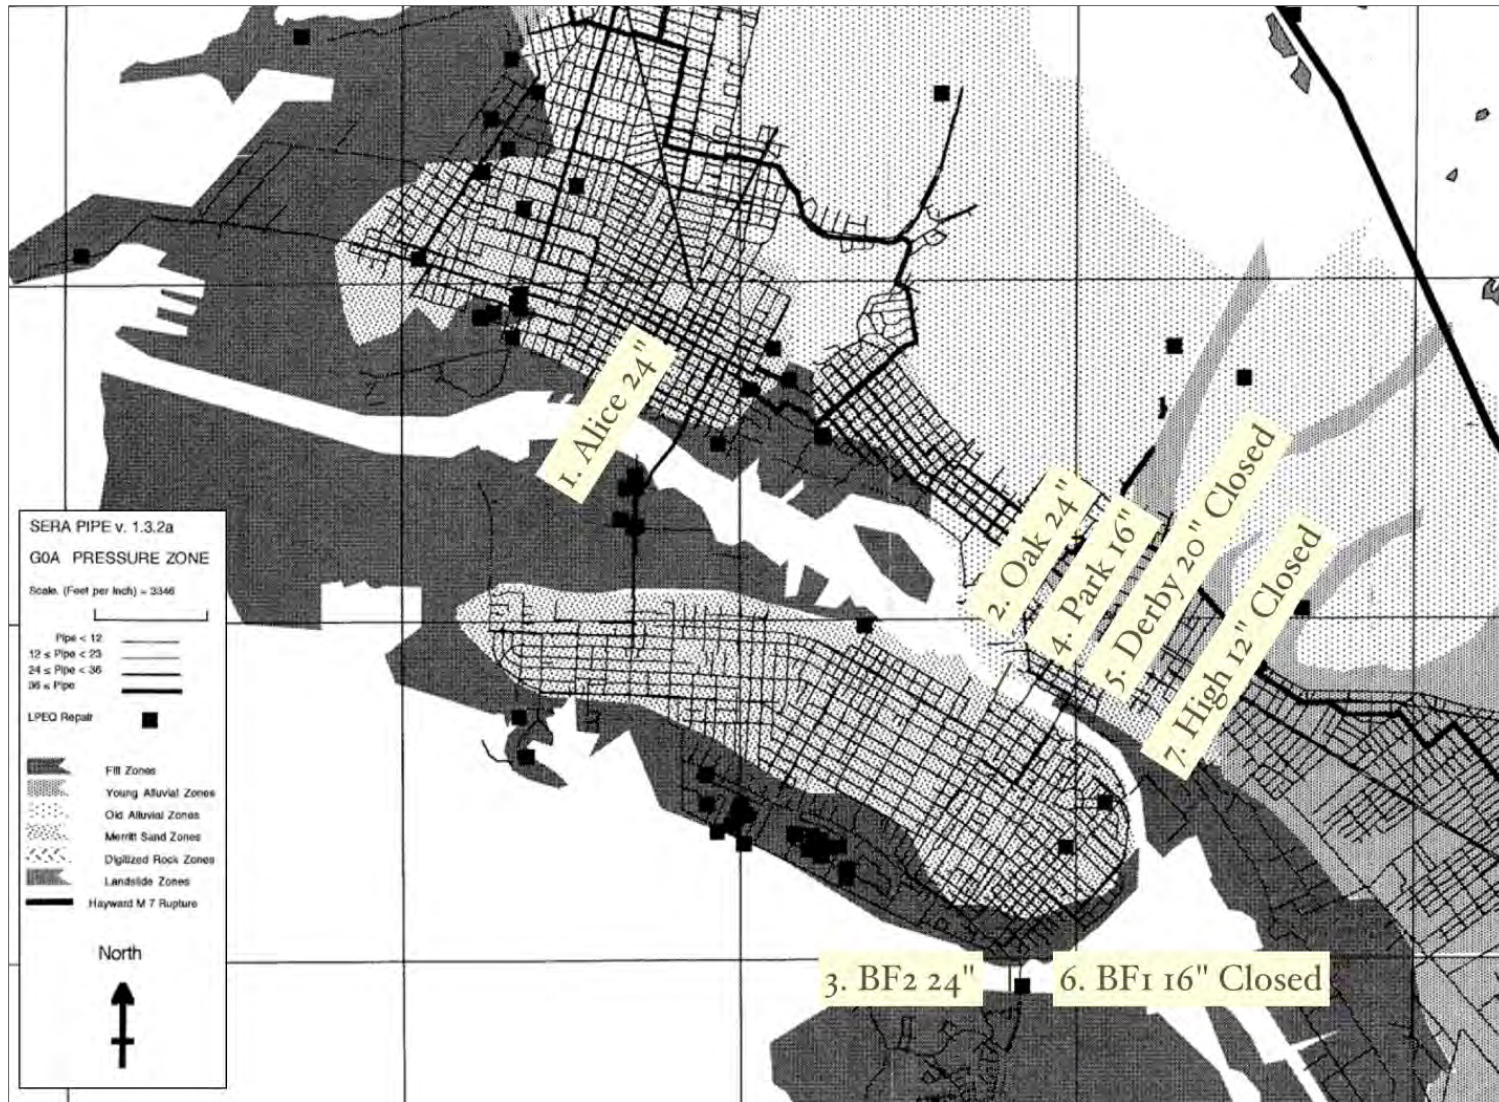
Figure 1-2. Existing Pipeline Crossings (2014) to Alameda and North Bay Farm Islands (gridlines are at 10,000-foot intervals)

Figures 1-2 and 1-3 show these seven existing pipeline crossings. Figure 1-2 also shows the locations of actual pipeline damage in the 1989 Loma Prieta earthquake (small squares). Figure 1-3 highlights the style of pipeline and year of original installation for the seven existing pipeline crossings. In Figures 1-2 and 1-3, the shading of the soils depicts the local surficial soil conditions (dark grey being Young Bay Mud and stippled depicting Merritt sands).

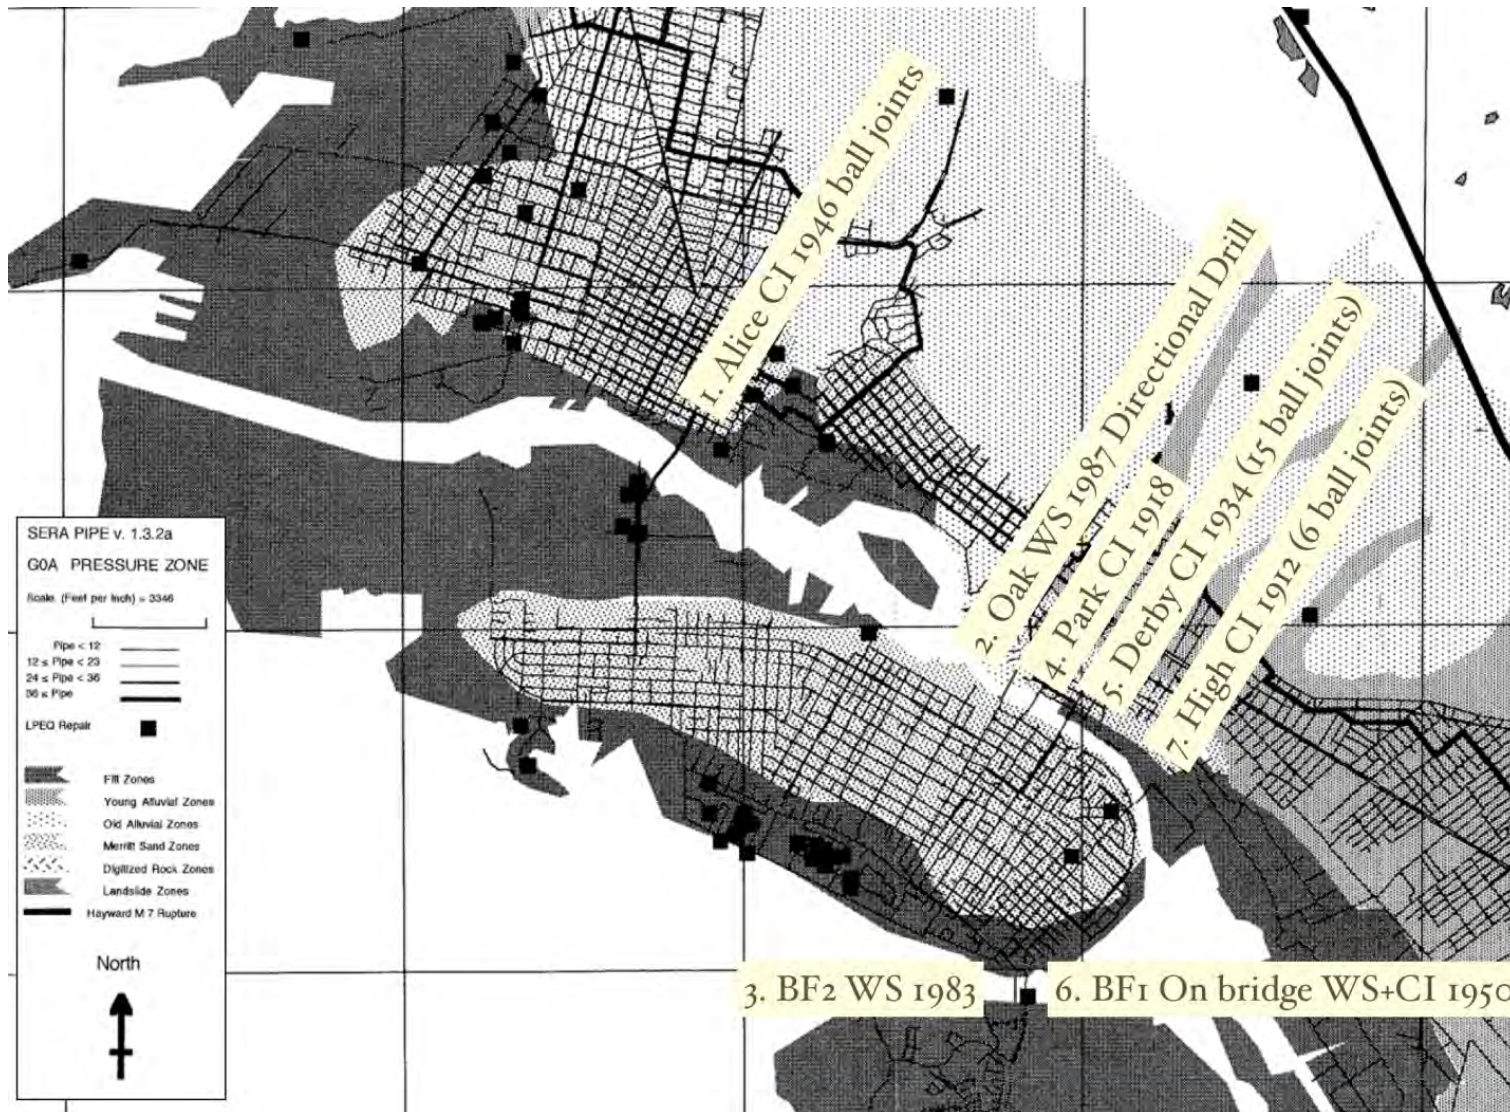
Figure 1-3. Existing Pipeline Crossings: Type of Construction and Age of Original Installation (grid lines are at 10,000-foot intervals)

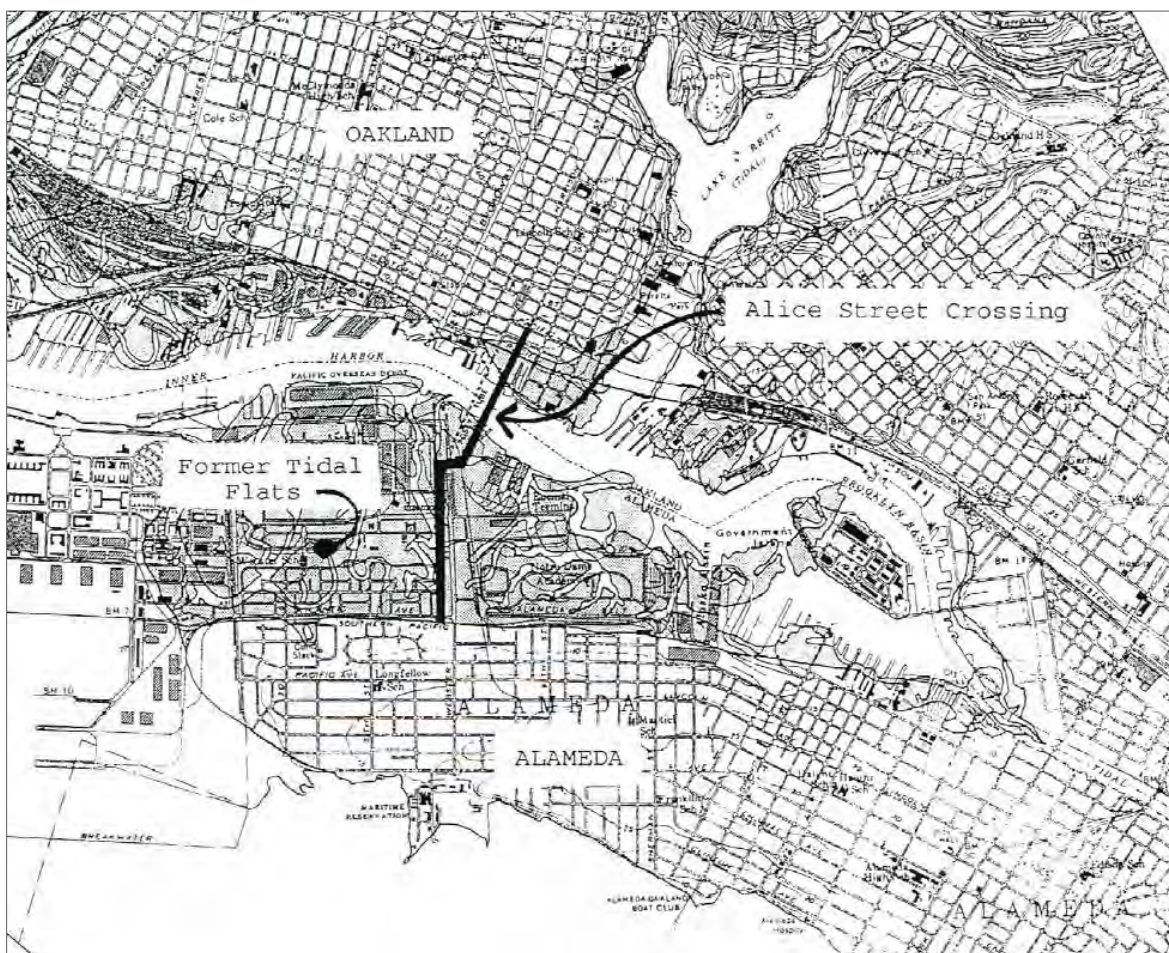
Both approaches and the submarine pipe traverse former tidal flat areas. Figure 3-1 depicts the former tidal flat area in relation to the modern shoreline and pipeline alignment. Oakland is toward the top and

Alameda Island is toward the bottom of the image. The shaded areas indicate the former tidal flat areas. The present day shoreline is at the edge of the former tidal flats. Hence, the onshore approach pipelines traverse significant distances of these soft soils.

Figure 3-1. Alice Street: Plan View Showing Formal Tidal Flats Areas

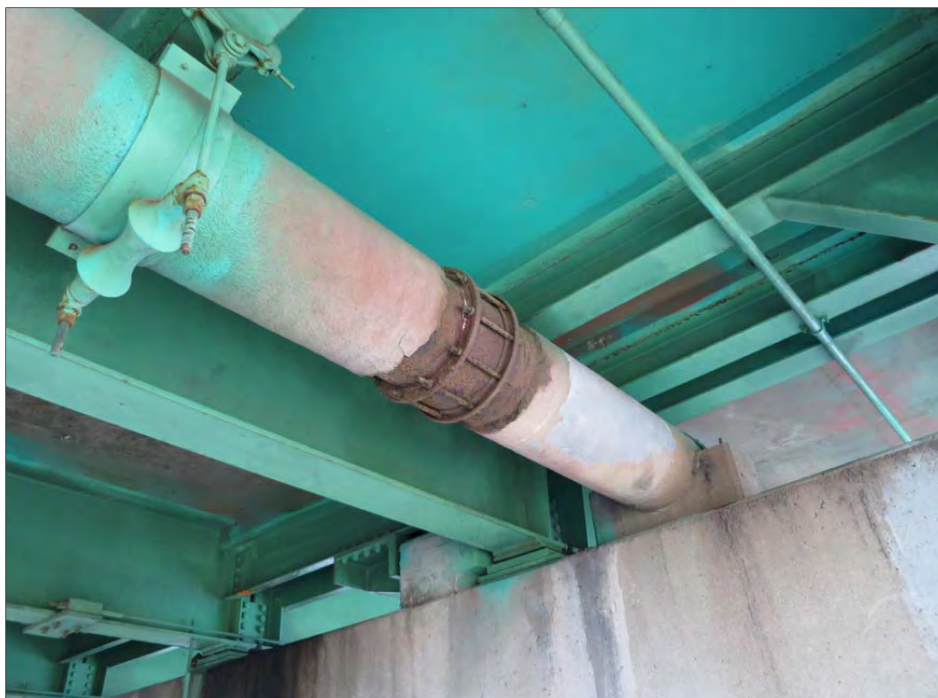
Figure 3-2. Bay Farm Island #1 Pipe Details (May 2013)

This 16-inch-diameter pipeline was built in 1950. The pipe is hung from the bottom of the Bay Farm Island Bridge, Figures A-20 and A-21. Figure 3-2 shows details of the pipe hanger locations for the north side of the bridge. The details for the south side bridge are similar. The pipe hung from the bridge is composed of a 16-inch OD x 3/16-inch mortar lined and coated steel pipe, on rod hangers, with Dresser-type coupling expansion joints (style 38 or similar) located between every other bridge span, along the fixed portion of the bridge (Figure 3-2). At the channel crossing, the pipe material changes to cast iron, the pipe drops down from the bridge, goes to one side of the draw bridge anchor block, and runs about 160 feet along the bottom of the channel (using Usiflex joints and fiberglass coating), and then rises up on the other side of the crossing. The total length of the bridge crossing is about 1,000 feet. (Reference: District drawings 2020G, 2021G, 2050G, 2051G, 2052G, 2053G, 2054G, 2055G, 932B, 934B dated 1950.)

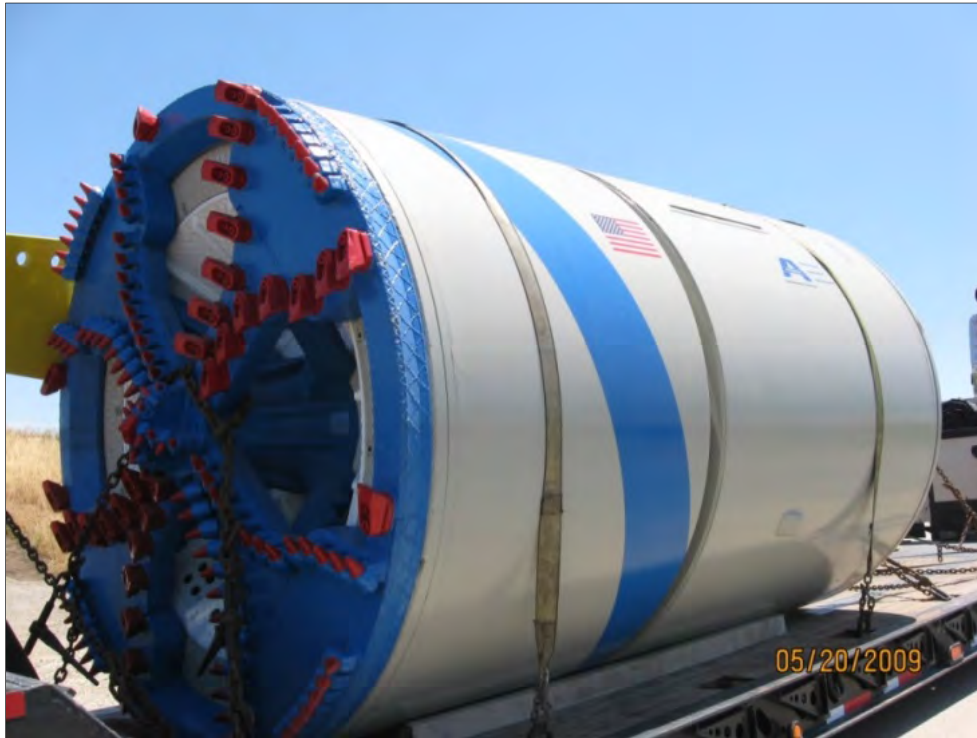
Figure 4-1. Typical Microtunnel Boring Machine (MTBM)

Microtunneling is a pipe jacking process that simultaneously excavates the ground with a microtunneling boring machine (MTBM), counterbalances groundwater pressure with an engineered drilling fluid, removes the excavated spoil via the slurry/drilling fluid, and advances pipe segments to support the excavation. The MTBM is remotely controlled, laser guided, and steerable. The carrier pipe (or casing) is installed behind the machine in a pipe string to transfer jacking forces to simultaneously jack pipe and advance the machine into the ground. Excavation is carried out by the MTBM in front of the lead pipe section. The MTBM and transport slurry exert continuous and controllable pressure at the face of the excavation to support the ground at the same time the slurry/drilling fluid counterbalances the groundwater pressures. A typical MTBM and pipe installation operation are shown in Figures 4-1 and 4-2.

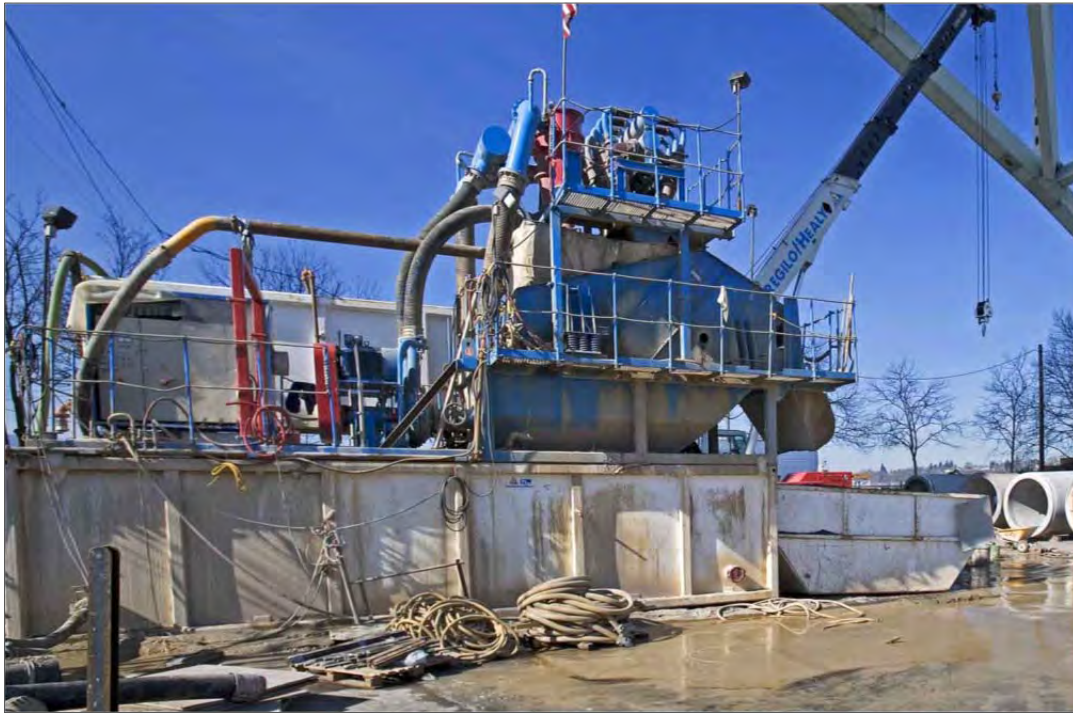
Figure 4-3. Typical Slurry Separation Plant

Excavated material is removed from a chamber behind the cutter wheel of the machine at a rate that is synchronized with the advance rate of the machine. These materials are typically transported back to the jacking shaft in slurry suspension. The drilling fluid/slurry not only transports the material, but it also counterbalances the hydrostatic pressures at the heading. The excavated materials are then separated from the slurry at the separation plant. The spoils, together with some residual drilling fluid, are hauled away from the site for disposal while the bulk of the drilling fluid is recycled back into the tunneling operation and pumped to the face of the MTBM. A typical microtunnel slurry separation plant layout is shown in Figure 4-3.

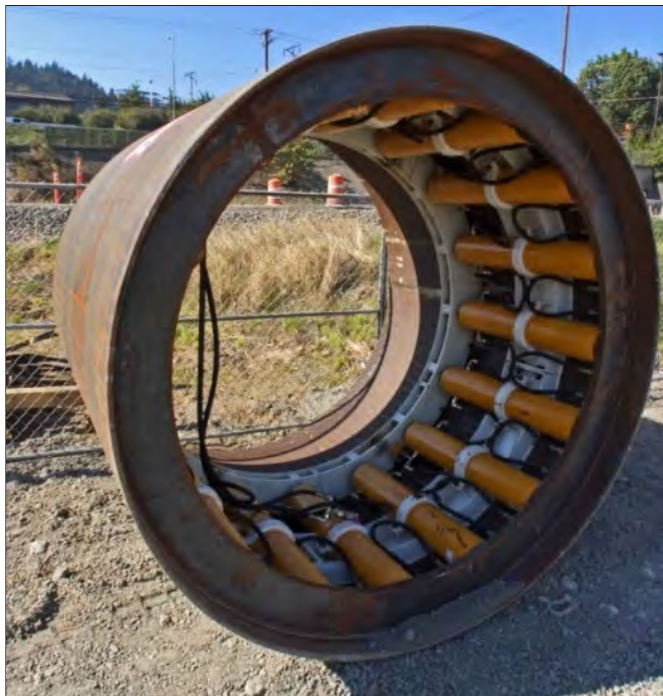
Figure 4-4. Intermediate Jacking Station (IJS)

A pipeline installed by microtunneling is constructed in a series of drives from a jacking shaft to a receiving shaft. The drive length (or distance from the jacking shaft to the receiving shaft) for microtunneling methods typically range from a few hundred feet to over 1,500 feet. The ultimate drive length is a function of the pipe diameter and pipe materials, machine capabilities, and ground conditions. For diameters greater than 36 inches, intermediate jacking stations (IJSs) can be installed in the pipe string to extend drive lengths. Figure 4-4 shows a typical IJS. With the addition of IJSs to increase the overall system jacking capacity, drive lengths can be increased to well over 1,000 feet.

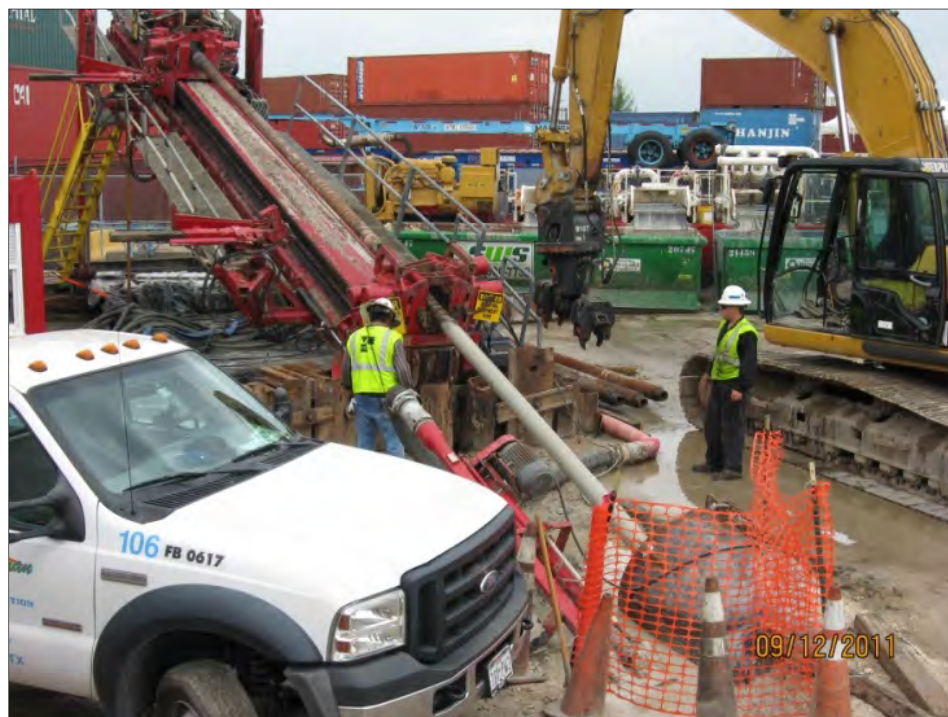
Figure 4-5. HDD Setup with Surface Conductor Casing

HDD is a three-stage construction method that originates from the surface thereby eliminating the need for shafts (Figure 4-5). The first stage consists of drilling a pilot hole with a U-shaped configuration with the apex located near the mid-point of the crossing (see Figure E-1). The second stage involves reaming and enlarging the pilot hole to the required size for pipe pullback. The third stage involves pulling the final carrier pipe into the stabilized hole. Alternately, a steel casing can be pulled into the excavated hole after which the final carrier pipe is inserted through the casing.

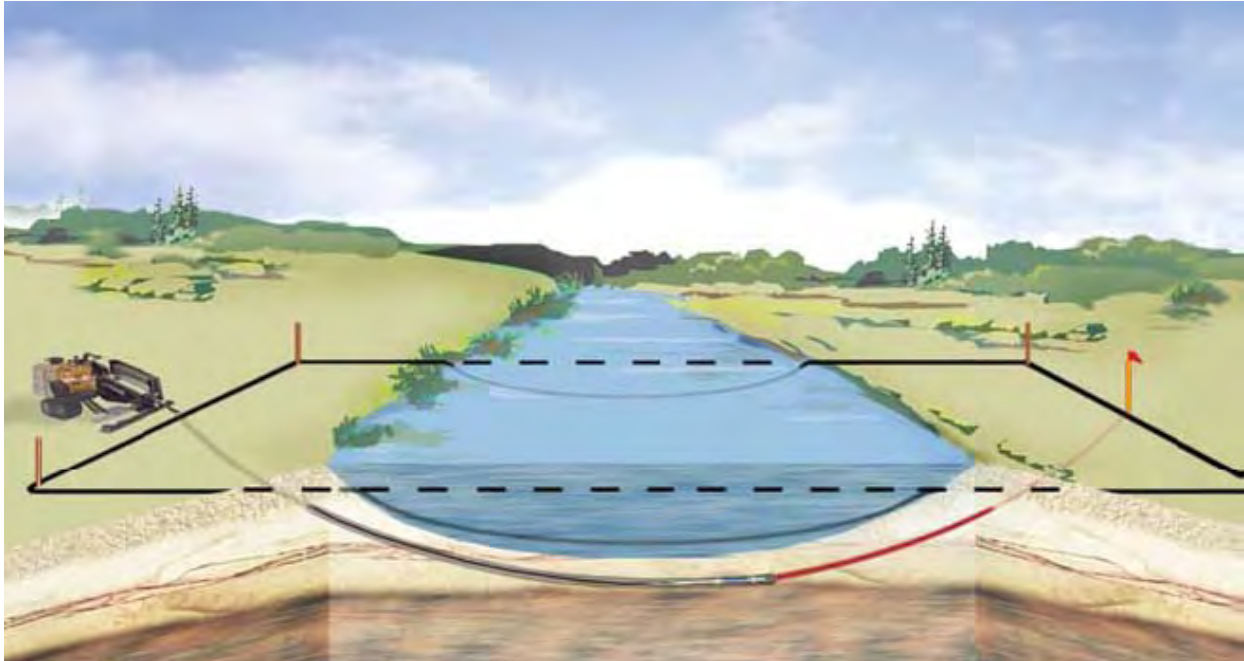
Figure 4-6. Surface Coil System to Monitor the HDD Drilled Path

HDD's distinguishing features include a guided and steerable drill tool used to develop a pilot bore through the ground in an inverted arc profile. The path of the drill tool is monitored by setting up a magnetic surface coil (see Figure 4-6). Spoils are typically washed back to the insertion pit at the surface through the excavated opening utilizing slurry (drilling mud). Once the pilot hole has been established, it is enlarged by attaching a reamer to the drill string and pulling the reamer back and forth (Figure 4-7). With each successive ream, the reamer size is increased to enlarge the size of the hole. Depending on the final hole size, the reaming process could take several passes. During the entire process the hole remains open by keeping the hole filled with slurry to prevent collapse of the reamed hole. The excavated opening (reamed hole) is oversized approximately 50 percent by volume (~30 percent by diameter) to accommodate the pullback of the final carrier pipe (see Figure E-2).
