Alameda-North Bay Farm Island Crossings Master Plan

*East Bay Municipal
Utility District*

November 2014

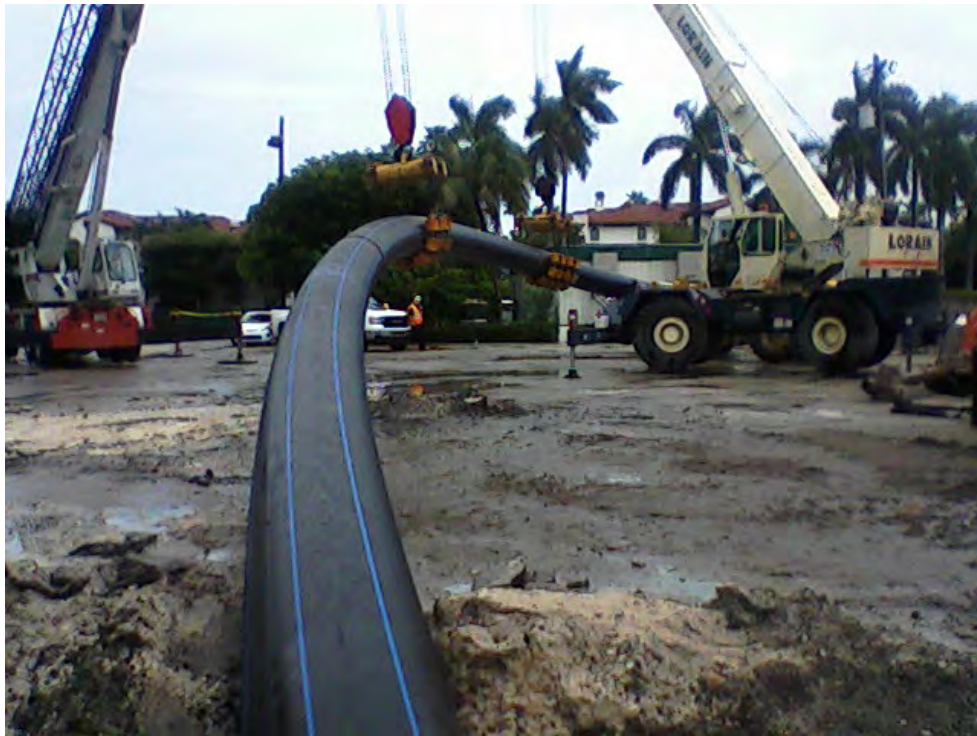
Figure 4-8. 24-inch ID HDPE Pipe Being Pulled into the Final Hole

After the hole has been enlarged to the required size, the pipeline (final carrier pipe or steel casing) is installed in the hole in one continuous pullback operation (Figure 4-8). Pressure testing of the carrier pipe as shown in Figure 4-9 is completed before pullback is started.

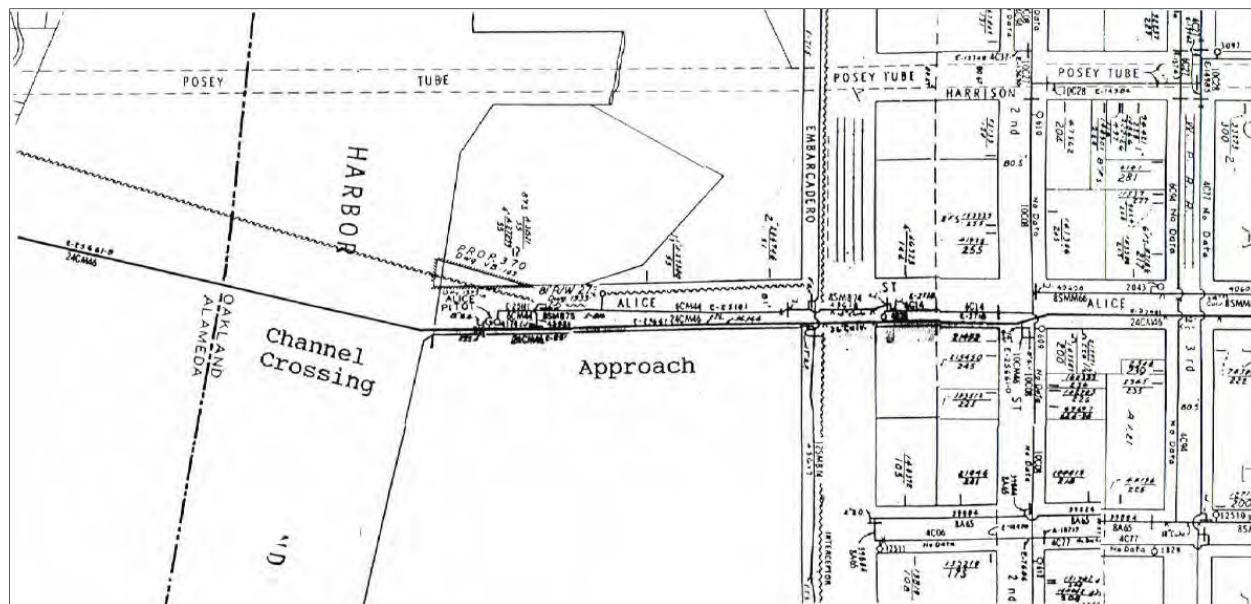
Figure 5-2. Alice Street Pipe: Plan, Oakland Side Approach

Merritt sands. The Merritt sands are not generally susceptible to lateral spreading PGDs. Figure 5-2 shows the pipe routing (from Drawings 1485-B-474, 1488-B-474).

The approaches consist of Class 150 bell-and-spigot cast iron pipe having nominal diameter of 24 inches (0.73 inch wall thickness), and the joints are lead-caulked. The pipe segment lengths are 18 feet. The weak points are the joints which are most vulnerable to damage from tensile pull-out or differential joint rotations. Three limit state criteria were defined: joint pull-out, rotation, and pipe wall ultimate strain. The values are contained in Table 5-3. The joint pull-out displacement defining leakage is based on the interpretations of prior experimental tests (Prior, 1935; O’Rourke and Trautmann, 1980; Elhmadi and O’Rourke, 1989), and the displacement for a total break is taken as the pipe socket depth. The limiting joint rotation and pipe wall strain are based on prior test values (O’Rourke and Trautmann, 1980).

There is uncertainty regarding the accuracy of the pipe position. For example, the noticeable angle change in the pipe run on the Oakland side (Figure 5-2) does not correspond to a location of a pipe joint (when superimposing 12 foot pipe segments lengths on the sketch). Moreover, pipe settlement over time in the soft bay fill materials may reduce abrupt kinks in the pipe alignment due to pipe catenary action.

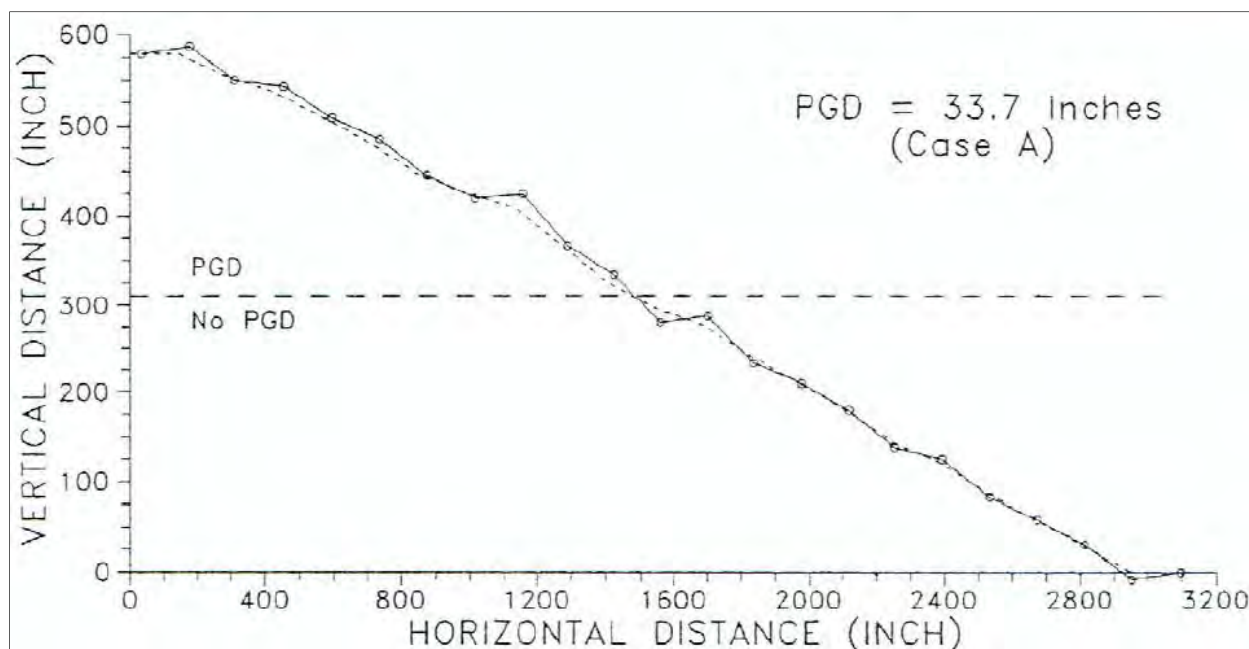
Figure 5-3. Submarine Pipe: Alameda Island Side Deflected Shape (Case A)

Cases A and B were analyses of the Alameda Island side. Case A uses upper bound soil properties per ASCE (ALA 2005) guidelines and Japanese study of permanent ground deformations. Figure 5-3 shows the deflected shape of the pipe under a PGD of 33.7 inches. Note the "accordion" type pattern of upward then downward deflection of the pipe segments. This mechanism was typical in each of the analyses. Case B is the same as Case A except reduced soil properties are used for the soils in the layer experiencing PGDs. The coefficient of subgrade reaction and friction strength are reduced by a factor of 10. This is to account for the expected large decrease in soil stiffness and strength due to liquefaction. Cases C and D were analyses of the Oakland side. Case C uses the upper bound soil properties, and Case D uses reduced properties in the soil layer having PGDs. The analyses indicate that the joints lock before a limit state axial force is developed in the pipe.

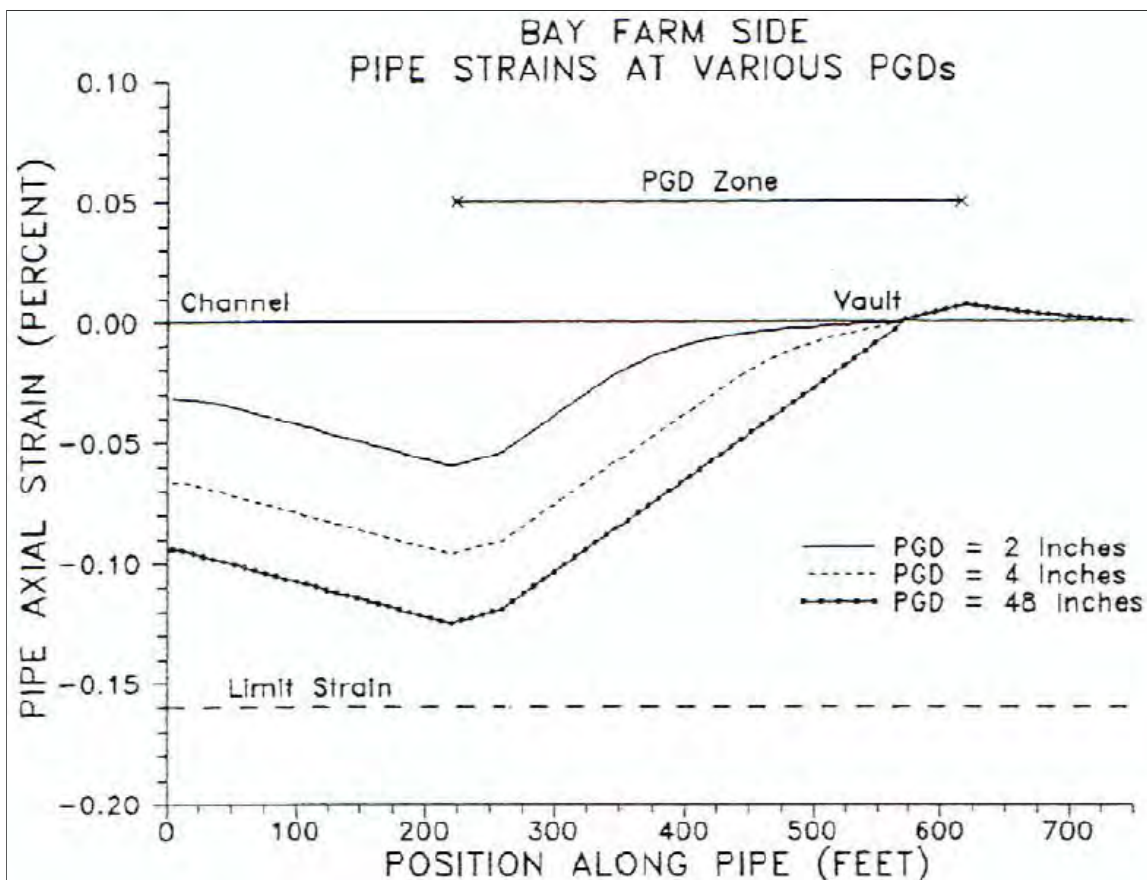
Figure 5-5. Bay Farm #2 Crossing: Pipe Axial Strain Along Pipe, North Bay Farm Island Side

Figure 5-5 shows the pipe axial strain plotted along the pipe run for three levels of PGD. The strains increase with increasing PGD. However, the pipe strain becomes independent of PGD once the soil

reaches its ultimate resistance, i.e., the pipe slides through the soil. Under a PGD of 48 inches, a peak pipe compressive strain of 0.12% occurs at a point near the front of the moving soil mass. The pipe strain is zero at the vault/anchor because the slip joint is opening and cannot resist tension. The key responses are compared to the limit state criteria (i.e., allowable) in Table 5-16.

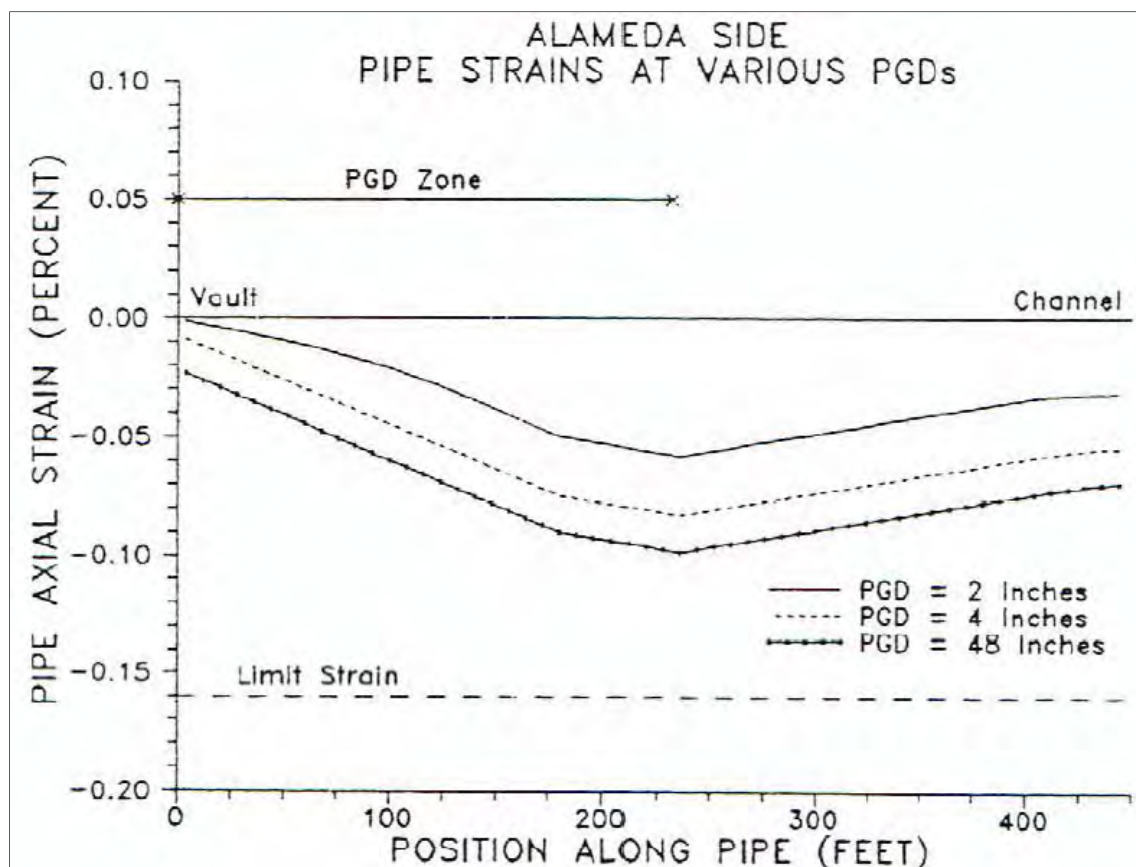
Figure 5-6. Bay Farm #2 Crossing: Pipe Axial Strain Along Pipe, Alameda Island Side

The analysis results of the straight run of pipe (from Station 1+40 to Station 5+85) are shown in Figure 5-6. The behavior is similar to that for the North Bay Farm Island side described above. The pipe strains become independent of PGD when the soil attains its ultimate resistance. Under a PGD of 48 inches, a peak pipe compressive strain of 0.10% occurs at a point near the front of the moving soil mass. A compressive pipe strain occurs at the vault/anchor because the slip joint is in compression and therefore an axial force develops in the pipe. The key responses are compared to the limit state criteria in Table 5-17.

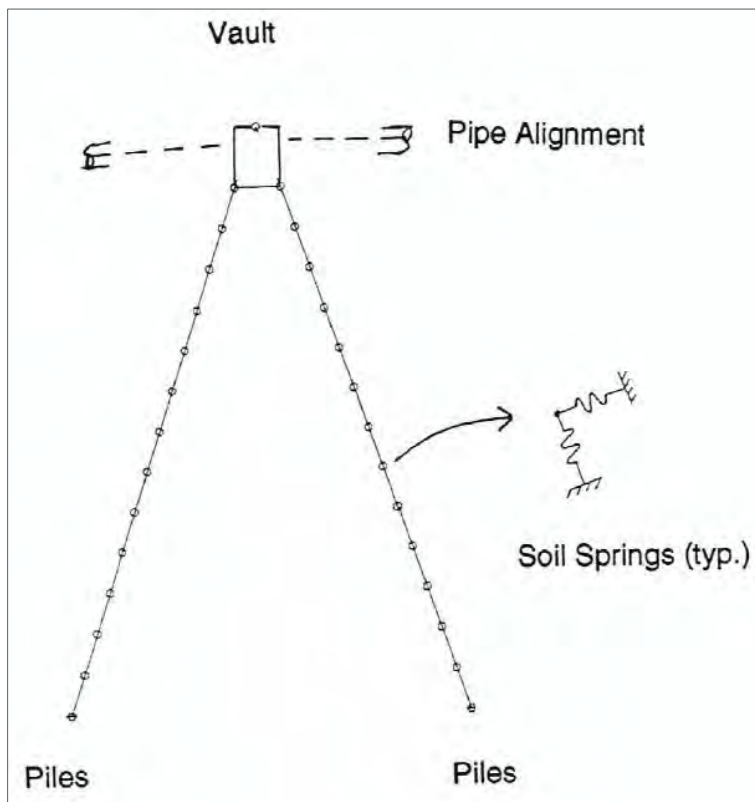
Figure 5-7. Bay Farm #2 Crossing: Vault / Anchor Model

Figure 5-7 depicts the vault/anchor model. The piles and vault/anchor are modeled with beam-column elements. The soil is modeled by translational springs connected to the nodes (at both the piling and vault/anchor). Soil springs are oriented both parallel and perpendicular to the pile axis. The springs have bi-linear force-displacement relations having stiffness and ultimate force properties based on ALA guidelines (2005). The vault/anchors have pilings that extend down into the stable soil having no PGD. The PGD is modeled by applied displacements at the ends of the soil springs in the soil experiencing PGDs.

The analyses indicate that after about a 2-inch PGD, the vault/anchor movement follows closely to the soil PGD, i.e., the vault/anchor is very compliant with the soil PGD.

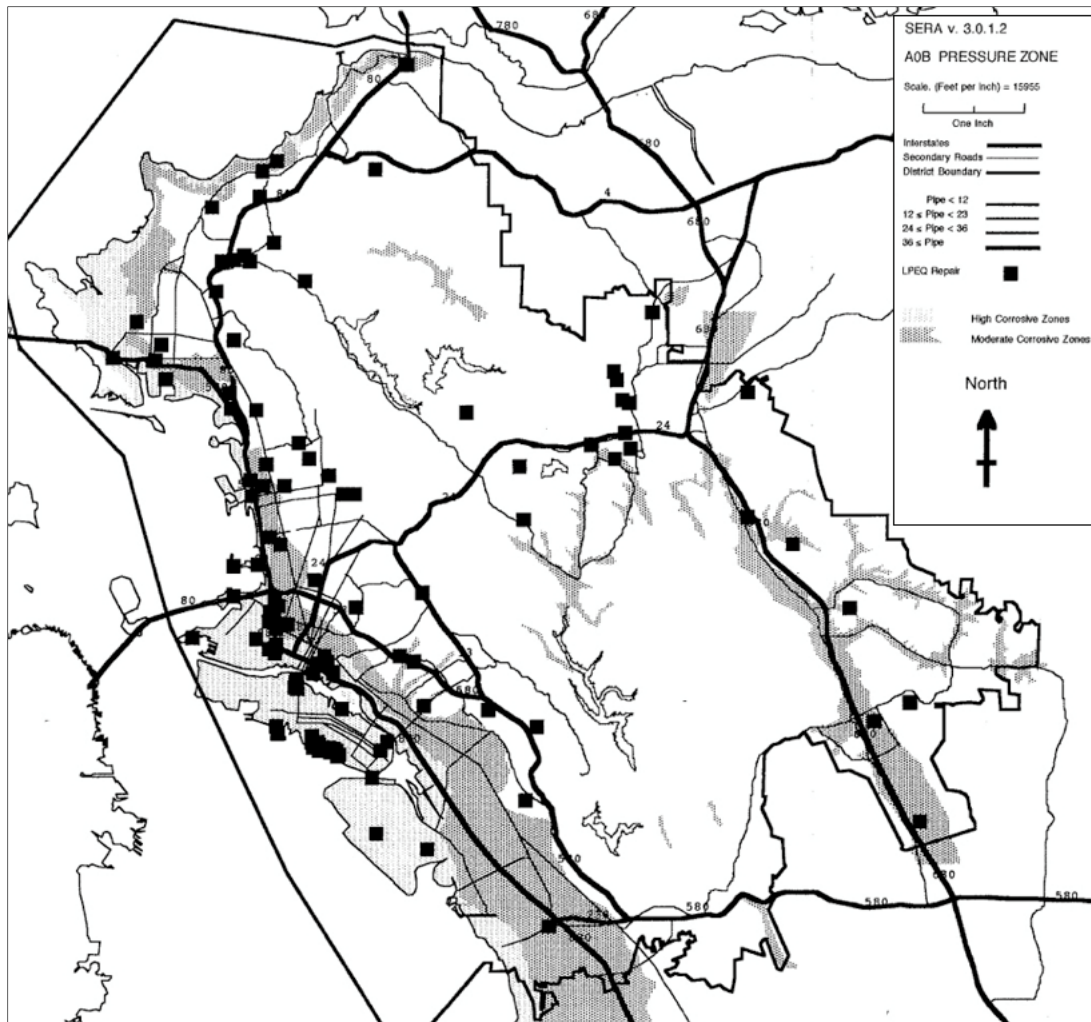
Figure 5-8. EBMUD Pipe Damage: 1989 Loma Prieta Earthquake

Figures 5-8 and 5-9 show maps with the locations of damaged pipelines in the District's system as a result of the 1989 Loma Prieta earthquake. In Figure 5-8, the background shading indicates areas with high corrosivity soils (light stipples, near the coastline of the Bay), moderate corrosivity (darker stippling, generally somewhat inland from the Bay), and low corrosivity (clear areas, generally inland).

There were a total of 113 pipe mains and 22 service lateral repairs (135 total repairs) due to the 1989 Loma Prieta earthquake. As can be seen in Figures 5-8 and 5-9, the bulk of the repairs were concentrated in areas underlain by Young Bay Mud and artificial fills, which are generally highly corrosive. In a future Hayward M 7 earthquake, the total number of pipe repairs may total 3,000 or more; the concentration of the repairs will likely show a pattern similar to that seen in Figures 5-8 and 5-9 (heavy concentrations of

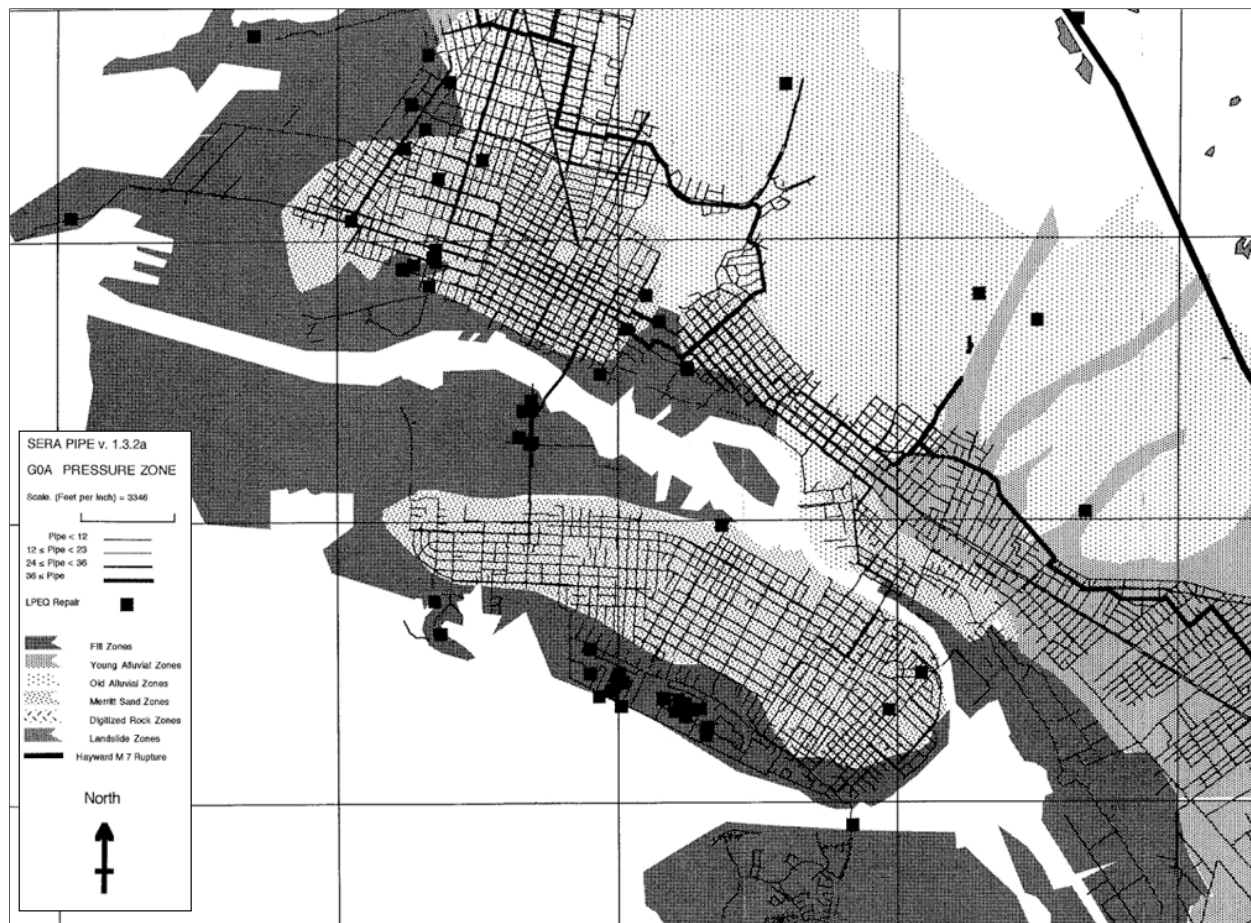
Figure 5-9. EBMUD Pipe Damage: 1989 Loma Prieta Earthquake, Near Alameda Island

In Figure 5-9, the dark background indicates Young Bay Muds / fills; the darker stippling indicates younger alluvial soils; the light stippling indicates older alluvial soils / Merritt sands; the clear areas indicate rock; the lines show the District's pipe grid in the central pressure zone (thickest lines being pipes up to 36-inch diameter); the heavy black line on the right (east) shows the location of the Hayward fault.

As indicated in Figure 5-9, there was a leak on the Bay Farm Island pipeline (believed to be BF#1 pipe on the bridge). There were also several smaller diameter pipes with repairs on Alameda Island near the Posey tube (the 24-inch Alice Street pipeline was not damaged). The heavy concentration of damage to pipes on the south shore of Alameda Island were typically 6-inch welded steel pipes, having poor welds and subjected to corrosive soils.

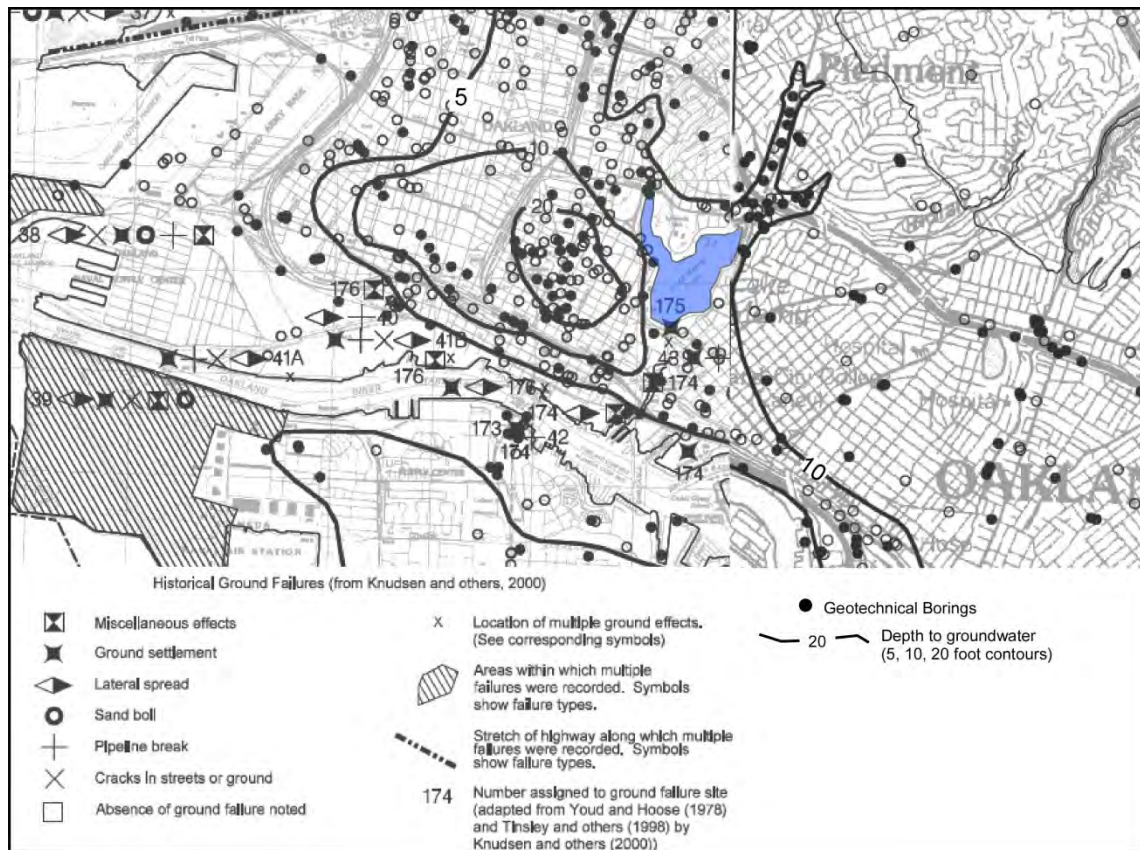
Figure 5-10. Observed Liquefaction Effects

Figure 5-10 shows a map of the downtown Oakland–Alameda Island area, highlighting locations with observed liquefaction effects from past earthquakes (1906 San Andreas and 1989 Loma Prieta).

Figure 5-10 shows that both ground settlements and lateral spreads have been observed near the Alice Street pipeline crossing location in past earthquakes. The numbers assigned in Figure 5-10 refer to ground failure sites, adapted from Youd and Hoose (1978) and Knudson et al. (2000).

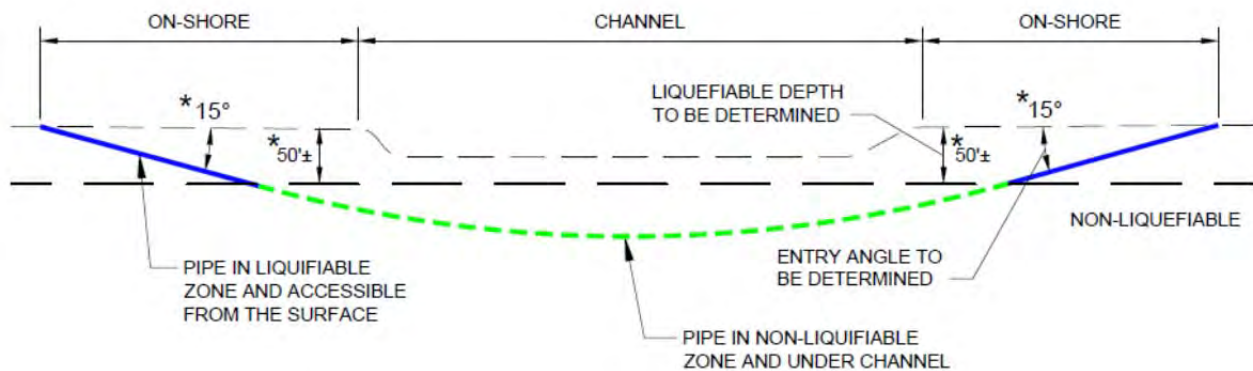
Figure 5-11. Typical Layout to Reduce the Vulnerability of the HDD Pipeline Crossings

* WORKING ASSUMPTION TO BE MODIFIED
BASED ON GEOTECHNICAL INVESTIGATIONS

- Use of a conductor casing will provide protection to the carrier pipe at the two ends. The conductor casings can be 100 to 200 feet long. At a length of 200 feet and 15-degree entry angle, carrier pipe is protected for the top 50 feet in the Young Bay Mud, avoiding the upper liquefiable zones (see Figure 5-11).

- The entry and exit points of the HDD crossing will be designed to be more than 200 feet from the shoreline, so any weak point at the end of the casing will be onshore and accessible from the surface (see Figure 5-11).

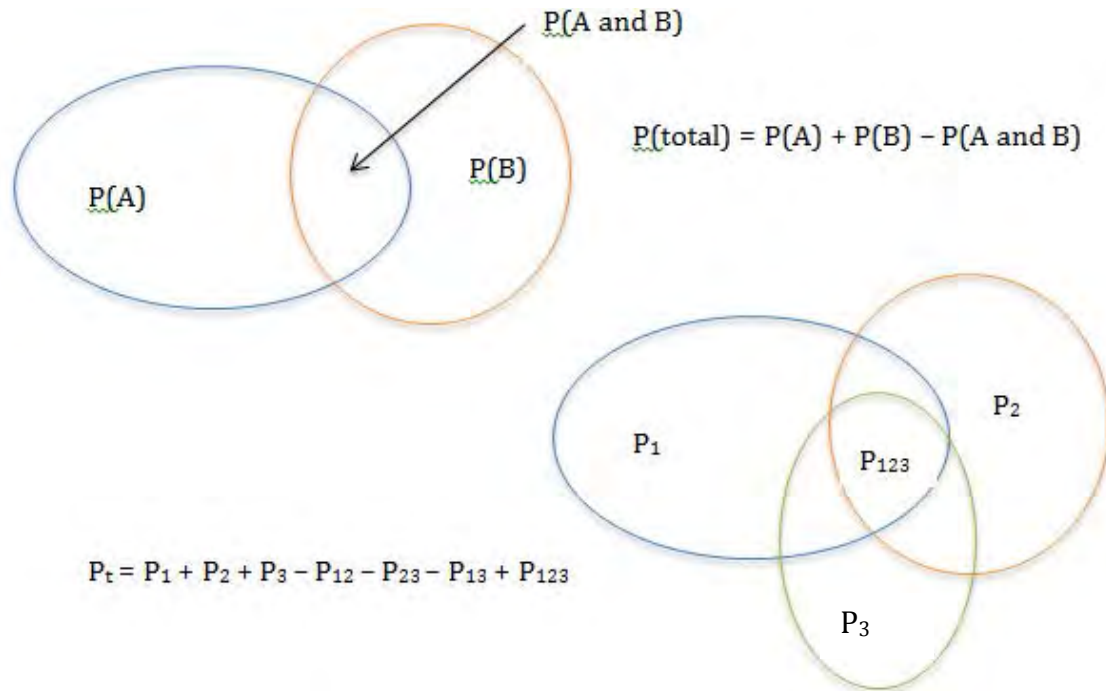
Figure 1-System Model

Survivability of the pipelines is modeled, though the probabilities are given as probability of failure. The system model is simply the sum of the probabilities (P) of all single and multiple failures minus the joint probabilities (as shown below in Figure 1 for two- and three-failure scenarios). Survivability is then 1 minus the total probability of failure.

The Info-Gap analysis will only consider portions of the crossings that may fail under water, therefore ignoring the terms associated with the connection to existing piping and approach pipelines, since these pipes are relatively easy to access and repair compared to the submarine portions. Extremely high robustness is desired for portions submarine portions, which are difficult to access and repair. We will therefore only consider an IGM with 2-points of failure. In the HDD alternative, these points are the submarine portion and the end of the conductor casing, when present. For microtunneling, these two points are the riser and the submarine portion.

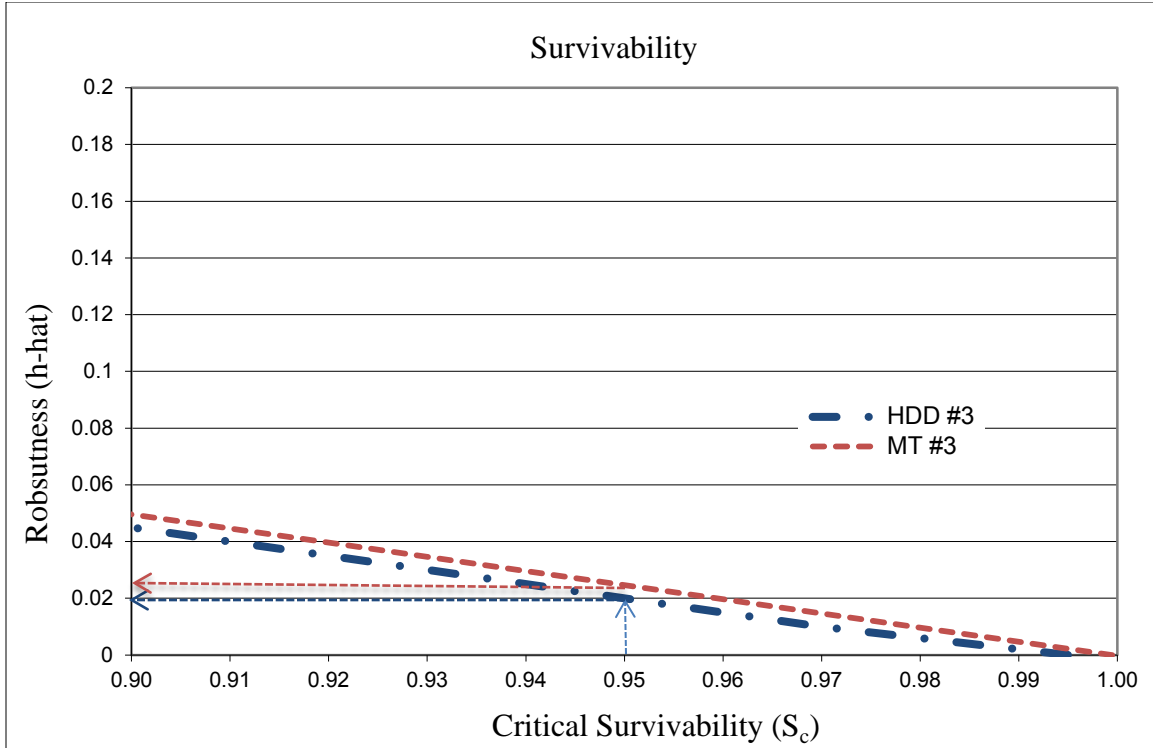
Figure 2. Robustness Results

Figure 2 shows robustness curves for two designs: HDD alternative #3 and MT alternative #3. The horizontal axis is the critical survivability, (S_c), while the vertical axis is the corresponding robustness (\hat{h}). The dashed red line is the robustness curve for the microtunnel design and the blue dot-dashed line is the robustness curve for the horizontal directional drilling design.

Zeroing. The estimated survivability (evaluated directly from the estimated subunit failure probabilities) has zero robustness against uncertainty. The horizontal-intercept of the curve is equal to the estimated survivability based on the submarine failures provided by the experts. Note that the robustness is precisely zero at the horizontal intercept; hence we cannot assess the designs in terms of the estimated survivabilities because the robustness is zero and we should have no confidence in those estimates.

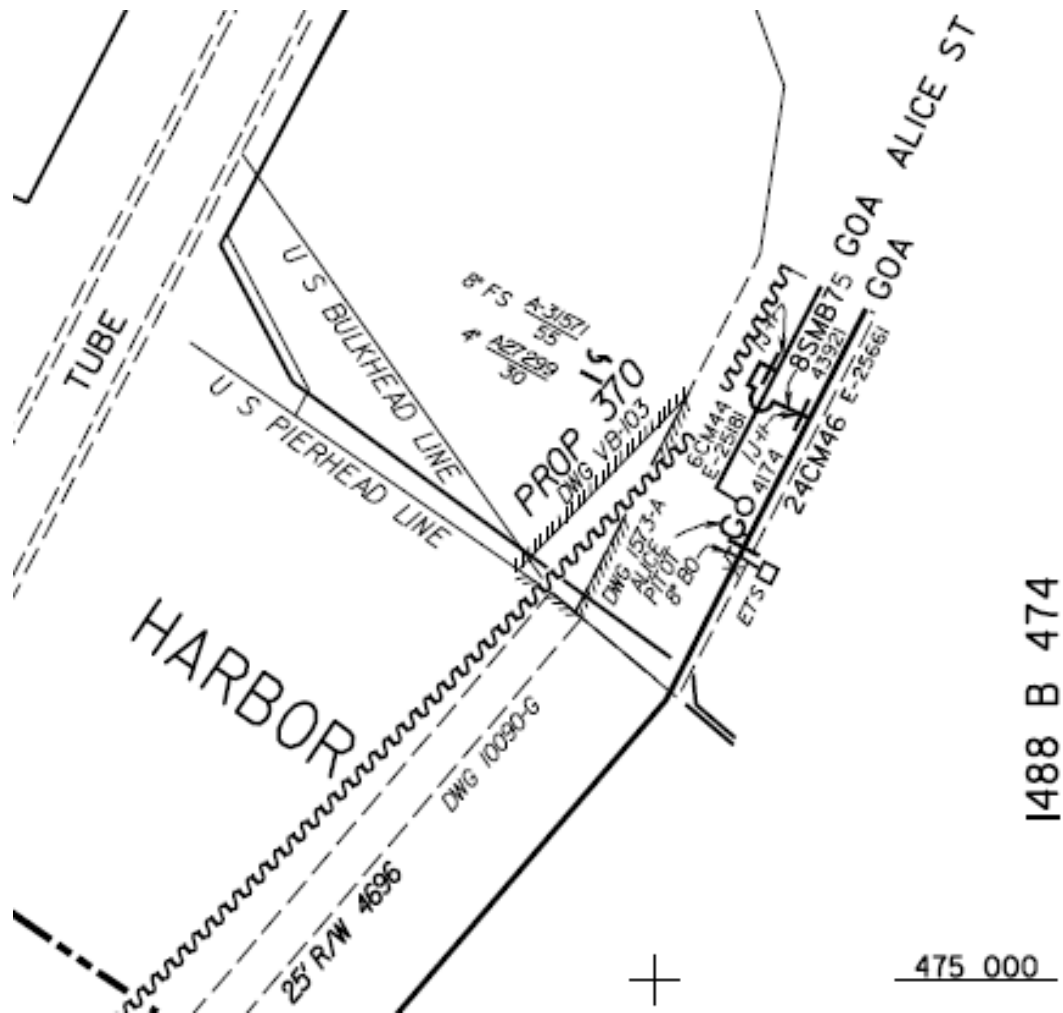
Figure 1: Alternative 1A – South Alice Street Connection Location

Connection piping for Tunnel Alternative 1A begins at the southern end of Alice Street south of Embarcadero (First Street). Figure 1 presents the B-Map extent (B-Map 1485B474) of the connection location.

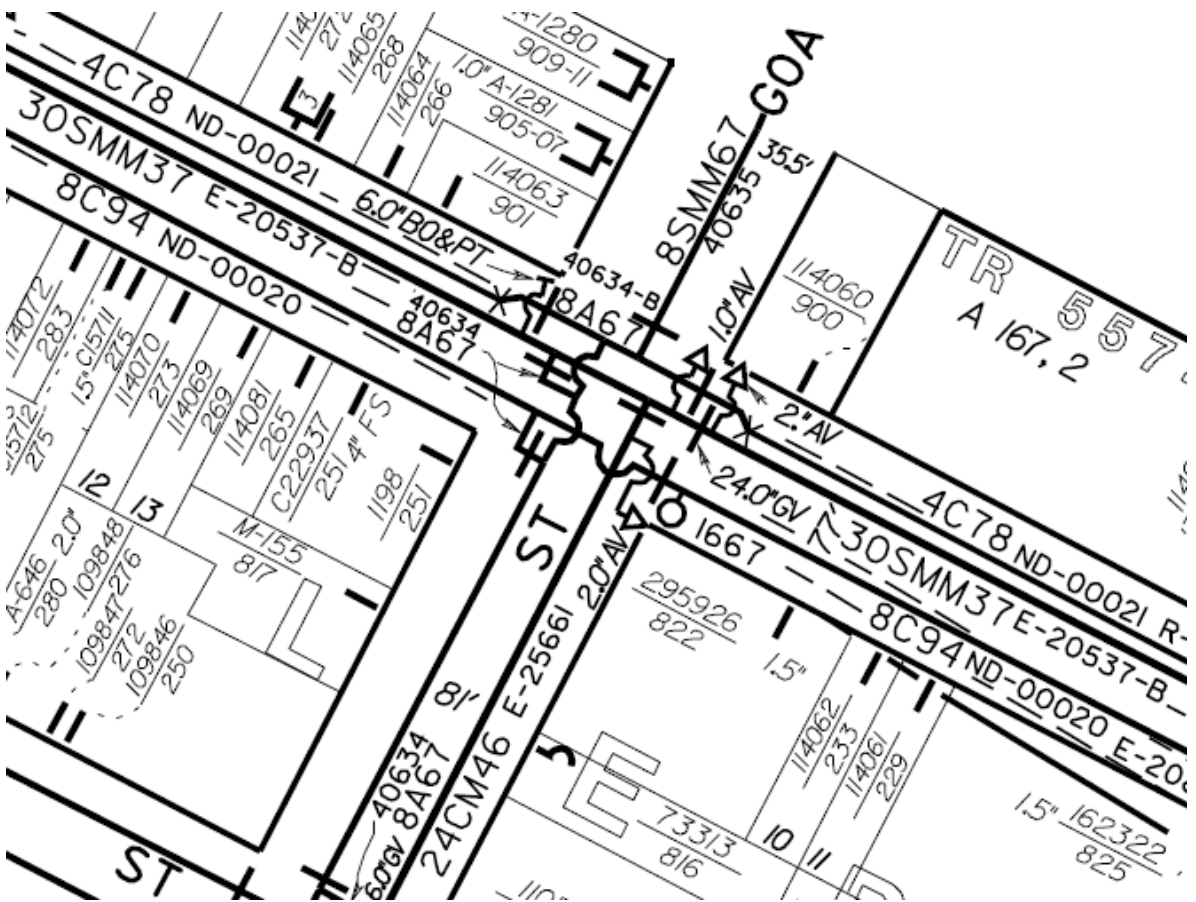
Figure 2: Alternative 1 – Alice at 9th Street Connection Location

The Oakland side street piping will extend from the east-end of the submarine crossing on Alice Street to the intersection of 9th Street and Alice, connecting to the existing 30SMM37 (E-20537-B) pipeline at a T-connection. Figure 2 presents the 9th Street and Alice Street intersection, taken from B-Map 1488B476. By connecting the new alignment at this location, the District could eventually replace approximately 2,300 feet of existing 24CM46 (E-25661) cast iron pipe in Alice Street (which exhibits a high consequence of failure based on the leak history) and about 300 feet of 24SMM53 pipe encased under the Hwy 880 embankment.

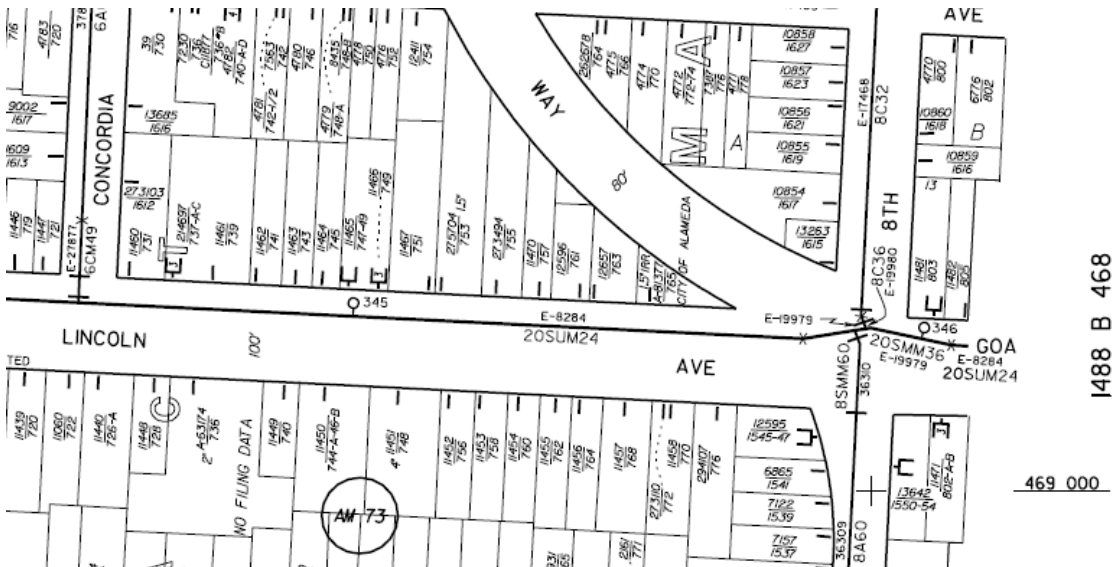
Figure 4: Alternative 1 – Alameda Connection at 8th and Lincoln

The submarine crossing for Alternative 1A will surface at Barnhill Marina and ultimately extend south about 7,000 feet to the intersection of Constitution Way, Lincoln Avenue, and 8th Street, in order to connect to the new 16-inch pipeline installed in Lincoln Avenue between 8th St. and Park Avenue. Figure 4, taken from B-Map 1485B468, shows the existing piping at the connection point including the 20SMM36 (E-19979) that will be removed from service.

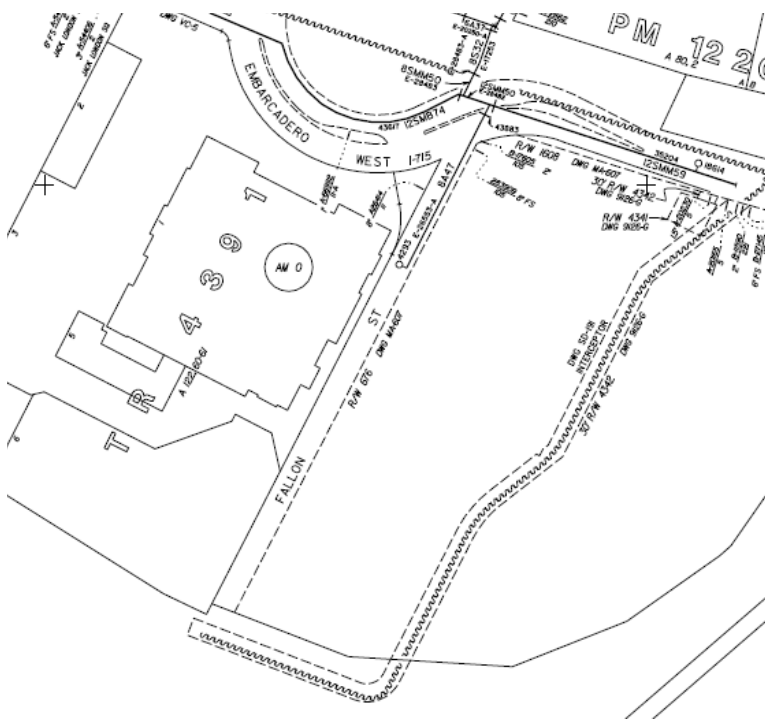
Figure 5: Alternative 1D – Oakland Connection at South Fallon Street

The connection or tie-in on the Oakland side is located at the southern end of Fallon Street, south of Embarcadero (First Street). Figure 5 (taken from of B-Map 1488B474) shows the street piping route leading from the Oakland Inner Harbor towards Embarcadero West. An aerial of the same vicinity is also shown below in Figure 6.

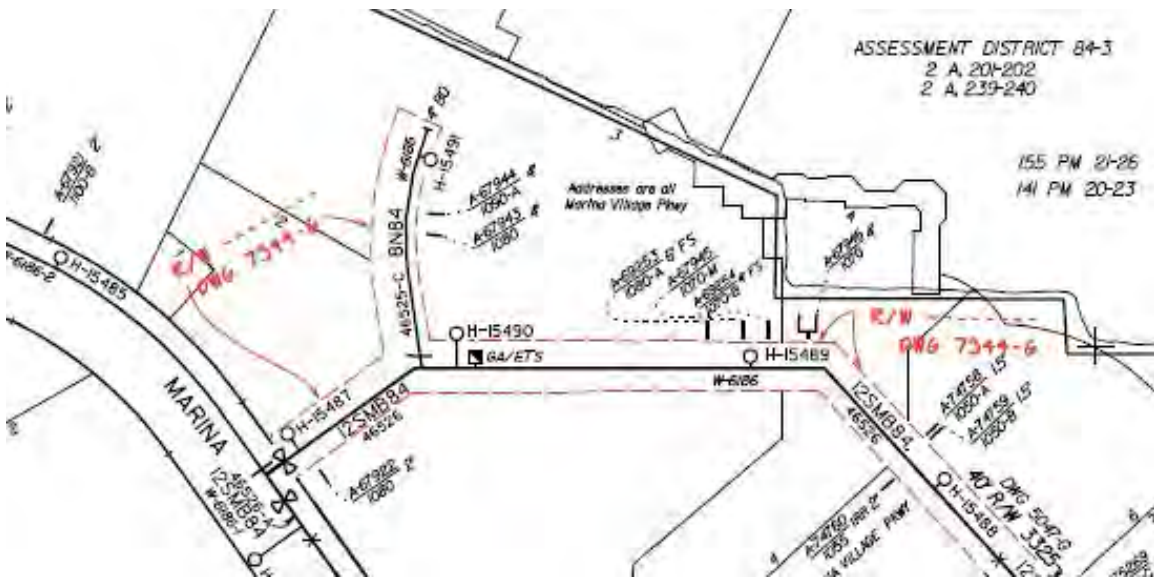
Figure 7: Alternative 1D - Alameda Connection at Telecare Corp. Parking

The Alameda side connection will be located within the paved parking area of Telecare Corporation, a mental health company, on the Alameda estuary shore along Marina Village Parkway. This site provides room for construction staging in the parking lot of the office park and minimal utility conflicts. Figure 7 shows an inset of B-Map 1488B472, including the location of the connection to the distribution system.

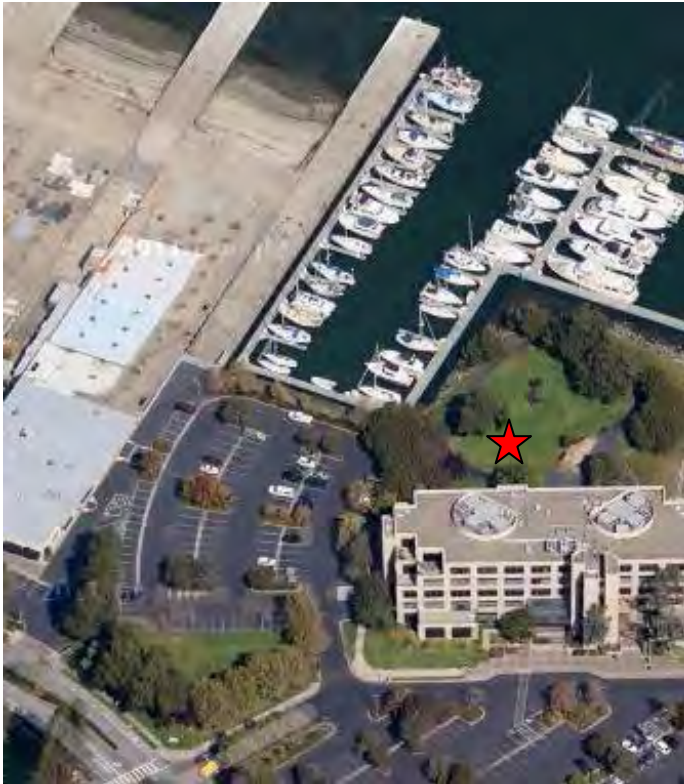
Figure 8: Alternative 1D - Alameda Connection at Telecare Corp. Parking Lot

Figure 8 shows an aerial photo of the parking lot where the submarine tunnel pipeline would connect to the street pipeline buried in the streets.

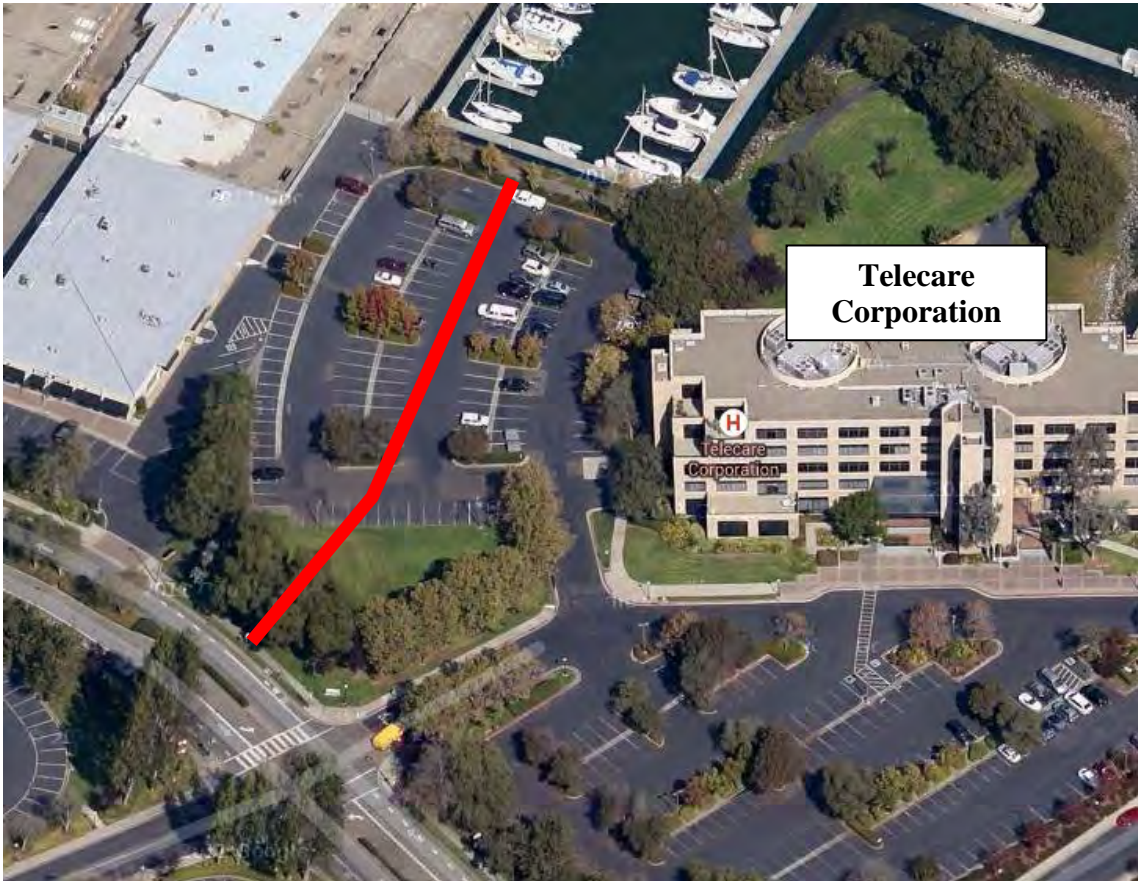
Figure 12: Telecare Corporation Park Area – Alignments 3 and 4

Pipeline alignments for submarine Crossing Alternative 1D on the Alameda side begin in the Telecare Corporation parking area. An easement would be required to work and install the new pipeline alignment within this property. Refer to Figure 12 for the tentative alignment (red line) located in the parking area.

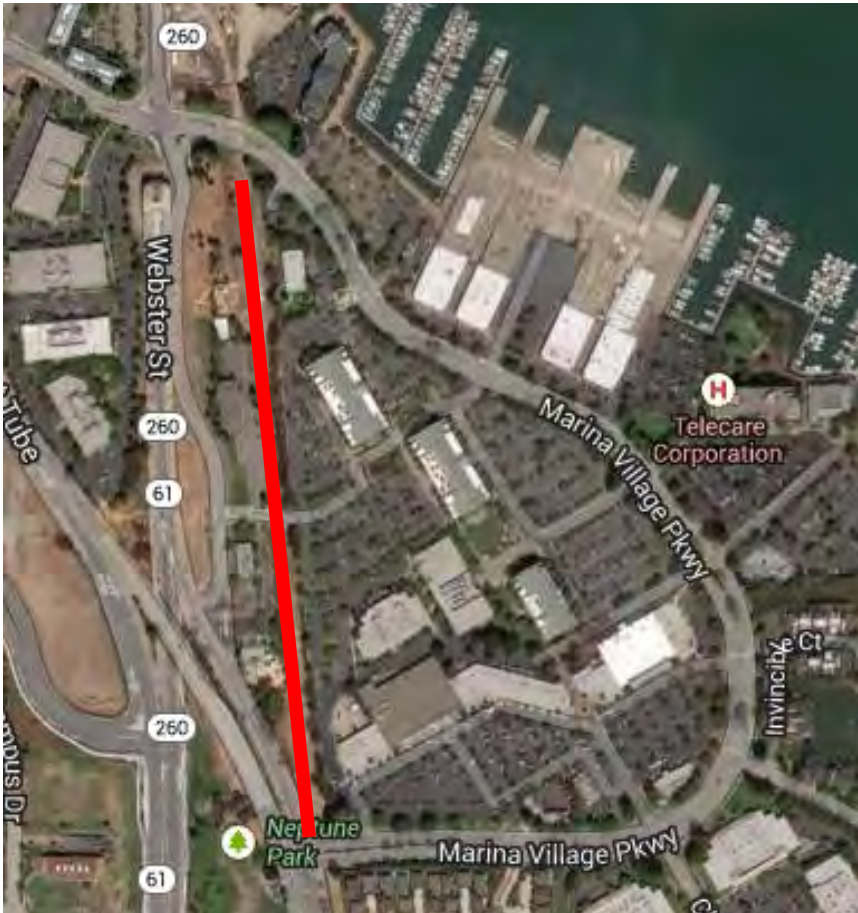
Figure 13: Abandoned Railroad Easement – Alignments 1 and 4

Shown in Figure 13, the abandoned railroad right-of-way associated with Alignments 1 and 2 between Marina Village Parkway and Constitution Way appears to be owned by Southern Pacific (S P CO 872-1-65A-2) or the City of Alameda. Further investigation by Real Estate Services will be needed if the alignment is pursued. An easement will be required for the installation of a new pipeline alignment along this corridor.

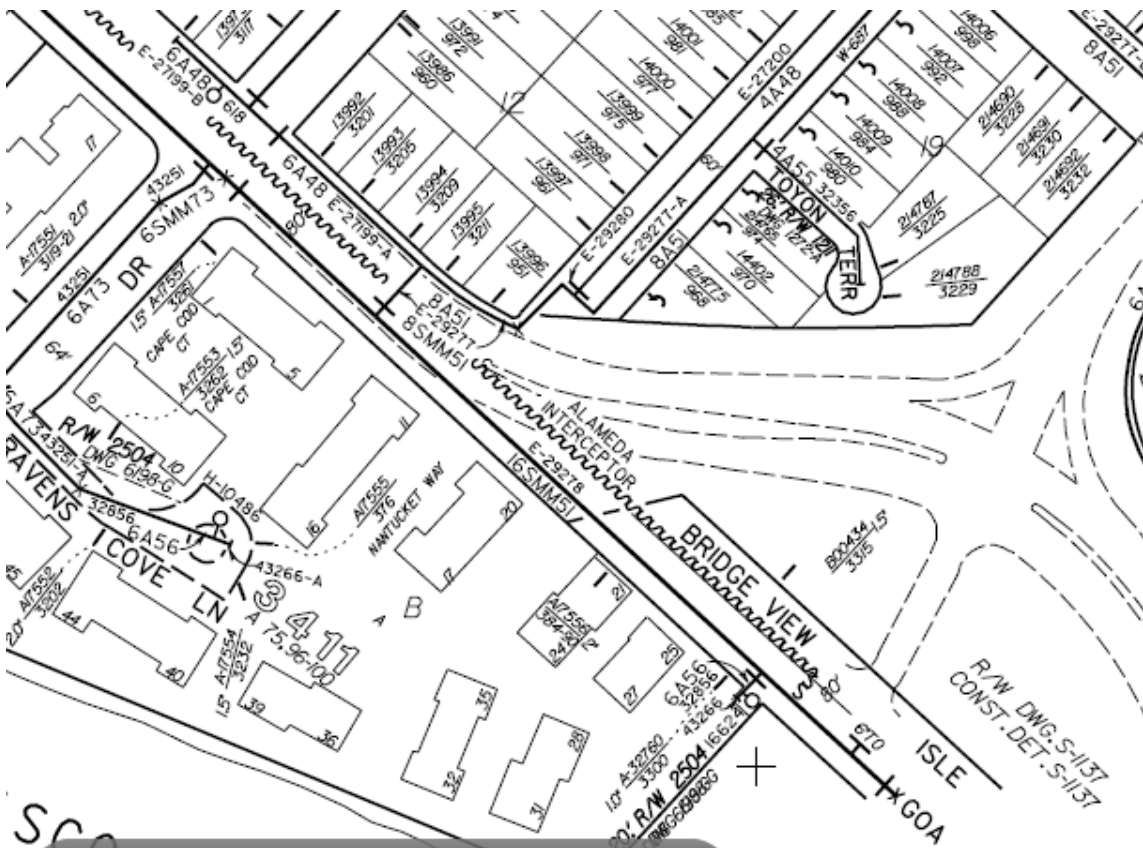
Figure 19: Alternative 2 – South Otis Drive Connection Location

The estuary crossing on the Alameda site will connect to a 16-inch mortar lined and coated steel main (16SMM51) at the south-eastern end of Bridge View Isle Drive and eventually extend back to Lincoln Avenue near Park St. via any number of street alignments as shown in Plate 18. Figure 19 shows a portion of B-map 1497B460 at the Bridge View Isle Drive connection point.

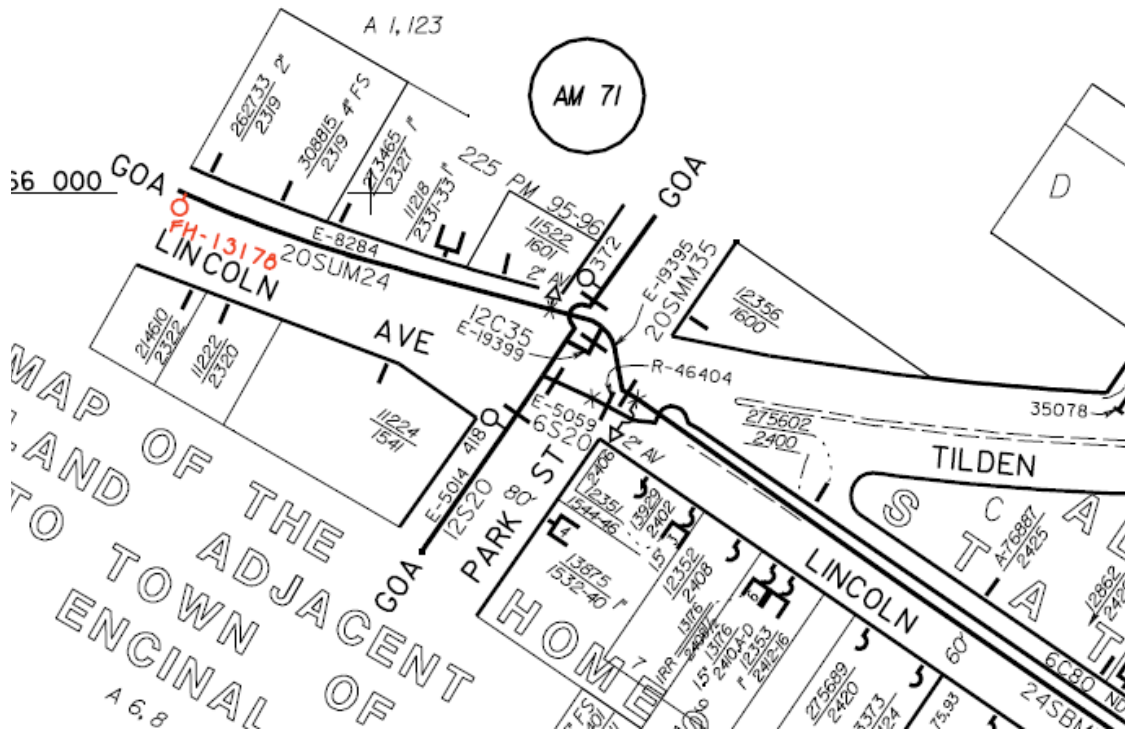
Figure 20: Alternative 2 – Lincoln Avenue Connection Location

The goal is to ultimately connect the new estuary crossing to the existing 20-inch unlined and mortar coated steel main (20SUM24) located at the corner of Lincoln Avenue and Park Street. Figure 20 presents the B-map extent (B-map 1497B464) of the Lincoln Avenue and Park Street connection point.
