Alameda-North Bay Farm Island Crossings Master Plan

*East Bay Municipal
Utility District*

November 2014

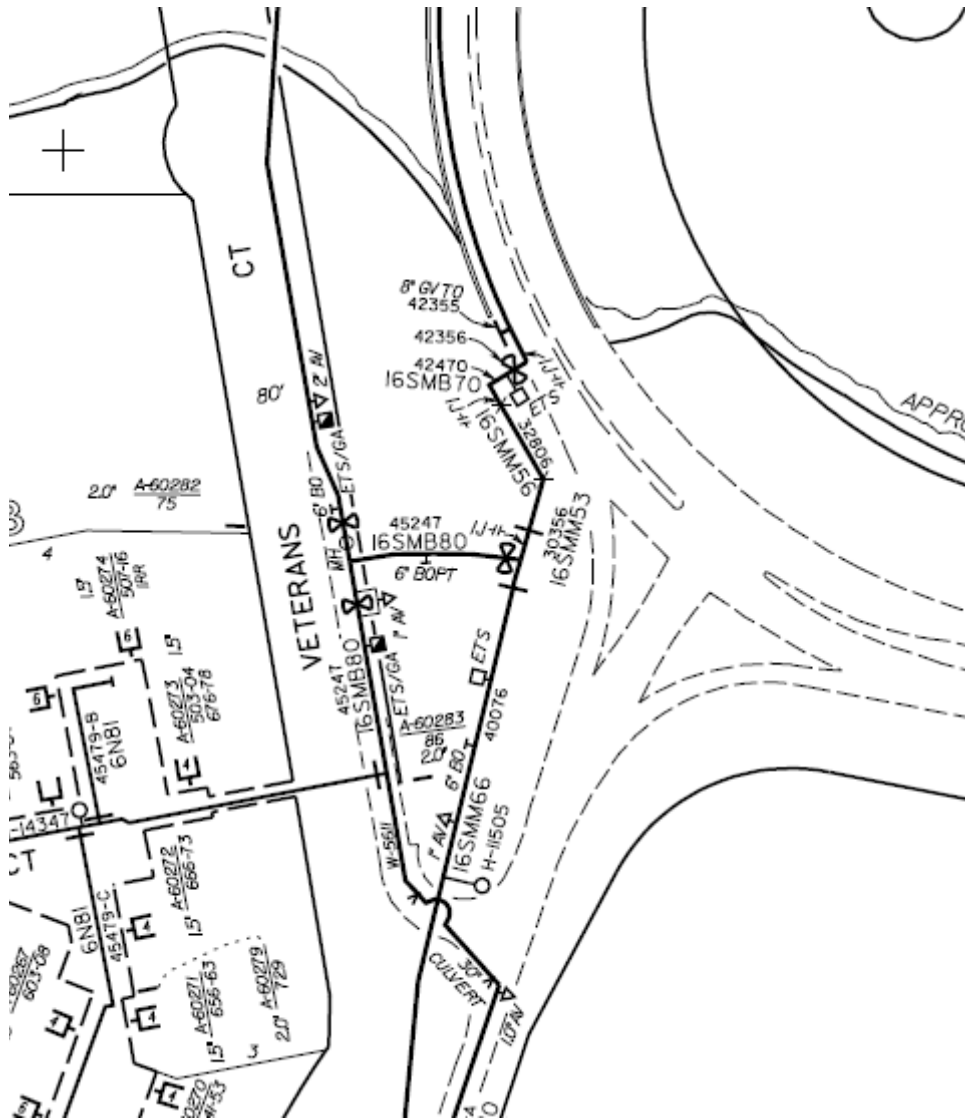
Figure 21: Alternative 2 – Veterans Court Connection Location

The tunnel crossing on the Bay Farm Island side will connect to an existing 16-inch mortar lined and coated steel pipe on the north end of Veterans Court (which borders the estuary) and then extends southerly to connect to an existing 16-inch transmission main at the intersection of Island Drive and Robert Davey Jr. Drive.

Figure 21 presents the B-map extent (B-map 1497B458) of the connection at the end of Veterans Court.

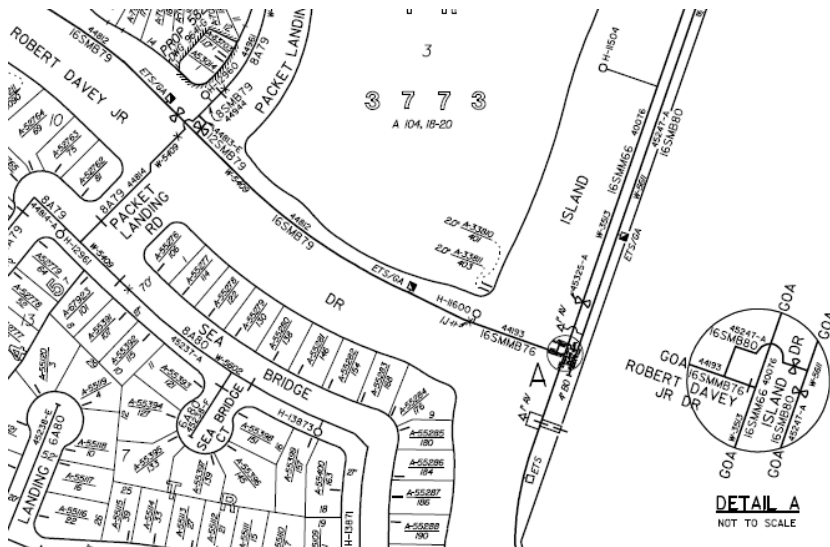
Figure 22: Alternative 2 – Robert Davey Jr and Island Dr. Interconnection Connection Location

Figure 22 presents an inset of B-Map 1497B456 of the connection at the intersection of Robert Davey Jr. Drive and Island Drive.

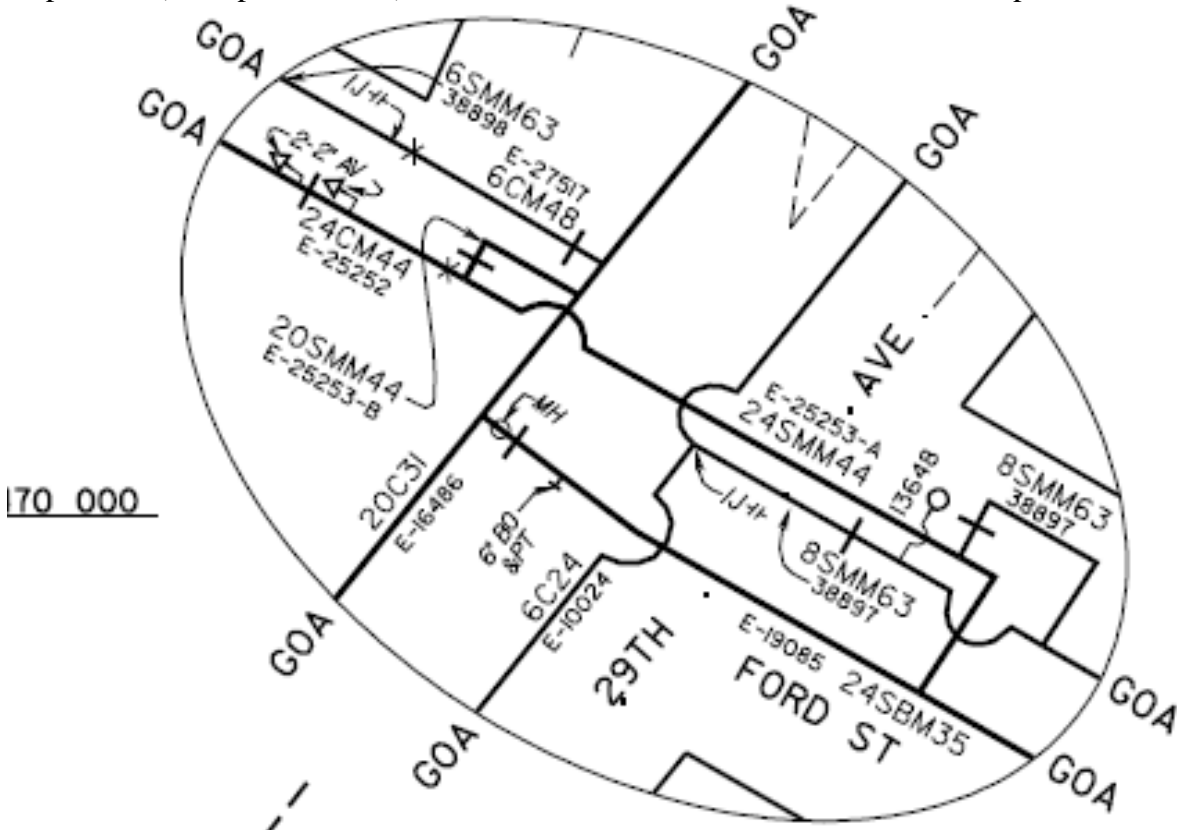
Figure 24: Alternative 3 – Ford St. and 29th Ave. Connection Location

The estuary crossing on the Oakland side will connect to a 24SBM35 at the south end of Derby Avenue and eventually extend northwesterly toward the intersection of 29th Avenue and Ford Street via either Glasscock Street and/or Ford Street. Figure 24 presents the B-map extent (B-map 1497B468) of the 29th Avenue and Ford Street connection point.

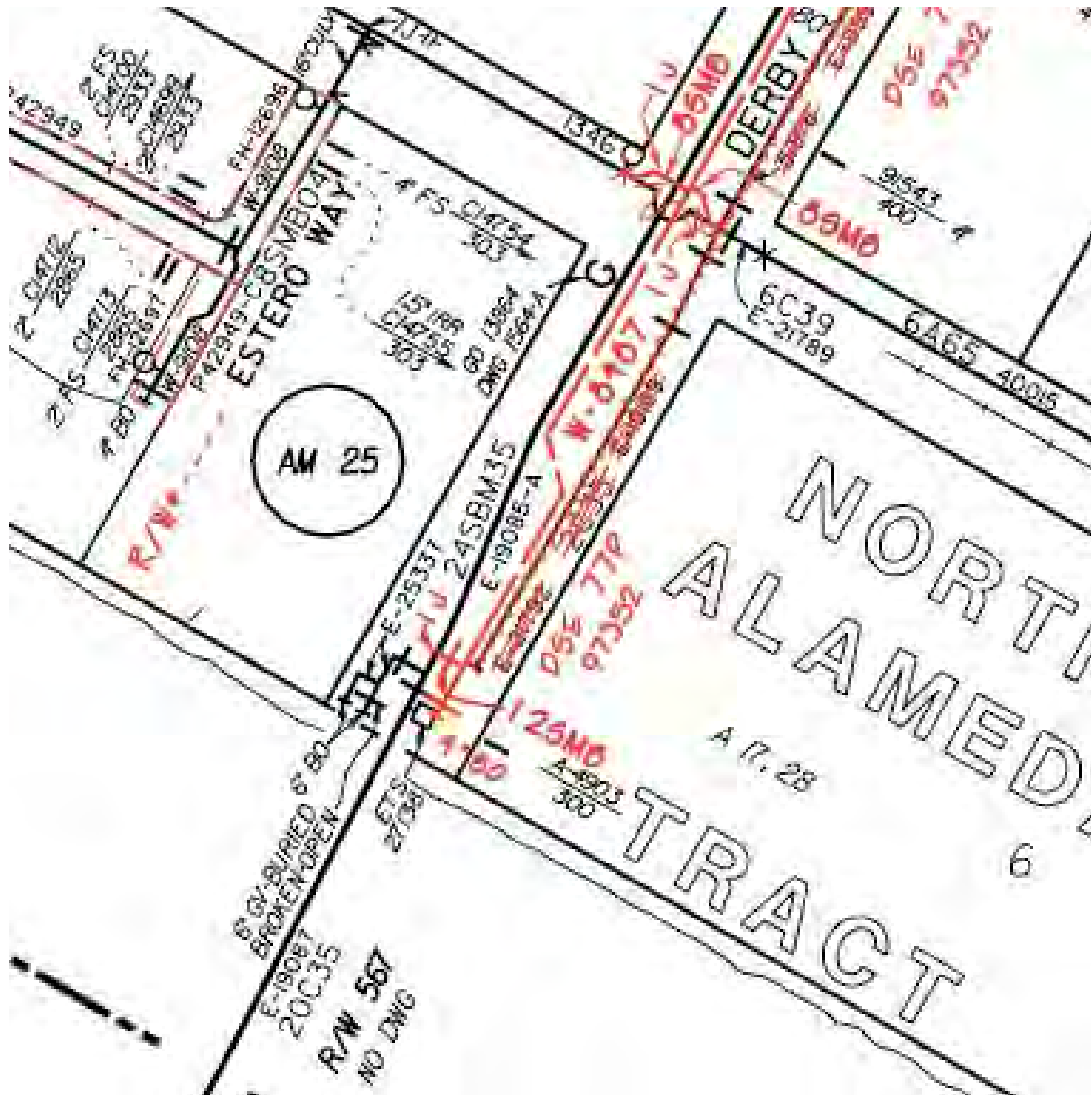
Figure 25: Alternative 3 – End of Derby Avenue Connection Location

Figure 25 shows the B-map extent (B-map 1497B466) of the connection point at the end of Derby Avenue at the estuary.

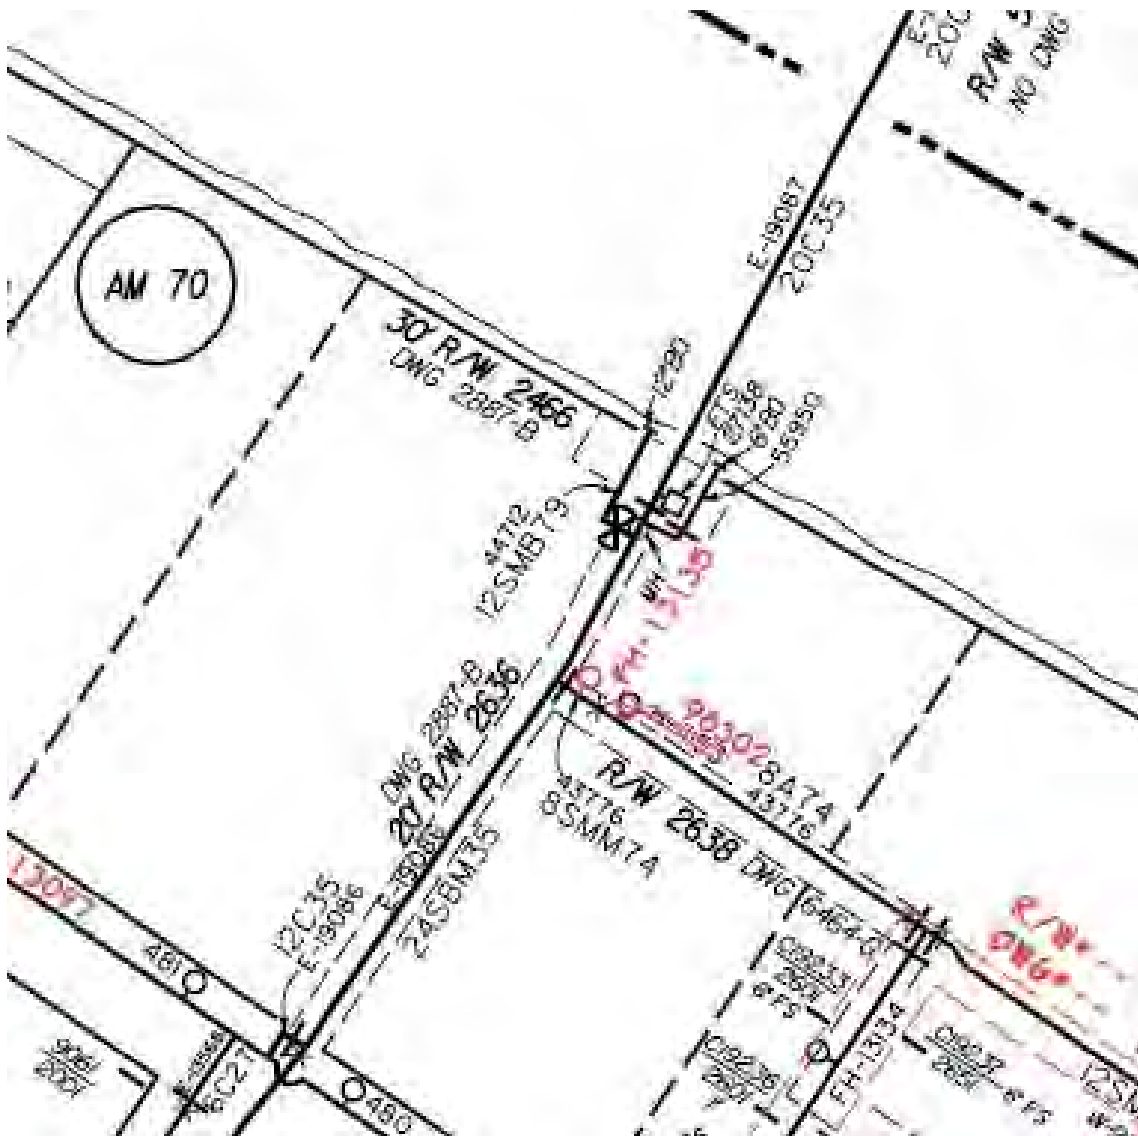
Figure 26: Alternative 3 – Bridgeside Shopping Center Connection Location

The tunnel crossing on the Alameda side will connect to the 24SBM35 steel main in the Bridgeside Shopping Center located at the corner of Blanding and Broadway (directly across the estuary from Derby Ave) and ultimately extend southwesterly, connecting to a 24-inch steel at the intersection of Lincoln Avenue and Park Street. Figure 26 presents the B-map extent (B-map 1497B468) of the Bridgeside Shopping Center connection.

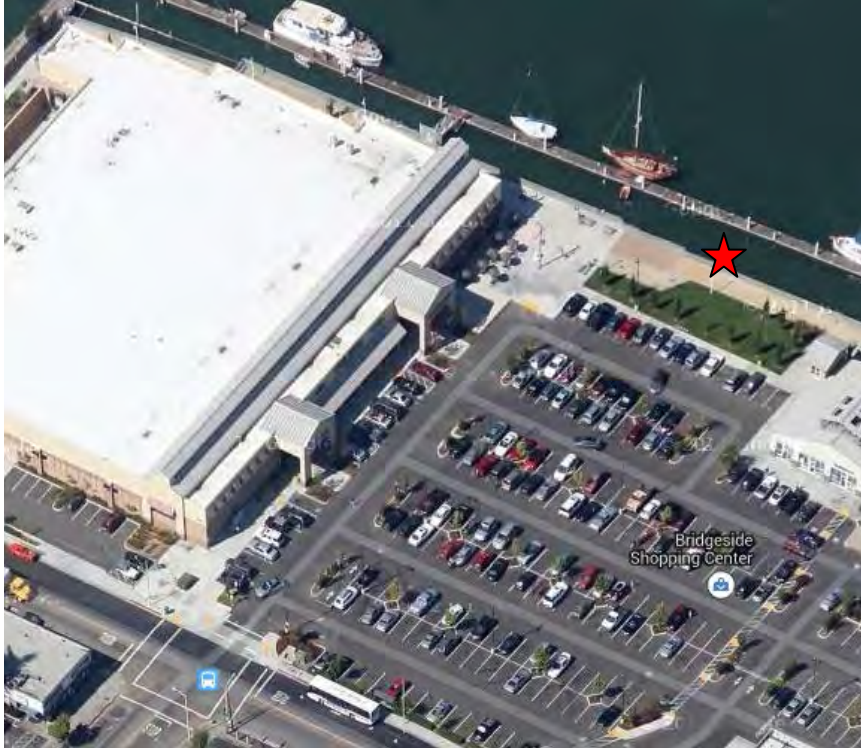
Figure 27: Alternative 3 – Bridgeside Shopping Center Parking Lot Location

The connection point will occur in the 20-foot right-of-way (R/W 2636) which is located in the shopping center parking lot. Figure 27 shows the location in the parking lot where the submarine tunnel pipeline would connect to the on-shore pipeline.

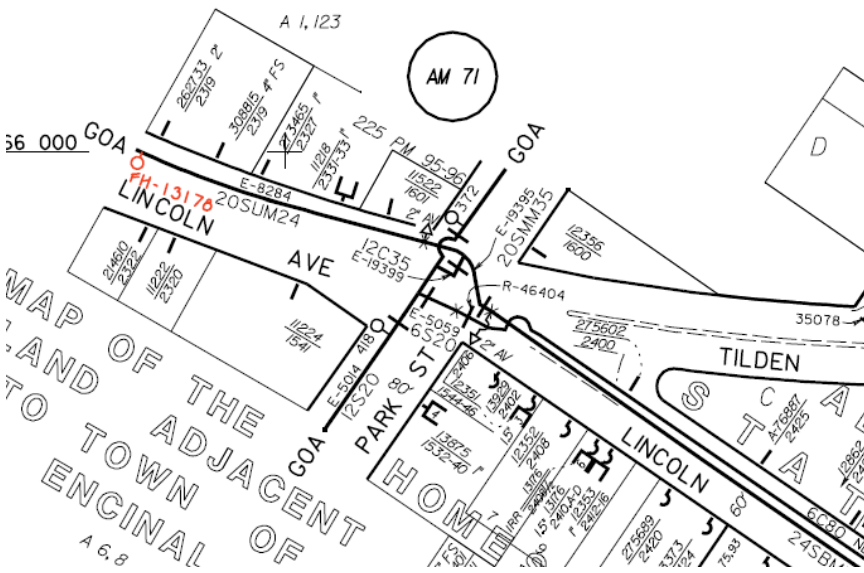
Figure 28: Alternative 3 – Lincoln Avenue and Park Street Connection Location

Figure 28 presents the B-map extent (B-map 1497B468) of the Lincoln Avenue and Park Street connection.

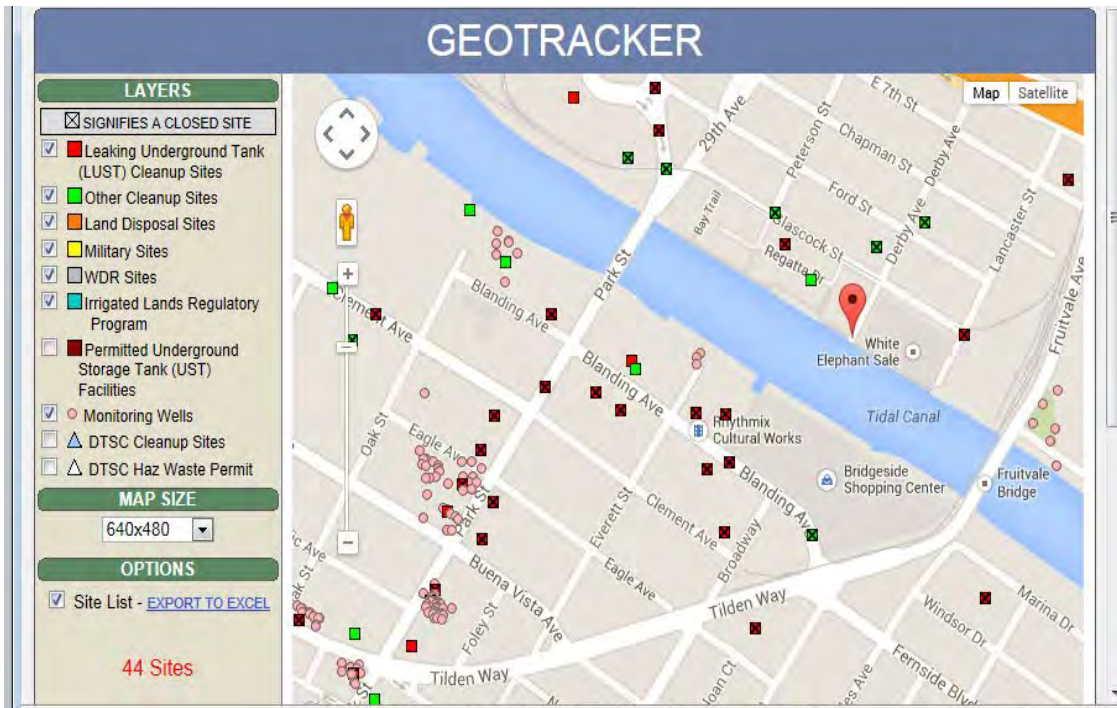
Figure 29 Geotracker Information, Park and Fruitvale Bridge Area

Geotracker sites on both the Alameda and Oakland side of the estuary are shown in Figure 29. Listed sites on Broadway in Alameda and Derby Avenue in Oakland will need to be considered in the preliminary design of the tunnel crossing alternatives at this location.

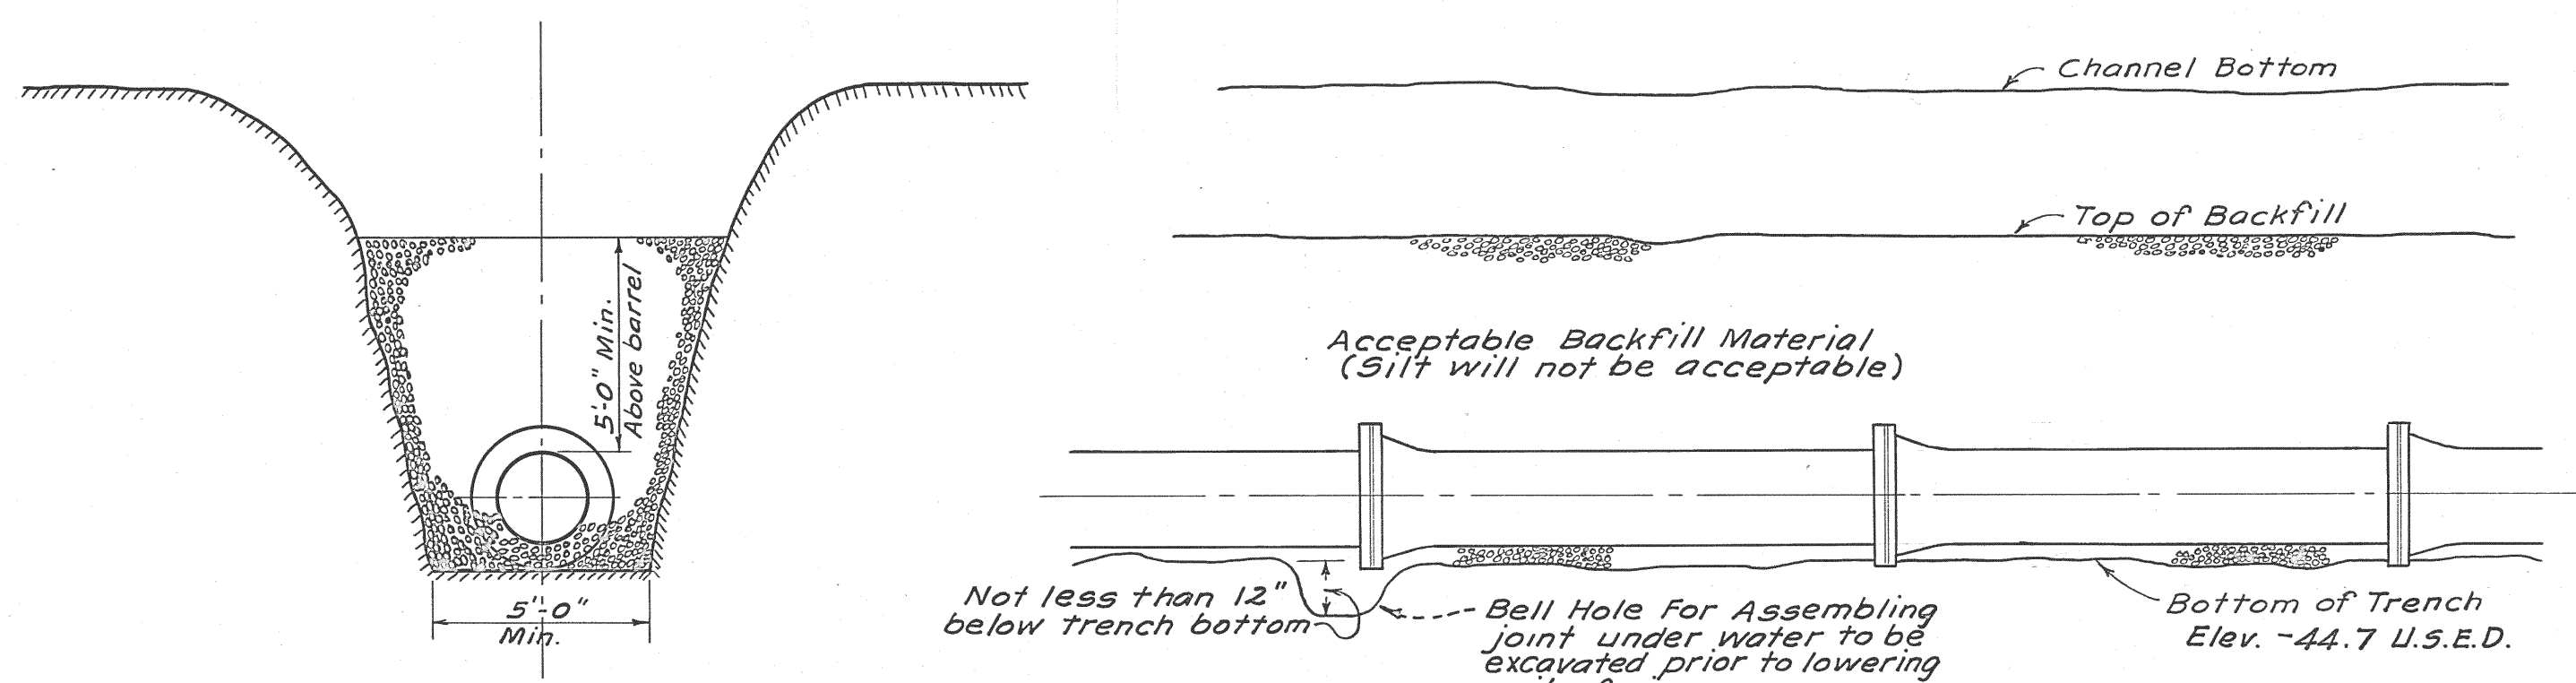
SUBMARINE PIPE TRENCH
Scale: 1"=4'

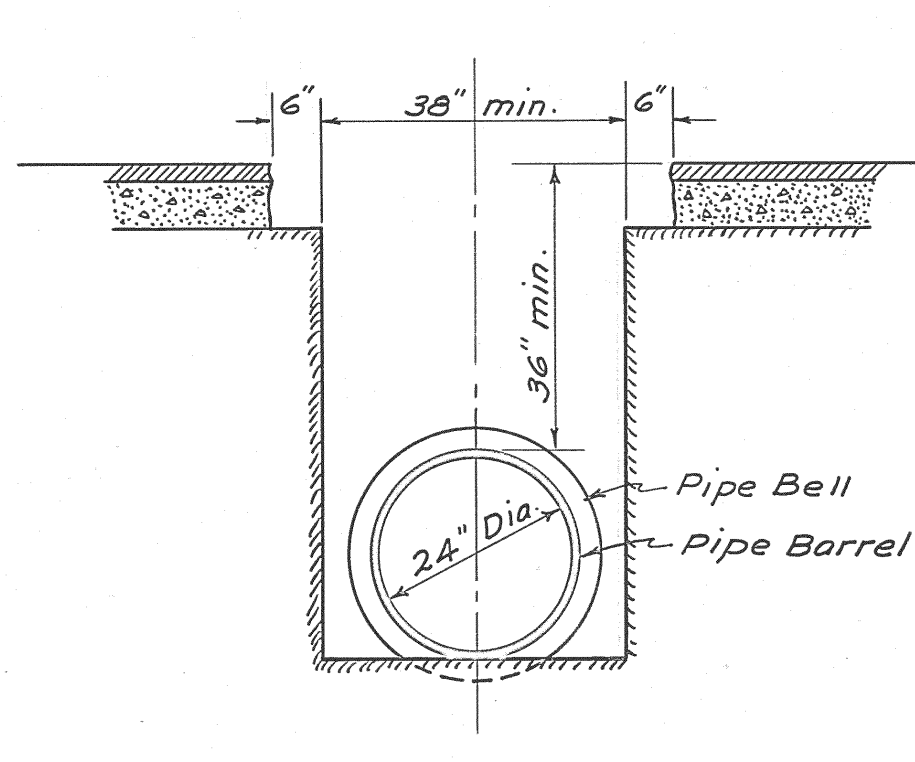
PIPE TRENCH IN PAVED STREET
Scale: 1"=2'

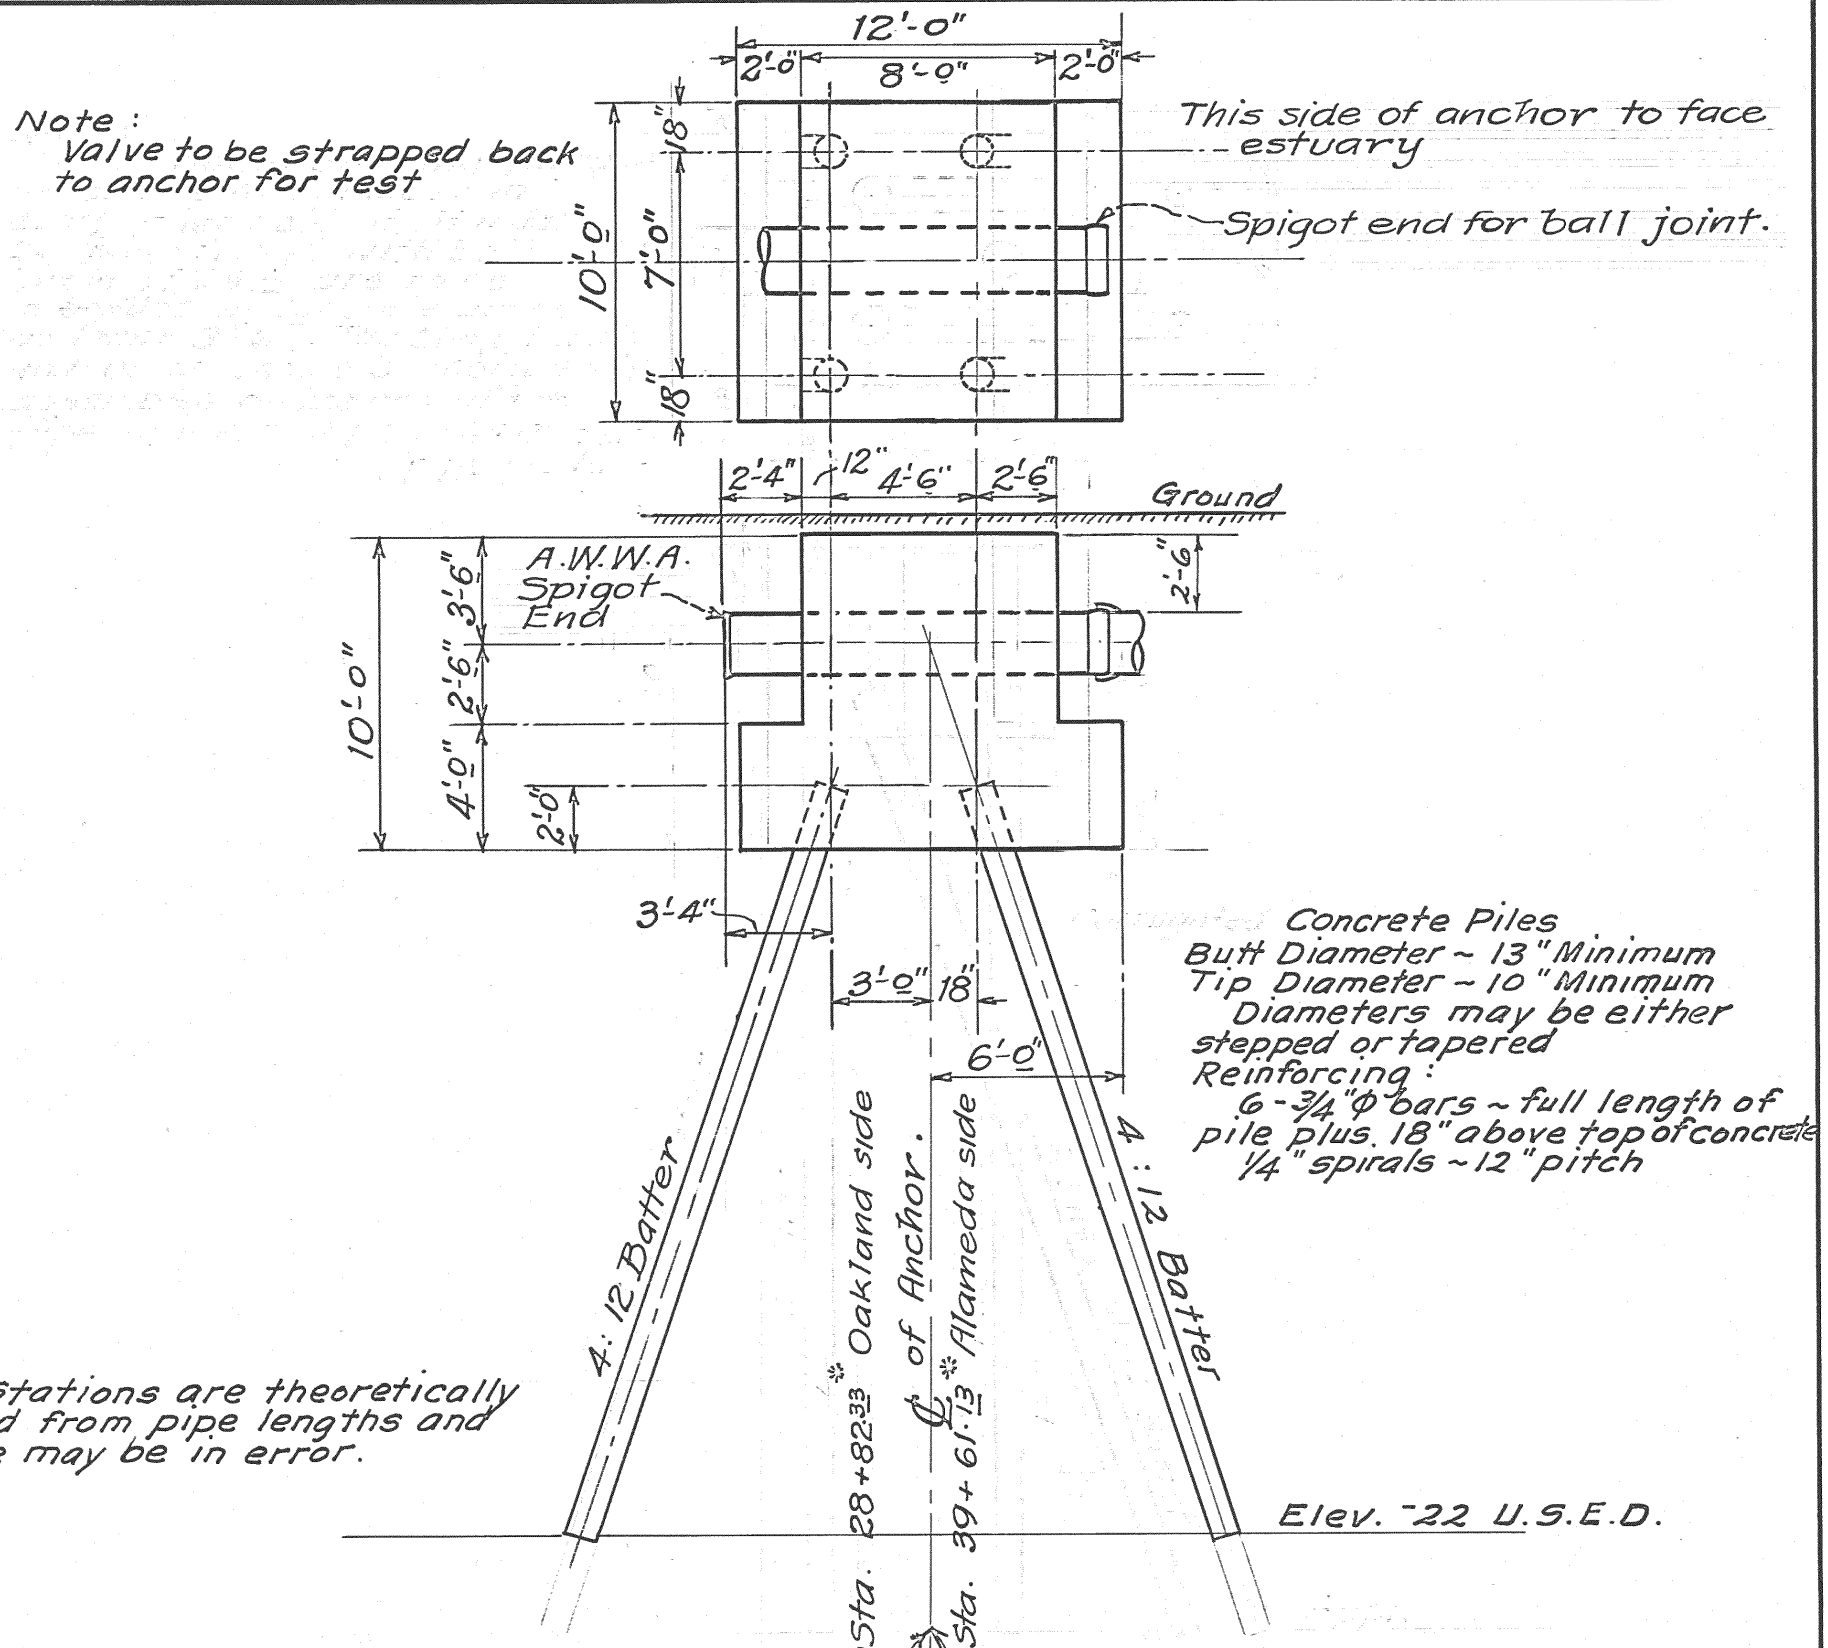
CONCRETE ANCHOR AND PILING
Scale: 1"=6'

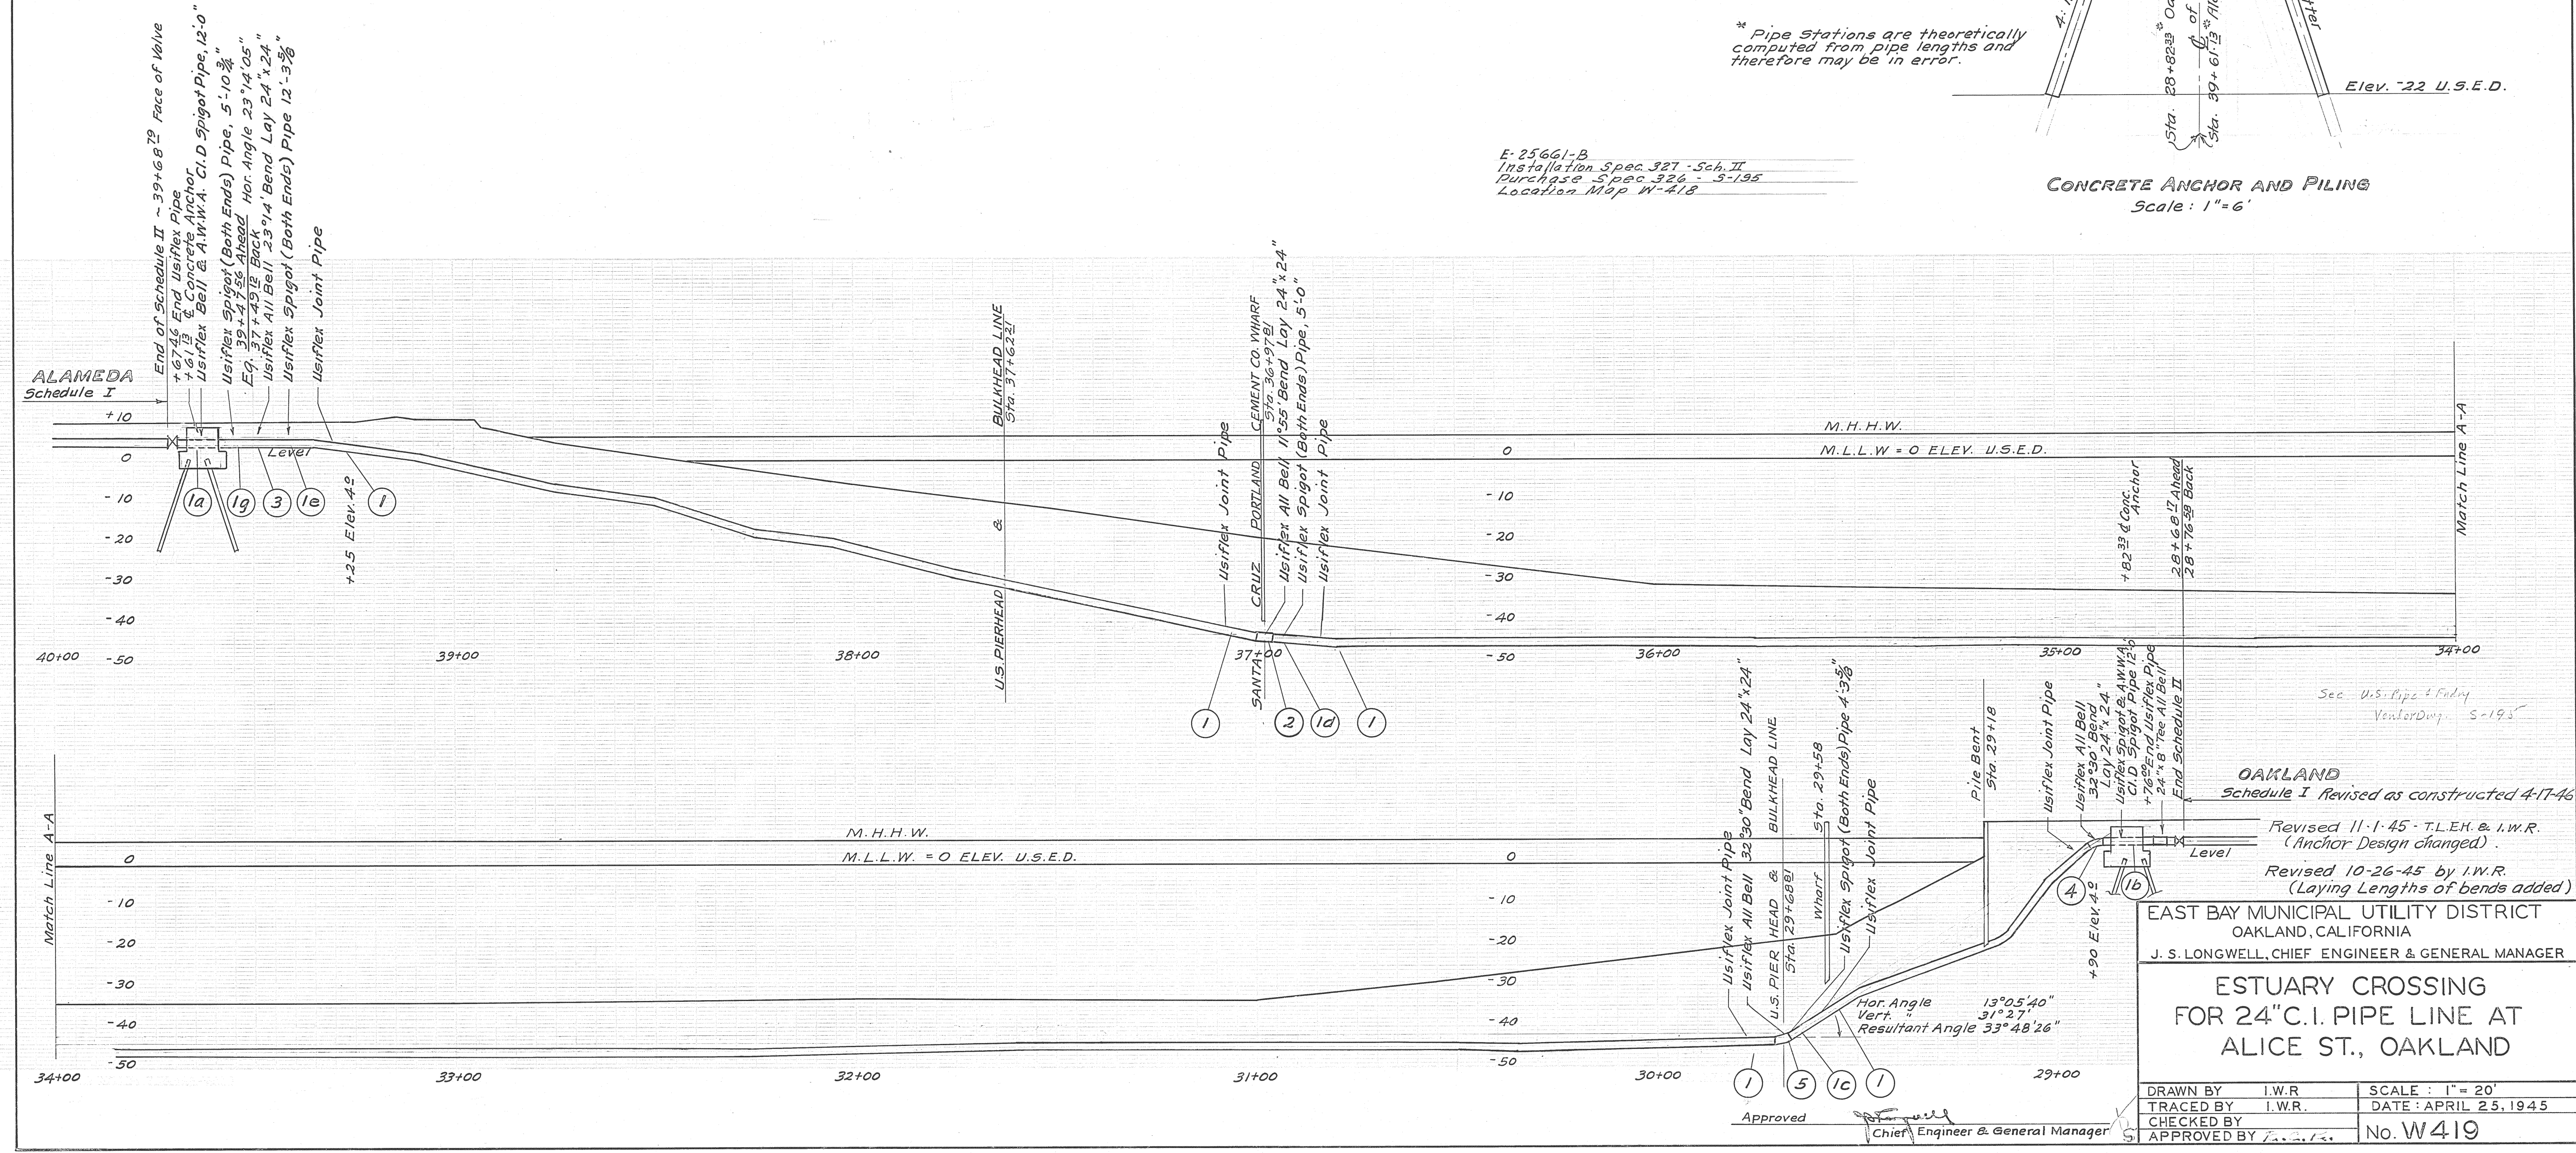
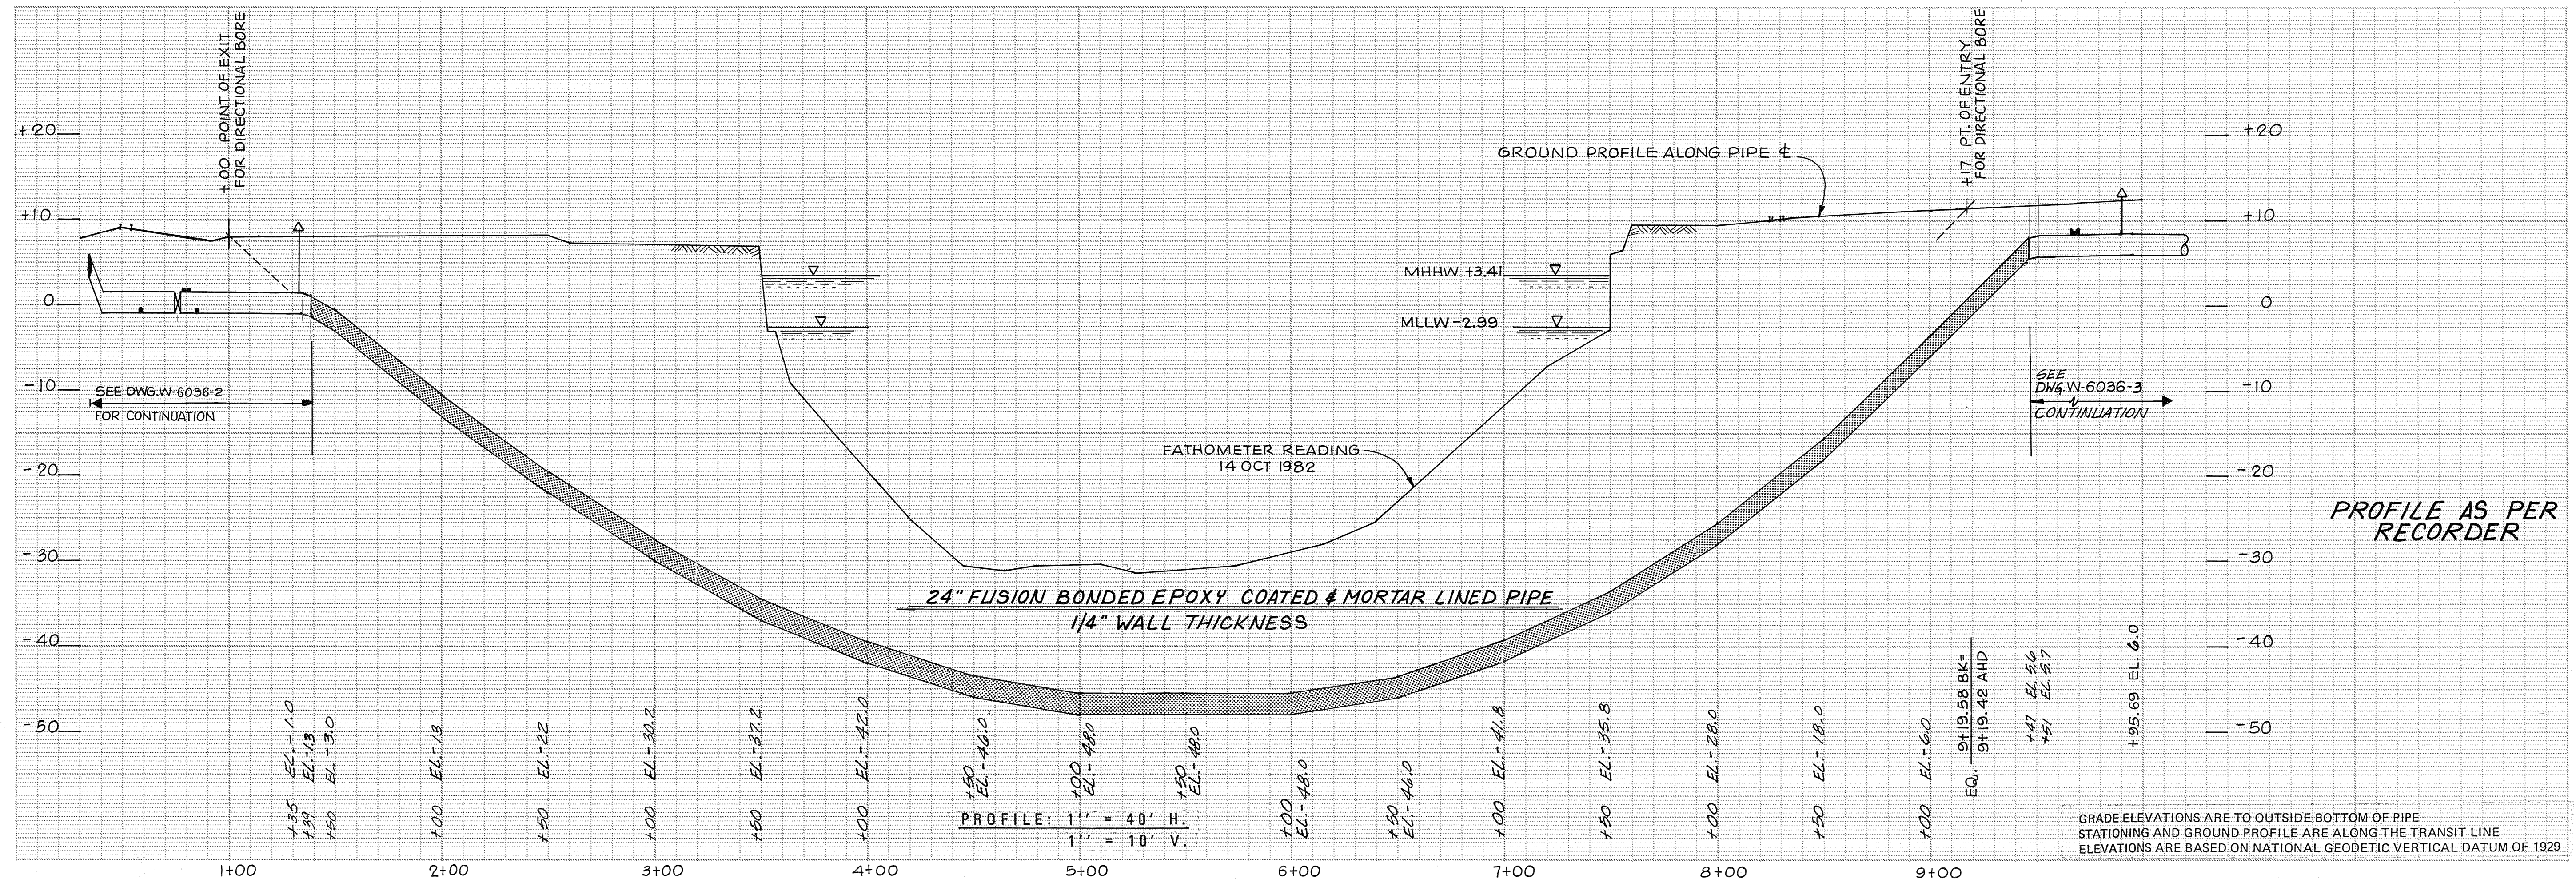
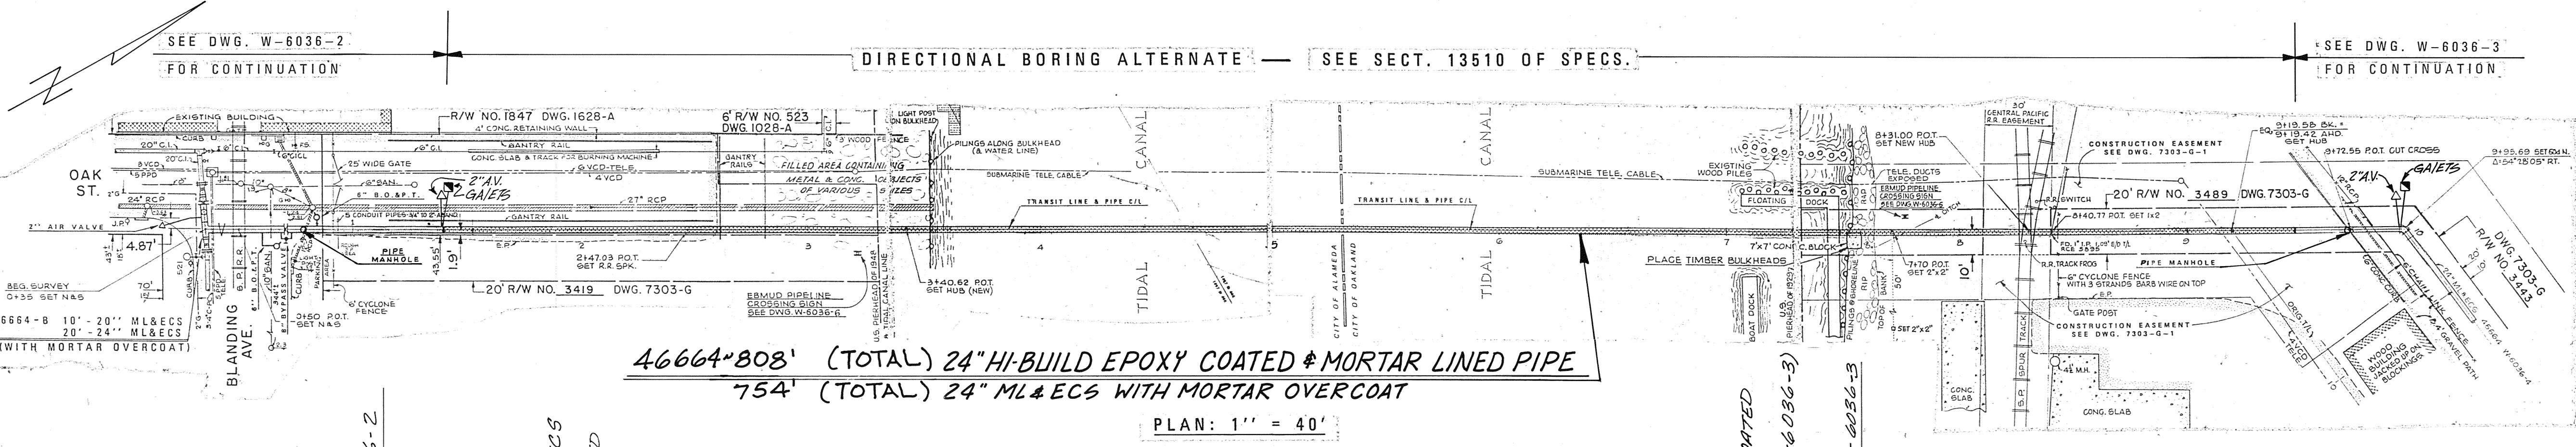
46664*808' (TOTAL) 24" HI-BUILD EPOXY COATED & MORTAR LINED PIPE
 754' (TOTAL) 24" ML&ECS WITH MORTAR OVERCOAT

PLAN: 1" = 40'

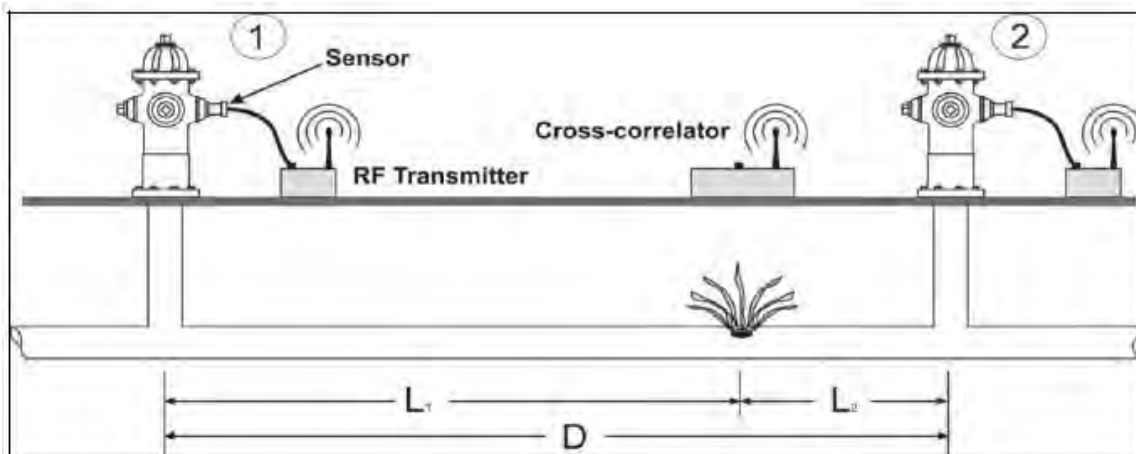
Alignment #	Length [feet]	Cost [\$]	Pros	Cons
1	3,800	\$1.6M	LIQ 0% Very High	
2	3,800	\$1.6M	LIQ 0% Very High	
3	3,800	\$1.6M	LIQ 0% Very High	
4	3,800	\$1.6M	LIQ 0% Very High	3 Utility Crossings 700 Utility R/W

Echologics uses a technology called the Leakfinder RT Correlation System (Leakfinder RT) to identify potential leaks in large diameter pipelines. The Leakfinder RT uses a cross correlation methodology which involves the use of two sensors connected to the water column on both ends of the pipeline segment under investigation. See Figure 1 below for a schematic of the Leakfinder RT set-up.

Figure 1. Schematic of the Leakfinder RT Set-Up

The two sensors act as hydrophones, detecting potential leaks by determining the location of a noise source based on the time difference that a noise is heard by the two separate stations. Each station contains a wireless radio transmitter that broadcasts the sound signals from the station to a central receiver, which then connects to a laptop that calculates the noise source location. The distance formula used for the location calculation ($\text{Distance} = \text{Velocity} * \text{Time}$). In this case, the sound velocity is used for the velocity term and is calculated using information on the pipe type, diameter, and thickness.

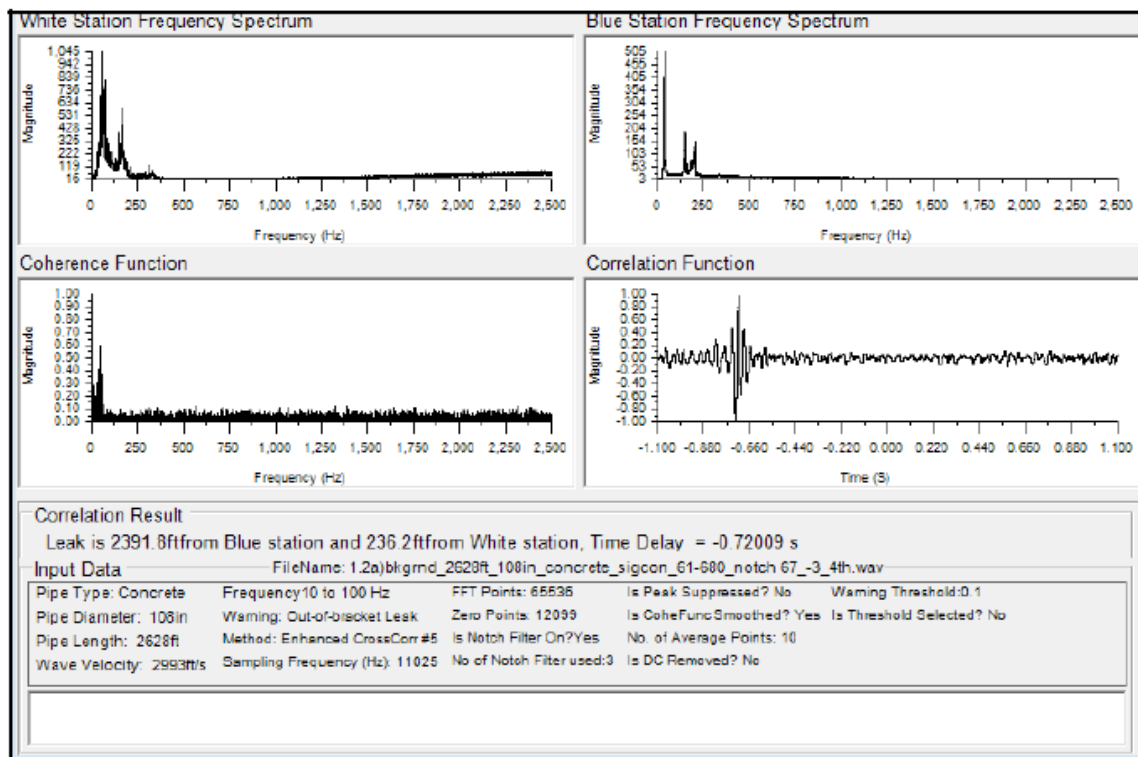
Figure 2 is an example of acoustic information that is used to determine the location of a possible leak or other point of interest. In this example, the two stations are located at air valves, approximately 2,600 feet apart. The pipe material is concrete and the pipe diameter is 108 inches so the predicted sound wave velocity is calculated to be 2,993 ft/sec; site photos are shown in Figure 3. The two top graphs in Figure 2 depict the distributions of sound frequency heard at each listening station. The bottom left graph is the Coherence Function which measures the degree of similarity in the frequency of sound signals from each sensor and which frequencies have the most commonality. The bottom right graph in Figure 2 is the Correlation Function which determines the time differential between sounds with the best coherence heard by each station. This time differential is then translated to a distance measurement using the sound velocity. In this example, the leak is initially estimated to be 2,392 feet from the Blue station and 236 feet from the White station.

Figure 2 Example of Echologics RT noise signal processing of suspected leak location.

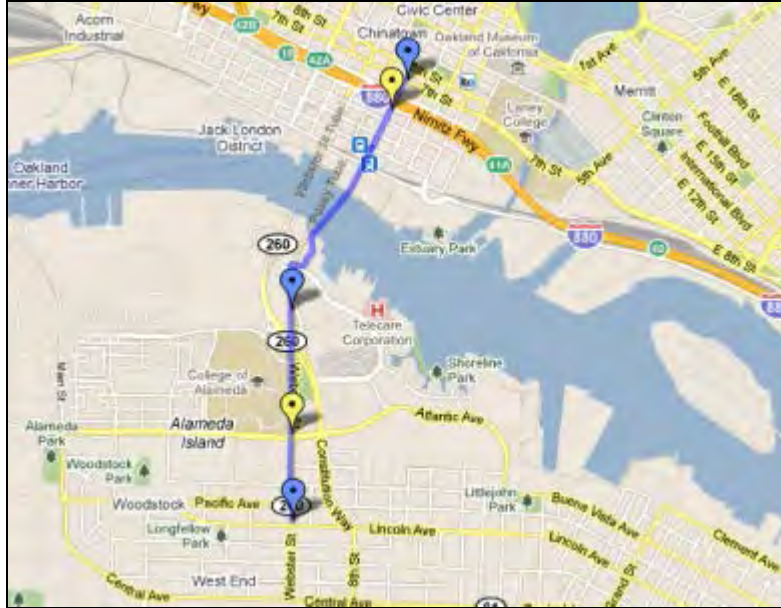
Figure 3. Alice Street estuary crossing investigation by Echologics.

The Alice Street Crossing, a 24-inch diameter steel pipe, was tested by Echologics on April 12, 2011. A total of 8,890 feet of pipe was surveyed in four consecutive pipe segments; the limits of the survey are shown in Figure 3. The estuary crossing alone is approximately 900 feet.

The blue and yellow dots represent the location of the transmitter stations for each segment tested. The first segment started at Hydrant 5269 on the corner of Alice St. and 7th St. in Oakland to a 2-inch air valve at the intersection of Webster and Lincoln St in Alameda. The survey extended into Alameda, across the estuary, and finished at the intersection of Webster St. and Lincoln Ave. No potential leaks were detected during the survey, and Echologics concluded that the probability of leakage for Alice Street Crossing is low.

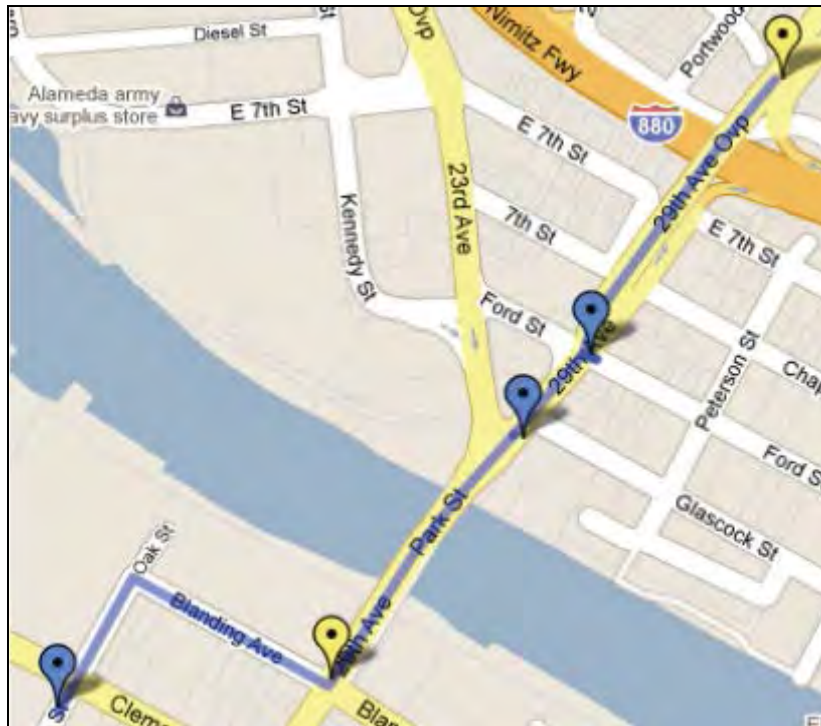
Figure 4. Park Street Crossing investigation by Echologics.

The Park Street Crossing, a 20-inch diameter steel and cast iron pipe, was tested by Echologics on September 23, 2010. A total of 4,715 feet of pipe was surveyed in four consecutive pipe segments; see Figure 4.

The survey investigation started at the intersection of Ford St. and 29th Ave/Park St. in Oakland, and ended on Oak St, just south of Clement Ave in Alameda. Hydrant and/or air valve information was not provided in the report for this crossing. No potential leaks were detected during the survey, and Echologics concluded that the probability of leakage for Park Street Crossing is low.
