Alameda-North Bay Farm Island Crossings Master Plan

*East Bay Municipal
Utility District*

November 2014

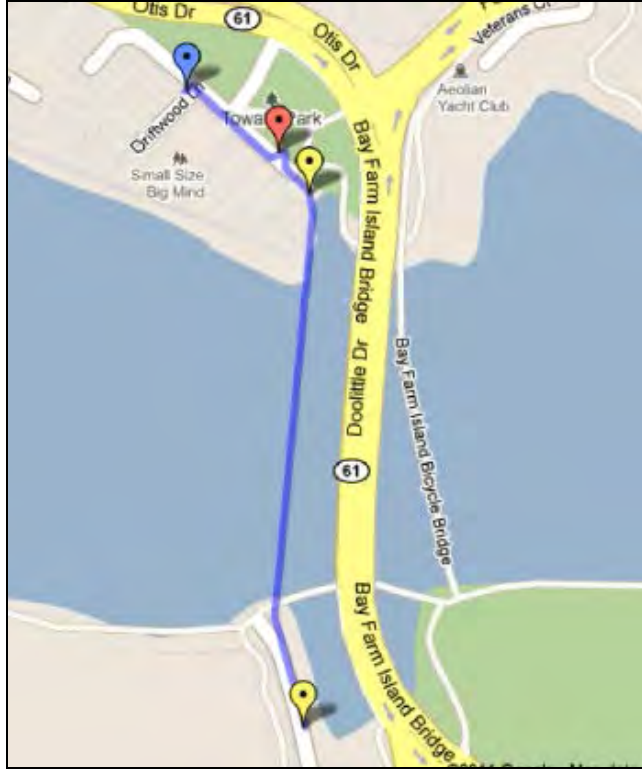
Figure 5. Alameda-Bay Farm 2 Crossing investigation by Echologics

The Alameda-Bay Farm 2 Crossing, a 16-inch and 20-inch diameter steel pipe, was tested by Echologics on April 13, 2011. A total of 1,430 feet of pipe was surveyed, with three consecutive pipe segments for the initial testing; see Figure 5.

The survey investigation started from Hydrant 16624 at the intersection of Driftwood Ln. and Bridgeview Isle, and ended at the 2-inch air valve in Veterans Ct. One potential leak was found on Bridgeview Isle, and Echologics concluded the probability of leakage is high. The detected leak's location is shown in Figure 6.

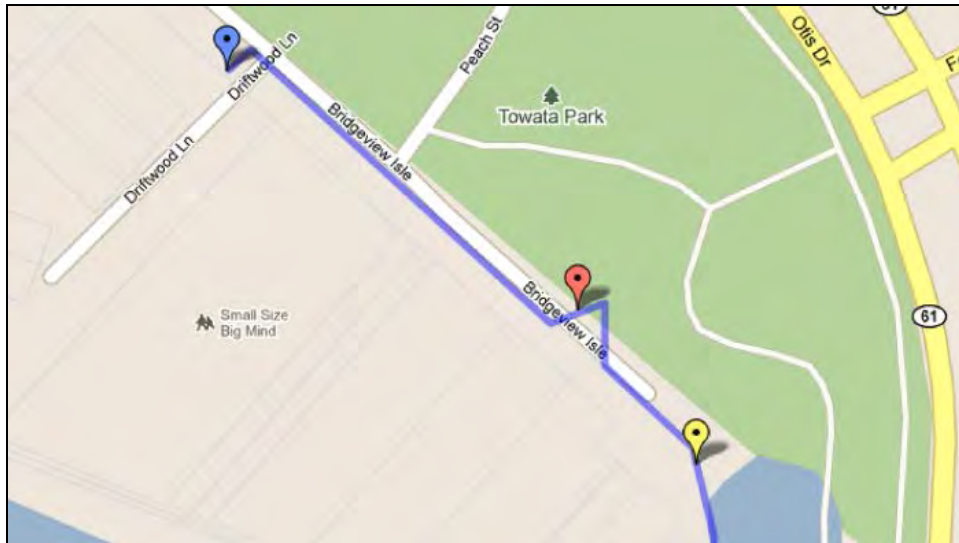
Figure 6. Potential leak located near Alameda-Bay Farm 2 Crossing.

The blue station in Figure 6 is Hydrant 16624 and the yellow station is a manhole. Two access points exposing the pipe barrel were made available for surface mounted sensors to further pinpoint the leak. The detected leak is approximately 196.3 feet from the blue station and 152.7 feet from the yellow station, as determined by the correlation result shown in Figure 7.

Echologic's survey detected one potential leak approximately 150 feet from the north end of the Alameda-Bay Farm 2 Crossing. No leaks were detected by Echologics during the survey of Alice, Park, Blanding (Oak St.) crossings. Echologics leak detection methods are not an exact science, and may not find all leaks.

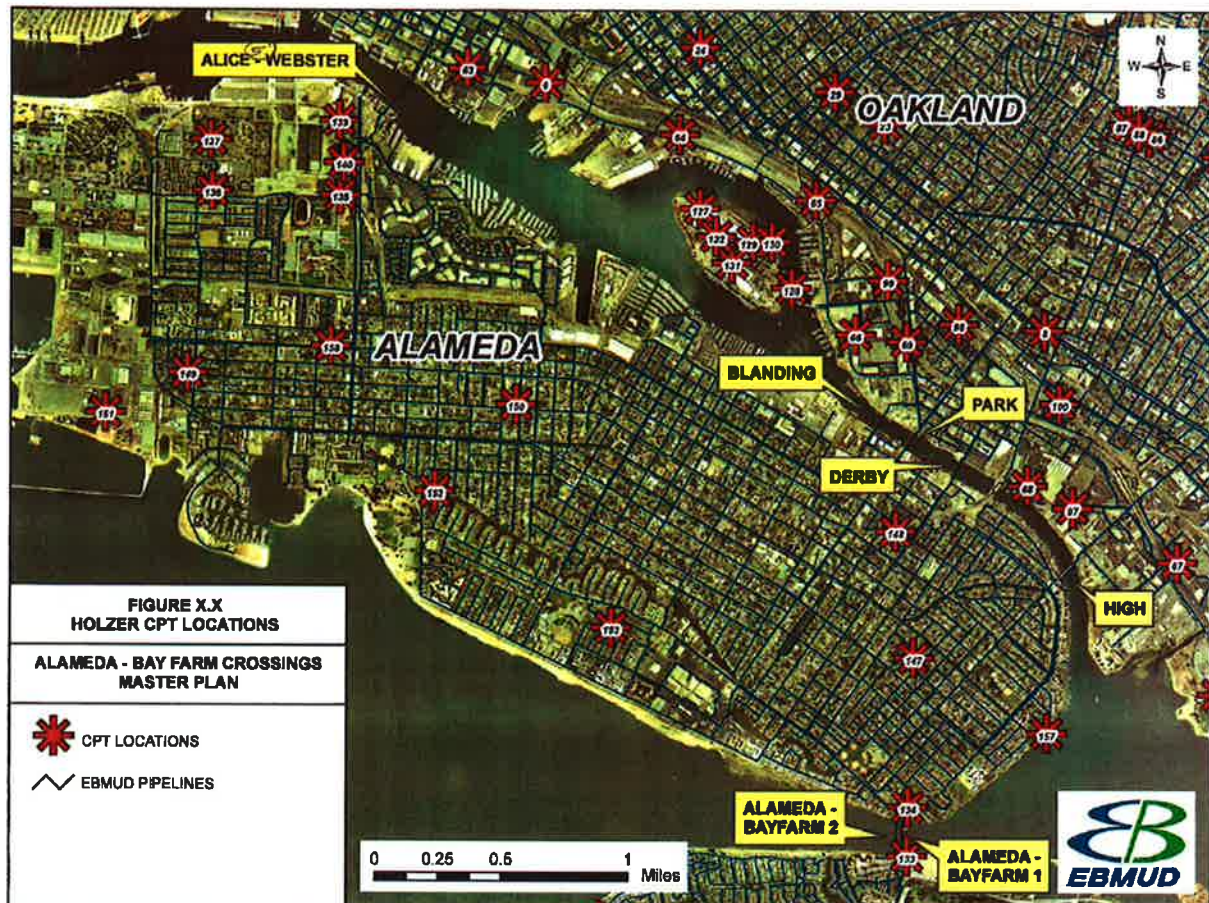
Illustration 1: Alameda Crossing Map Indicating Location of Pipeline

The six crossings evaluated are shown below in Illustration 1. Each pipeline crossing is located below ground surface, with the exception of Alameda-Bay Farm 1, which is suspended from the bridge deck for most of the channel crossing.

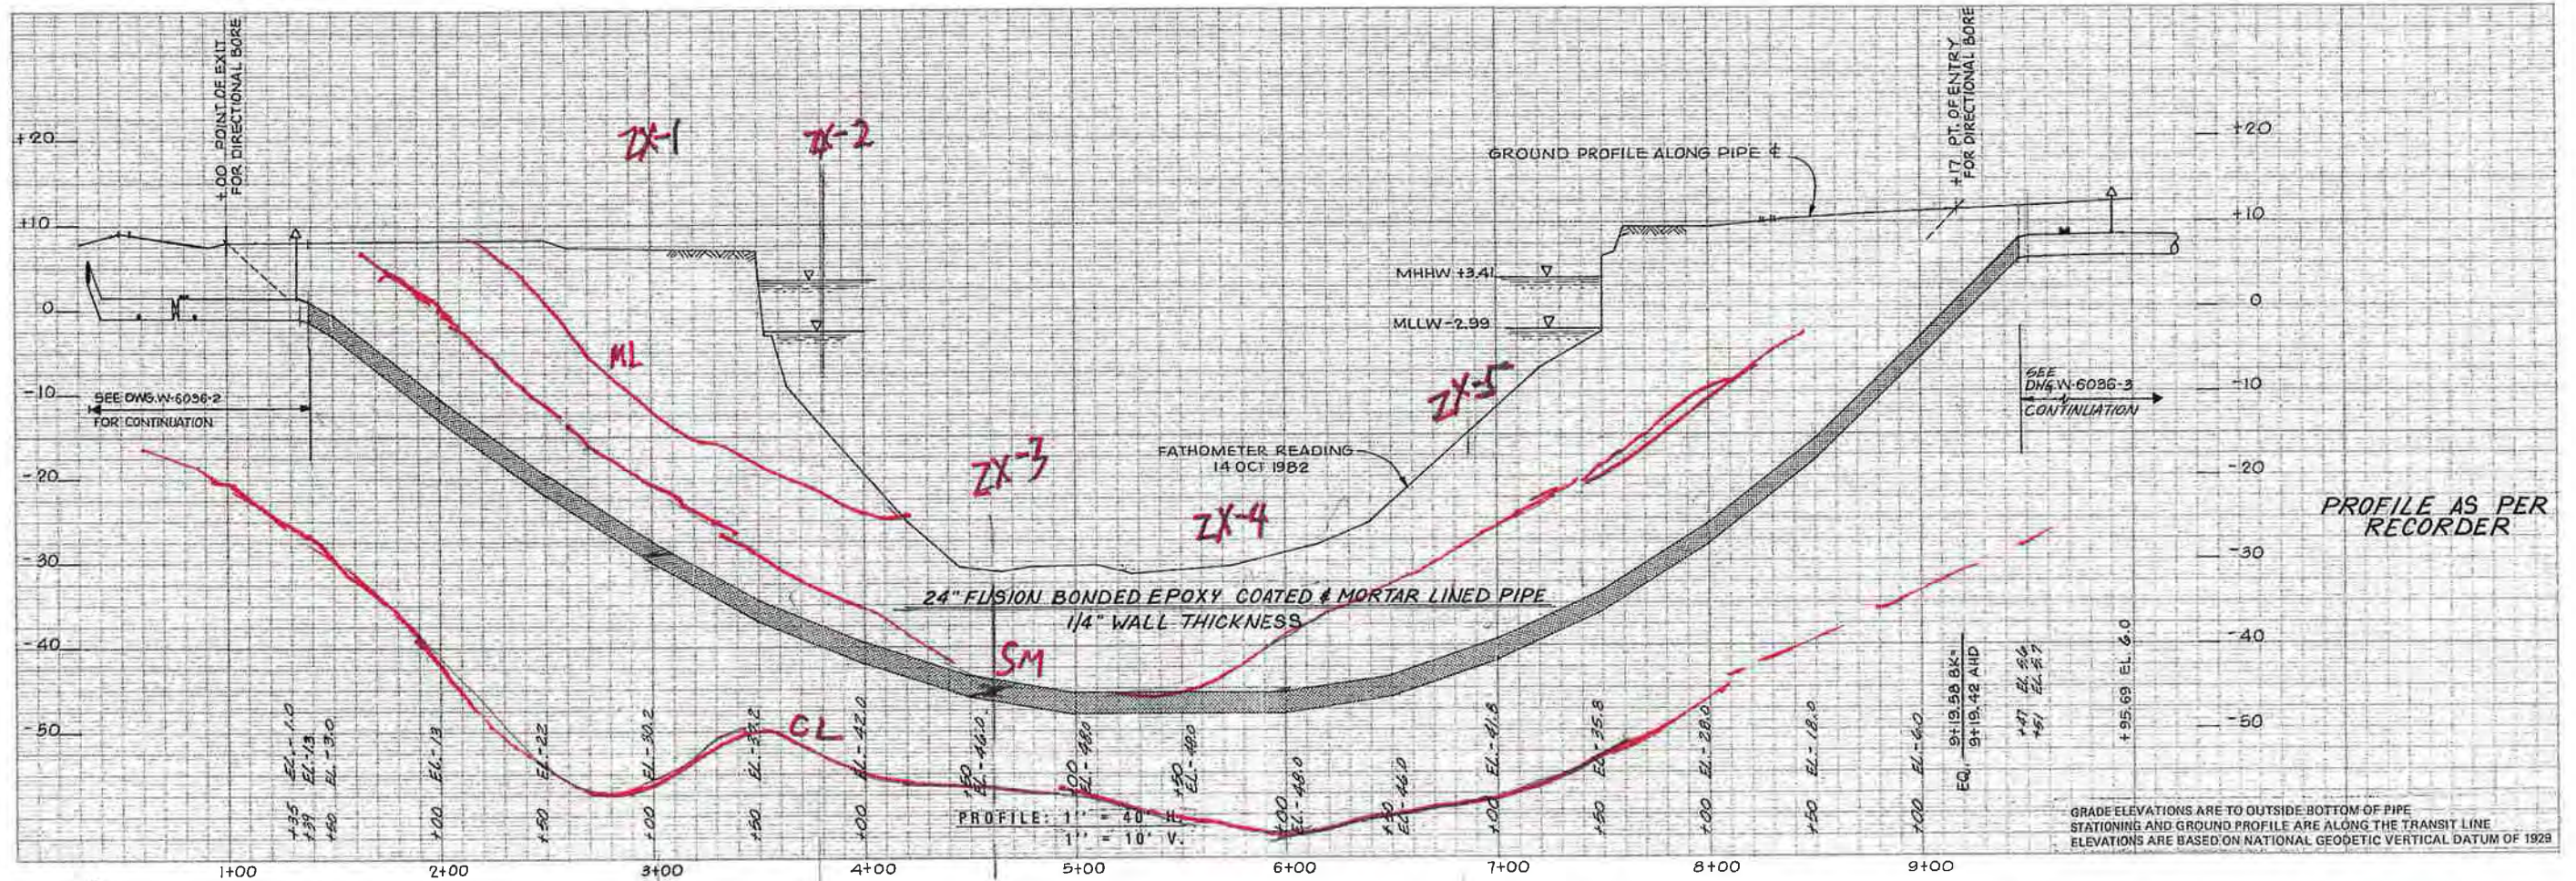
Figure 1A
Alice Webster Soil Profile

1. Alice-Webster Crossing (Ref. Figure 1A): Multiple boring logs were done at the Alice-Webster crossing. The Alice-Webster pipeline crosses the Oakland Inner Harbor. In the vicinity of the pipeline, the soil near the Alameda side of the crossing is underlain with very soft, high plasticity silt. The soil surrounding the pipeline at the Oakland Inner Harbor contains clayey-sand with low blow counts. This clayey-sand layer is loose and can liquefy

under a strong earthquake. This soil poses a high risk to the pipeline and it is susceptible to large deformation and possible damage in the event of an earthquake. The referenced 2000 Olivia Chen Consultants report concluded that soils in the vicinity of the pipeline are liquefiable and require mitigation.

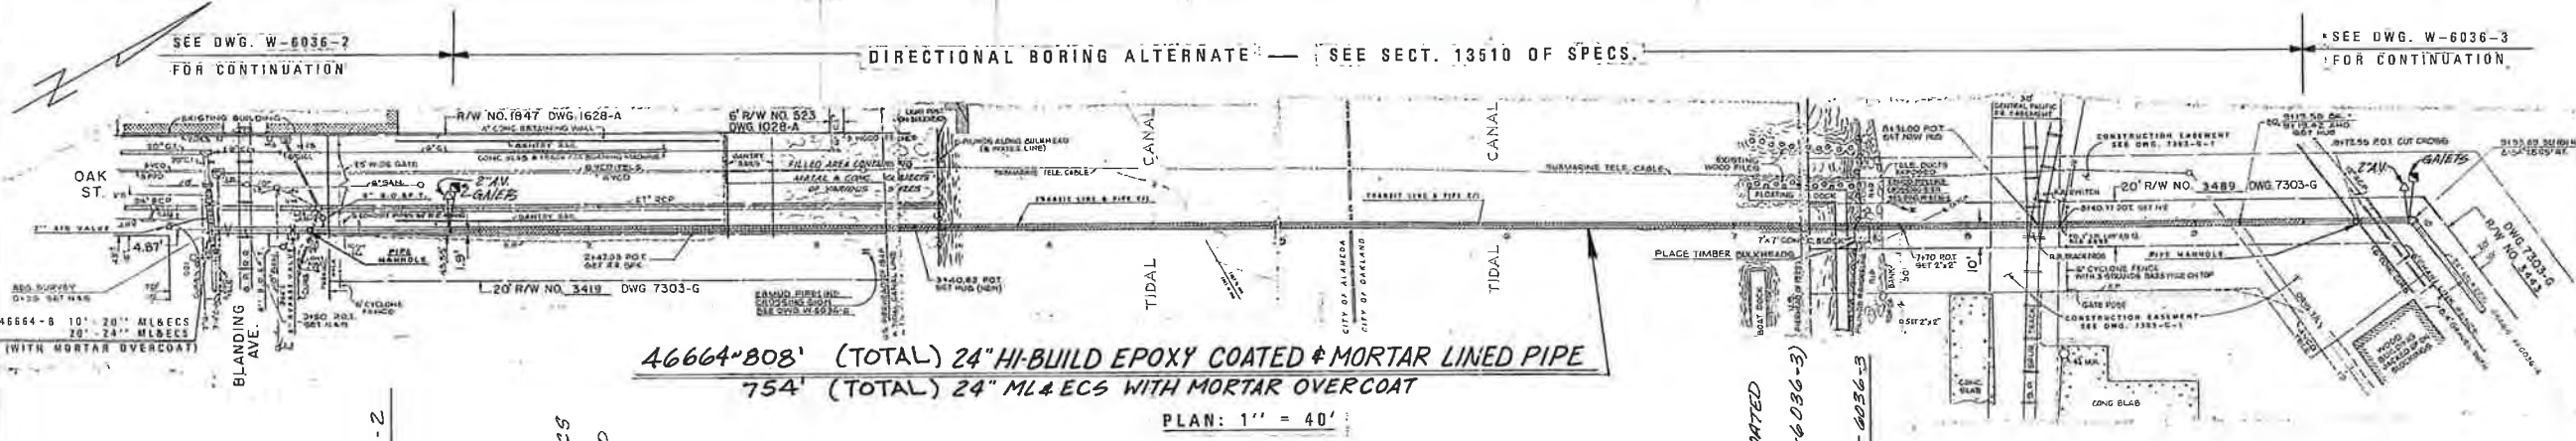
Figure 2A
Blanding General Soil Profile

2. Blanding Crossing (Ref. Figures 2A & B): Blanding is located on the northeast side of Alameda. The soil throughout the vicinity of the pipeline can be described as a soft, silty clay. Additionally, liquefiable soils are also present in the crossing. This pipeline, however, is **not** under the risk of damage from an earthquake **because** it is embedded deeper in the soil; it is located below the sandy layers, so liquefaction-induced settlement will not affect the pipeline.

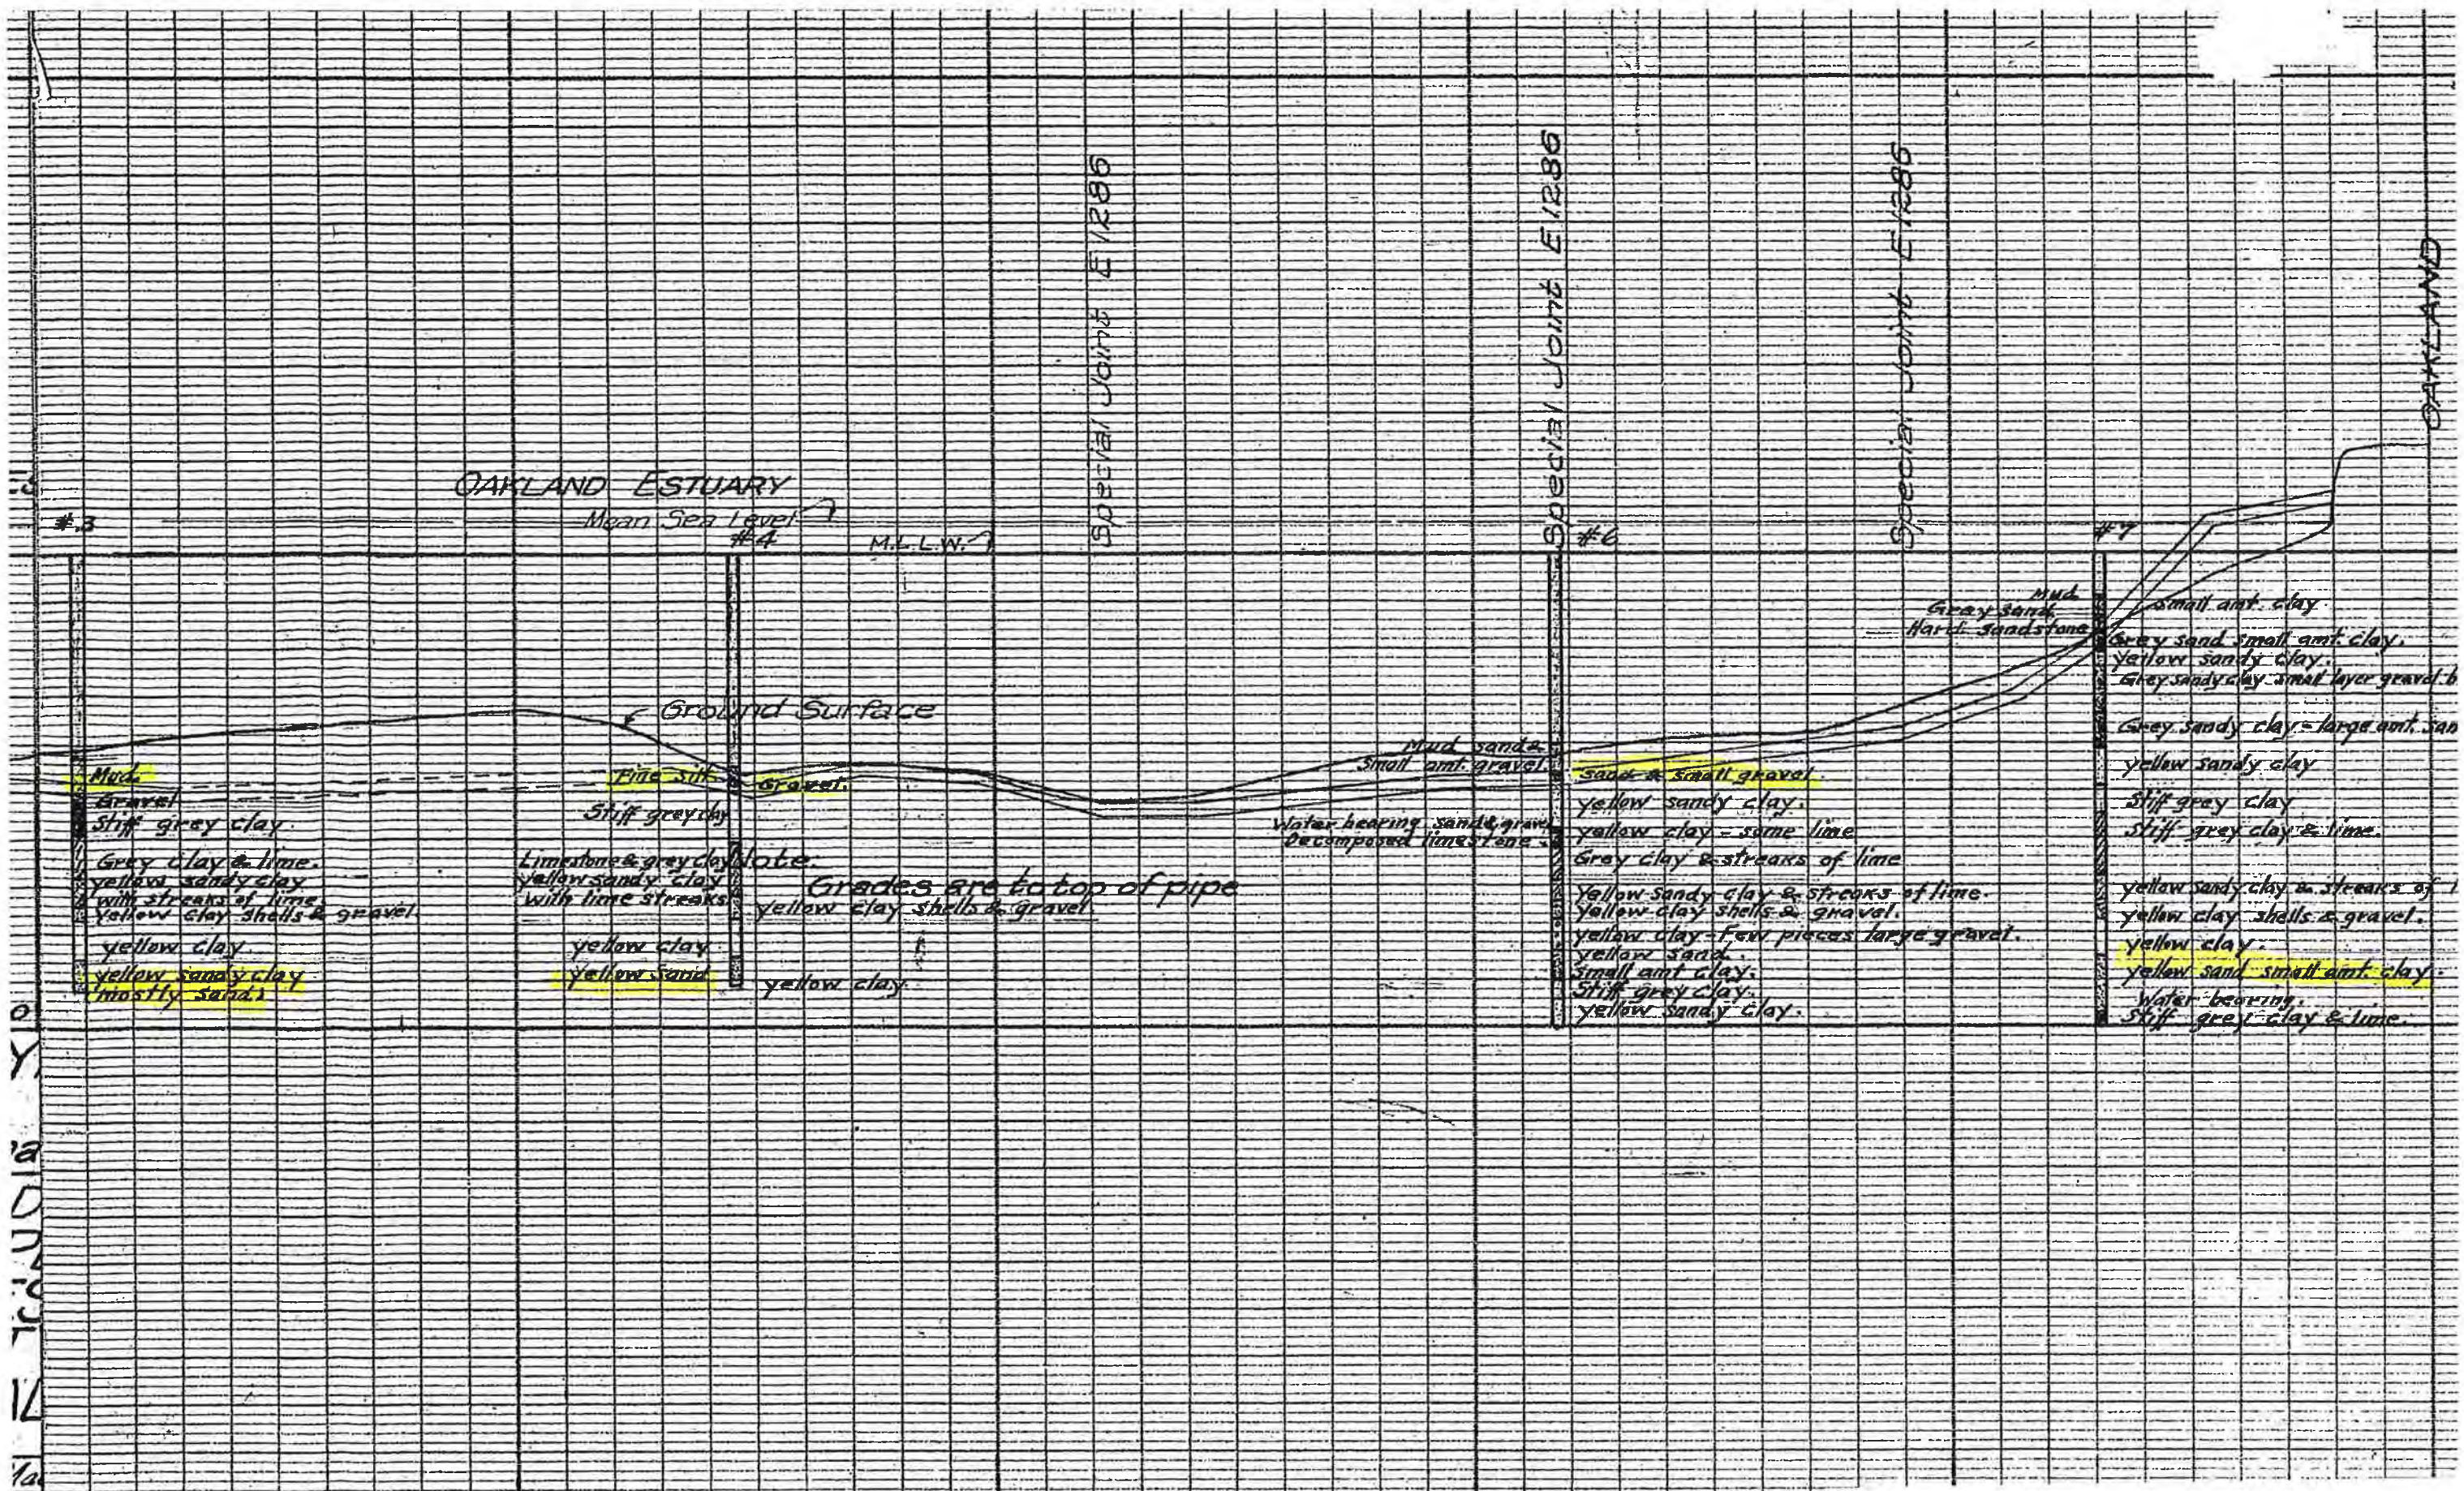
Figure 3A
Park General Soil Profile

3. Park Crossing (Ref. Figures 3A, B, & C): The park crossing is located east of the Blanding crossing. The information provided here was limited; the soil profile only described the subsurface conditions qualitatively. There is a sand layer located underneath near the pipeline that could pose a liquefaction hazard. There is also a risk of lateral spreading and slope instability due to the liquefaction of this sand layer. However, a complete assessment can only be done through further tests, and this assessment is based on limited data.

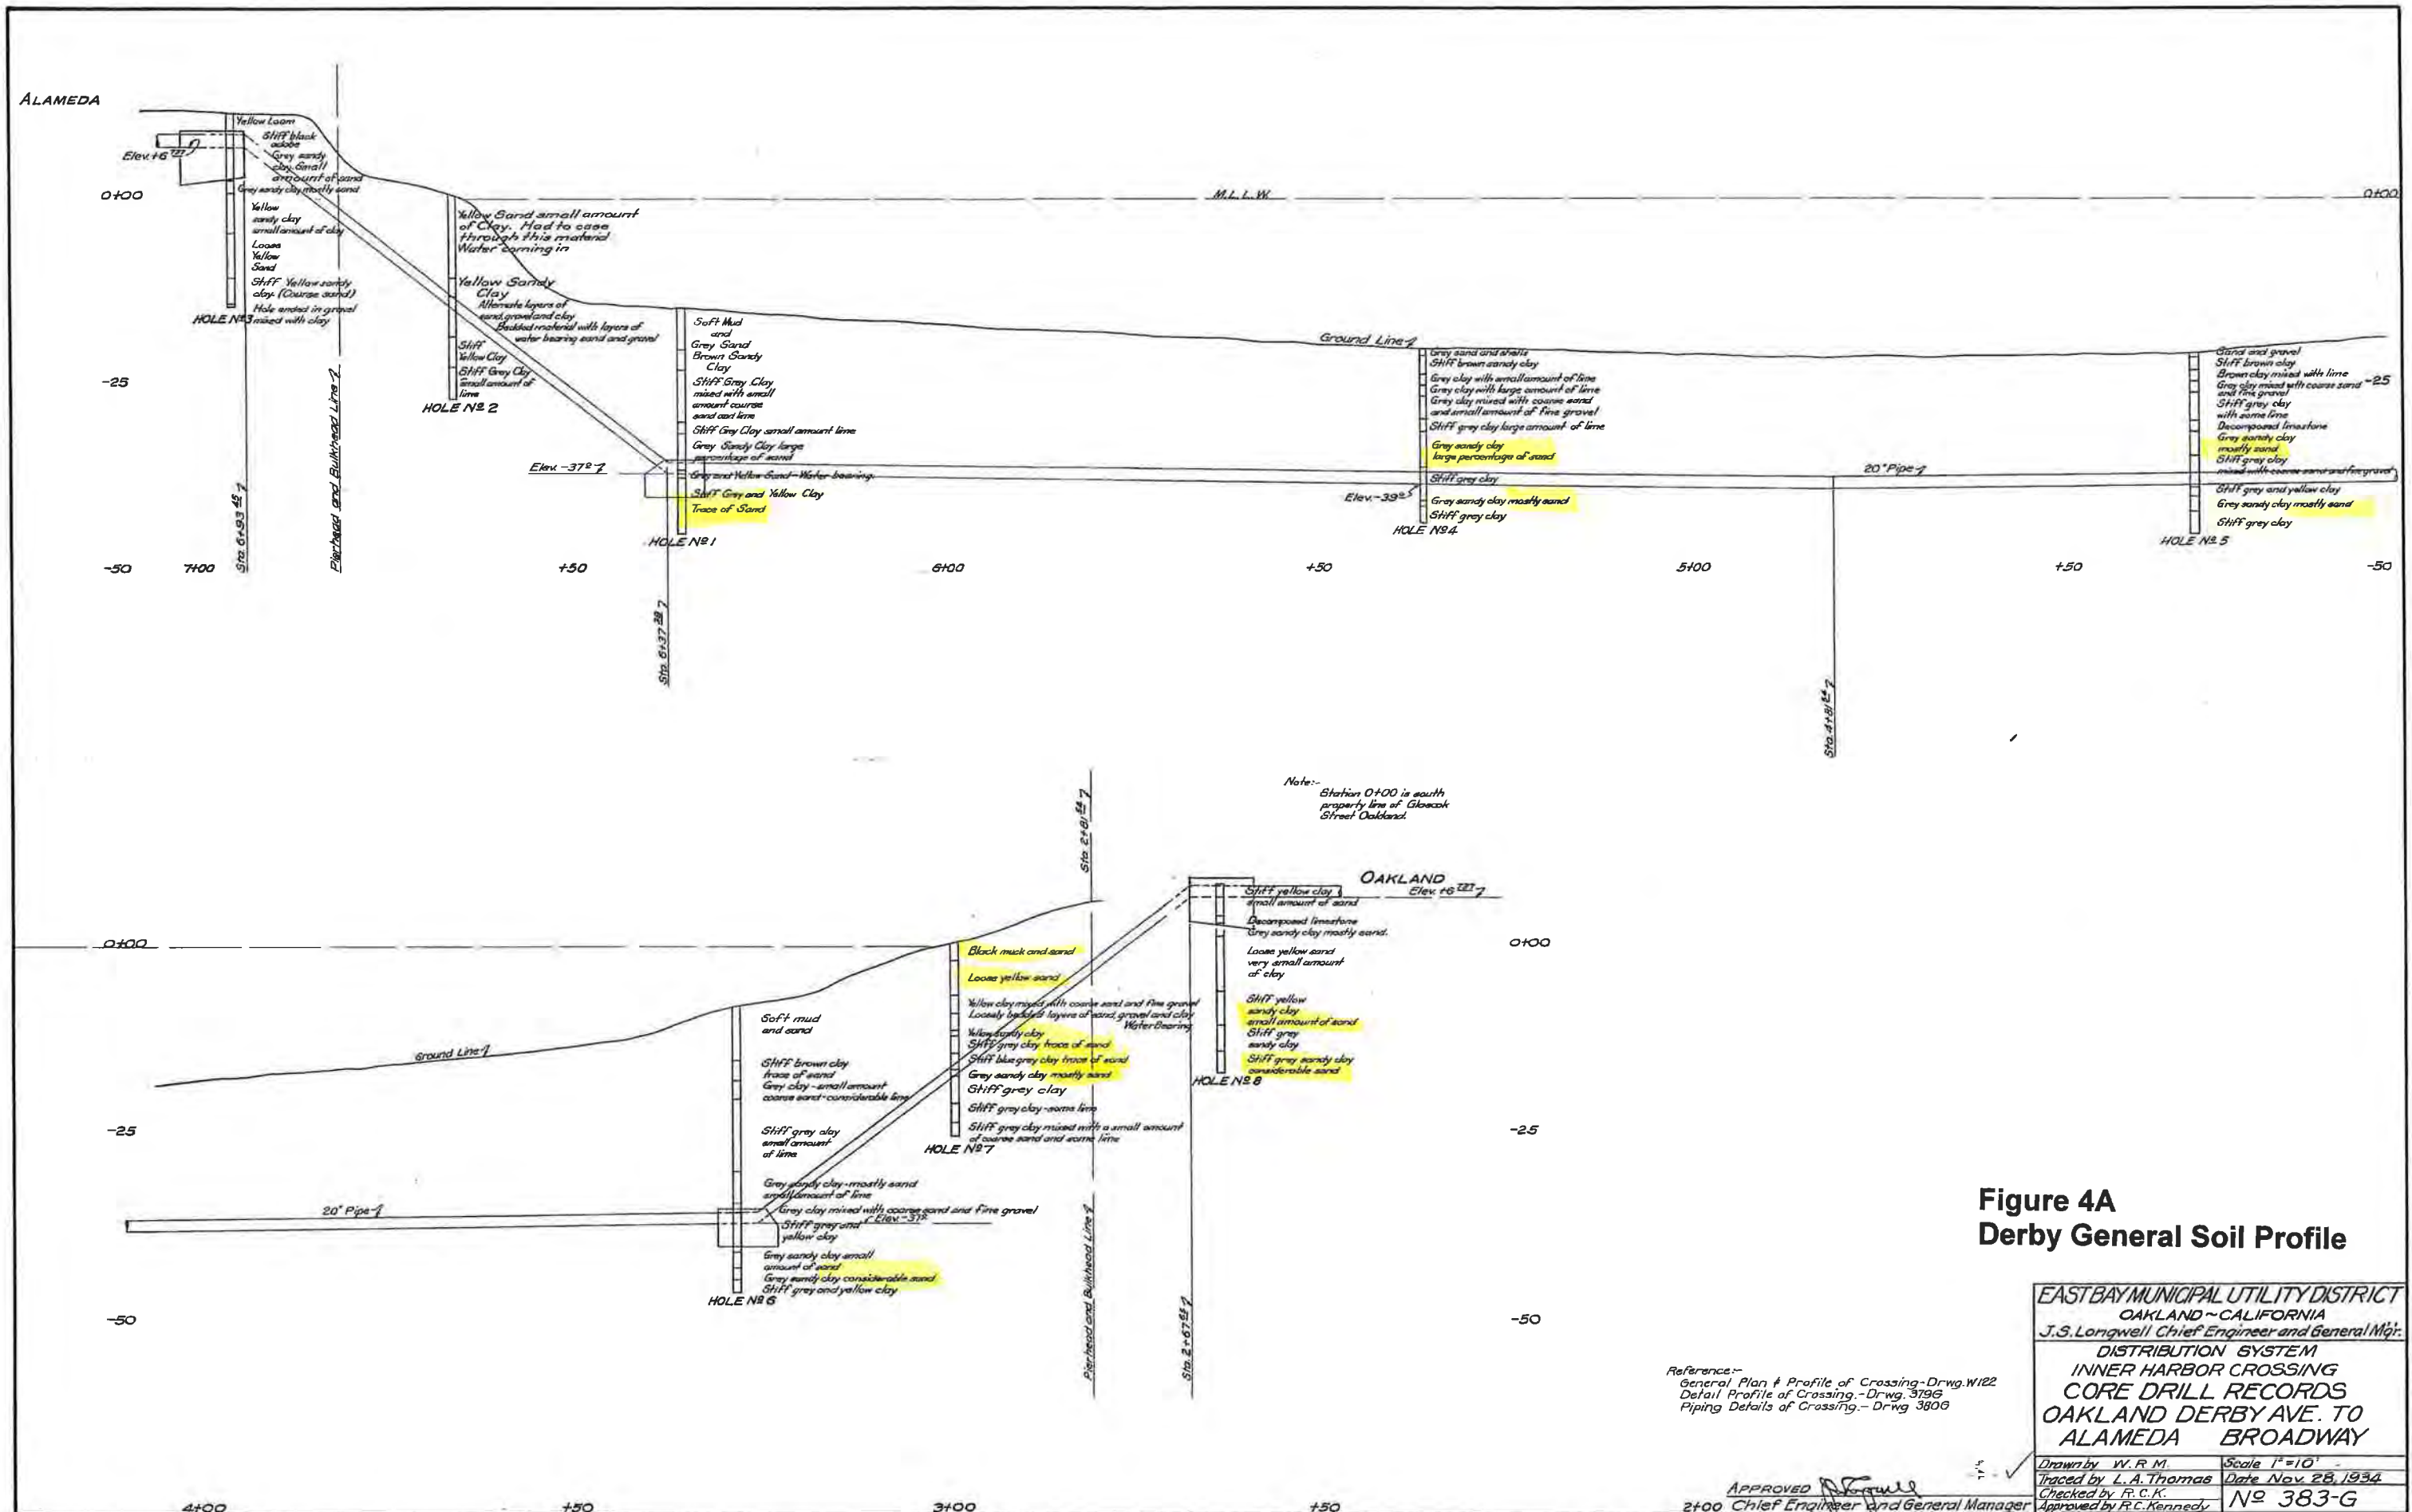
Figure 3C
Park General Soil Profile Continued

4. Derby Crossing (Ref. Figures 4A, B, & C): Subsurface soils surrounding the pipeline generally are potentially liquefiable and available boring data is sparse. Subsurface soils surrounding the pipeline consist of soft Bay Mud followed by layers of sandy clay to clayey sands with gravel. Boring stick logs did not contain strength data or field blow count data.

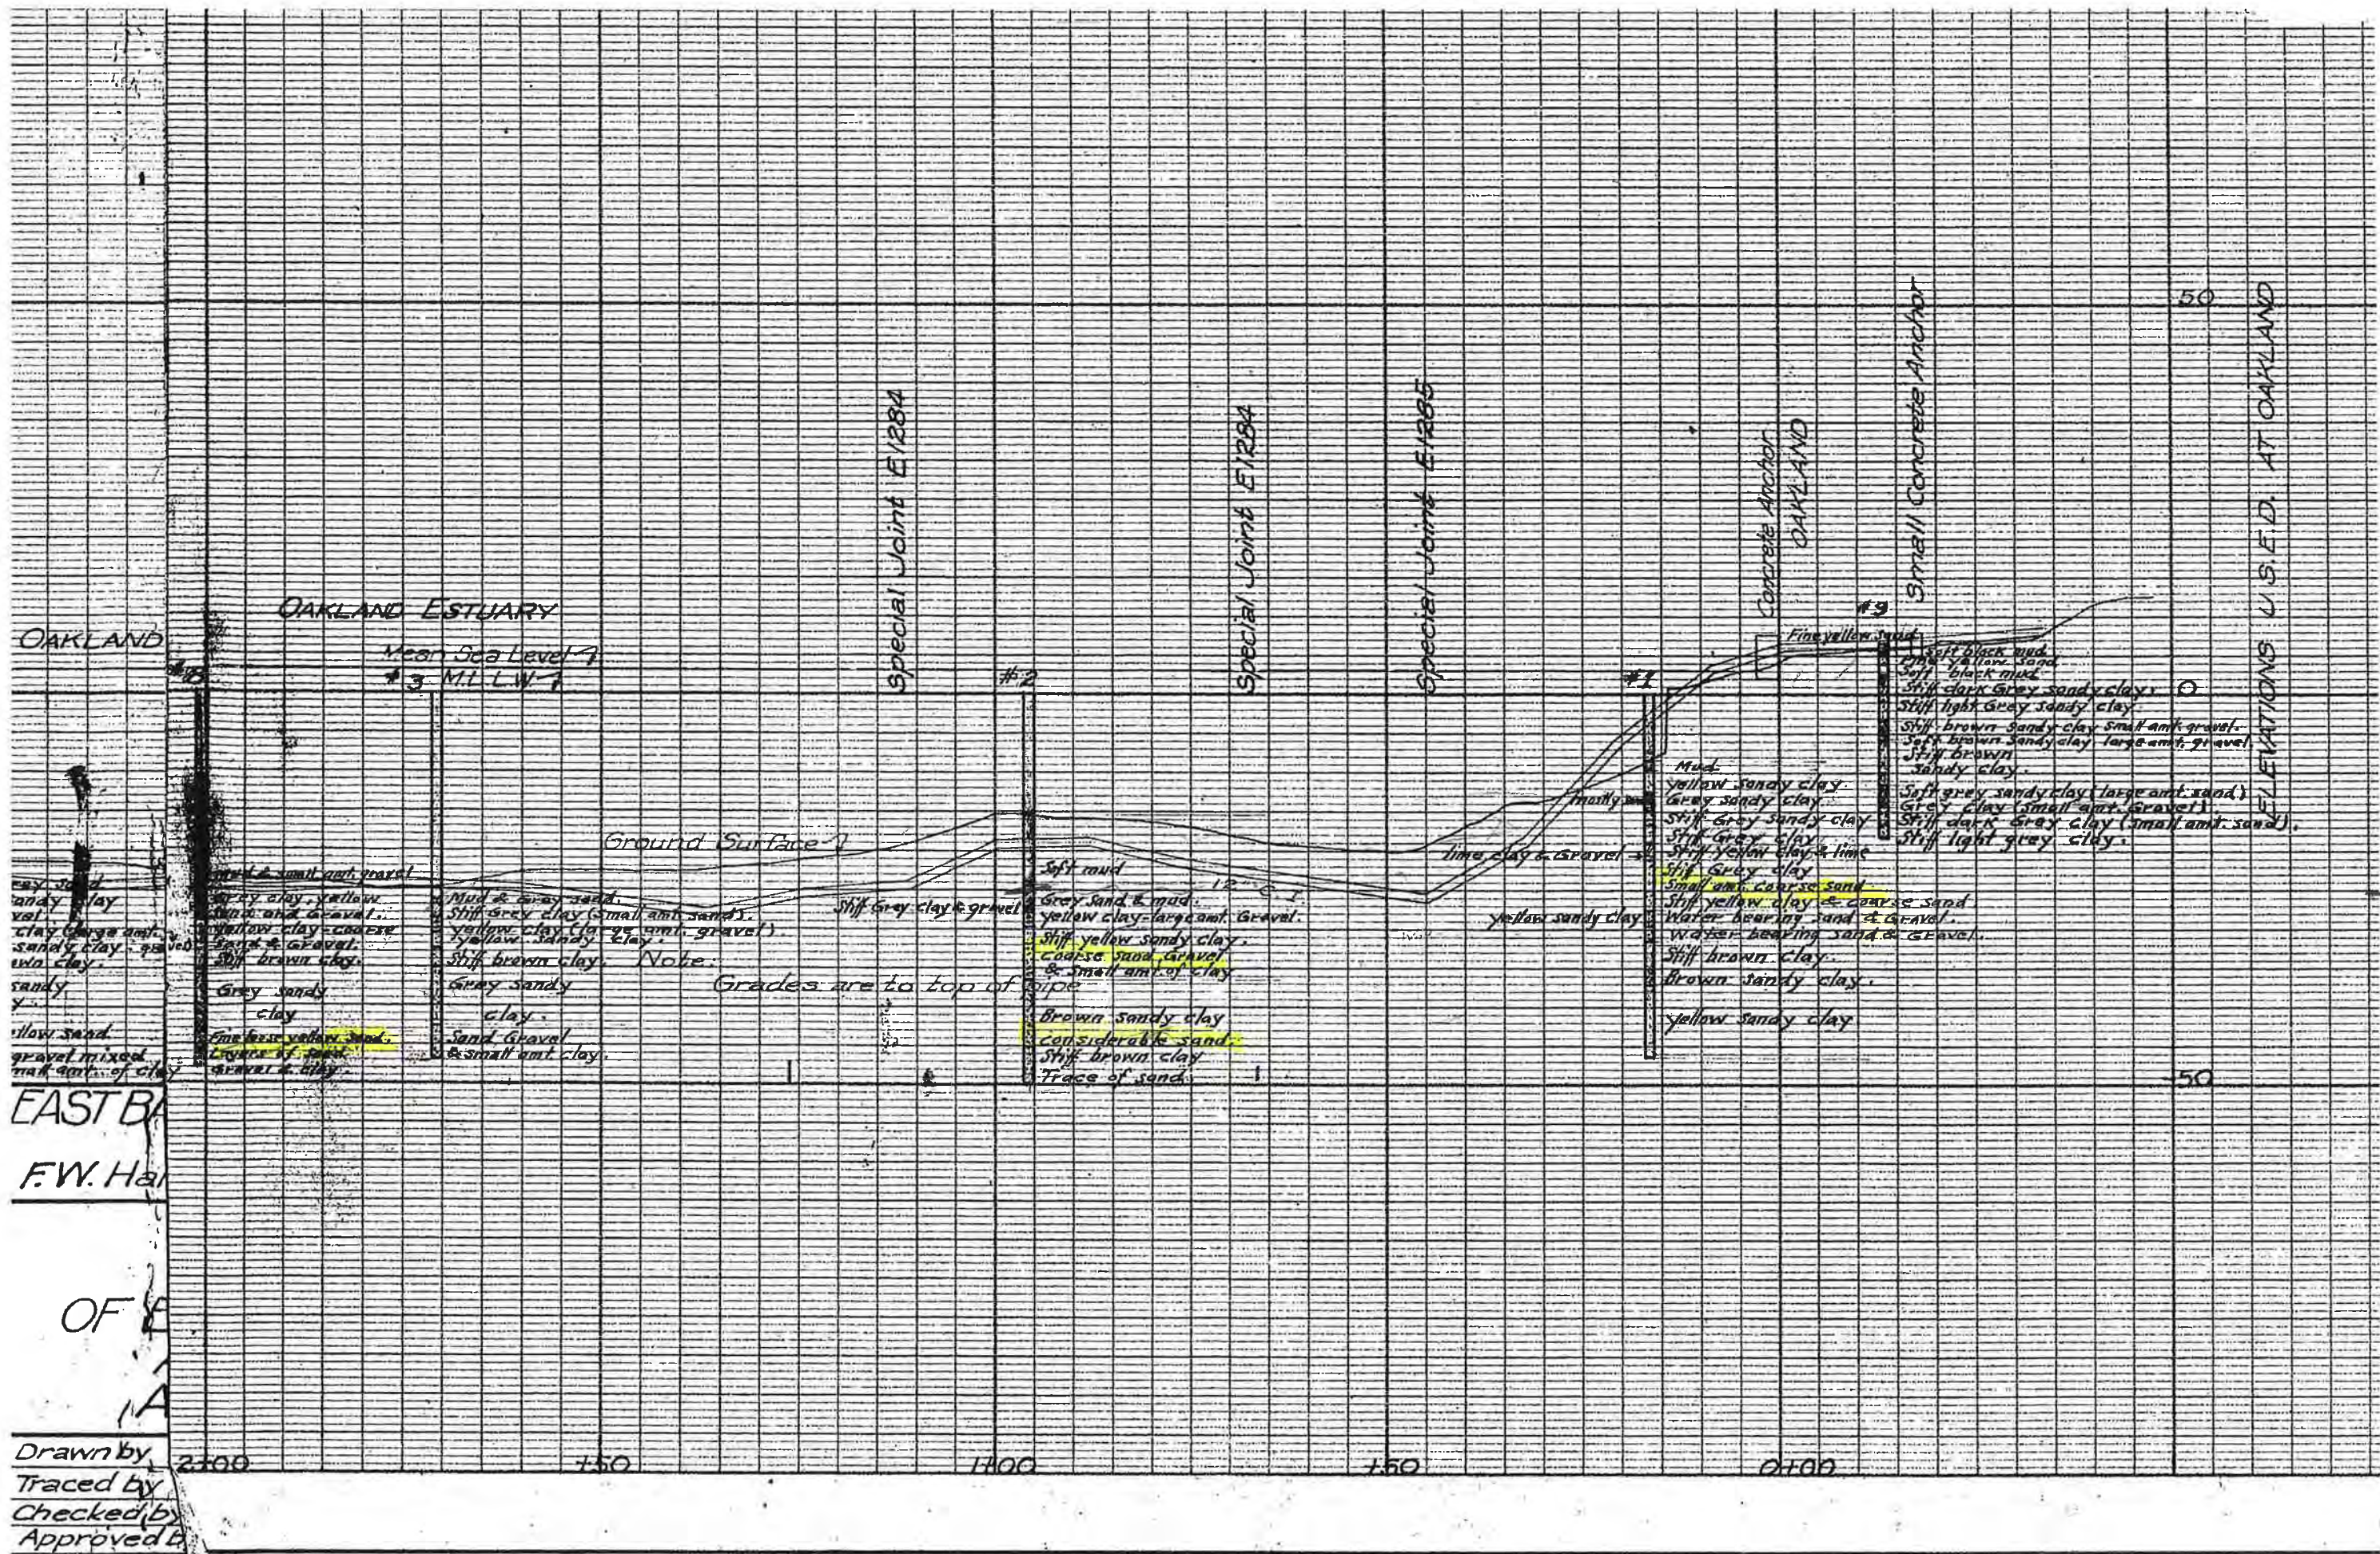
Figure 5A
High General Soil Profile

5. High Street Crossing (Ref. Figures 5A & B): The pipeline burial depth is fairly shallow (~10 feet). Once again, since the boring stick logs do not contain details of any soil strength, index properties, and blow count data, we assume based on descriptions of Bay Mud overlying alternating layers of clayey sand to sandy clays that soils are potentially liquefiable.

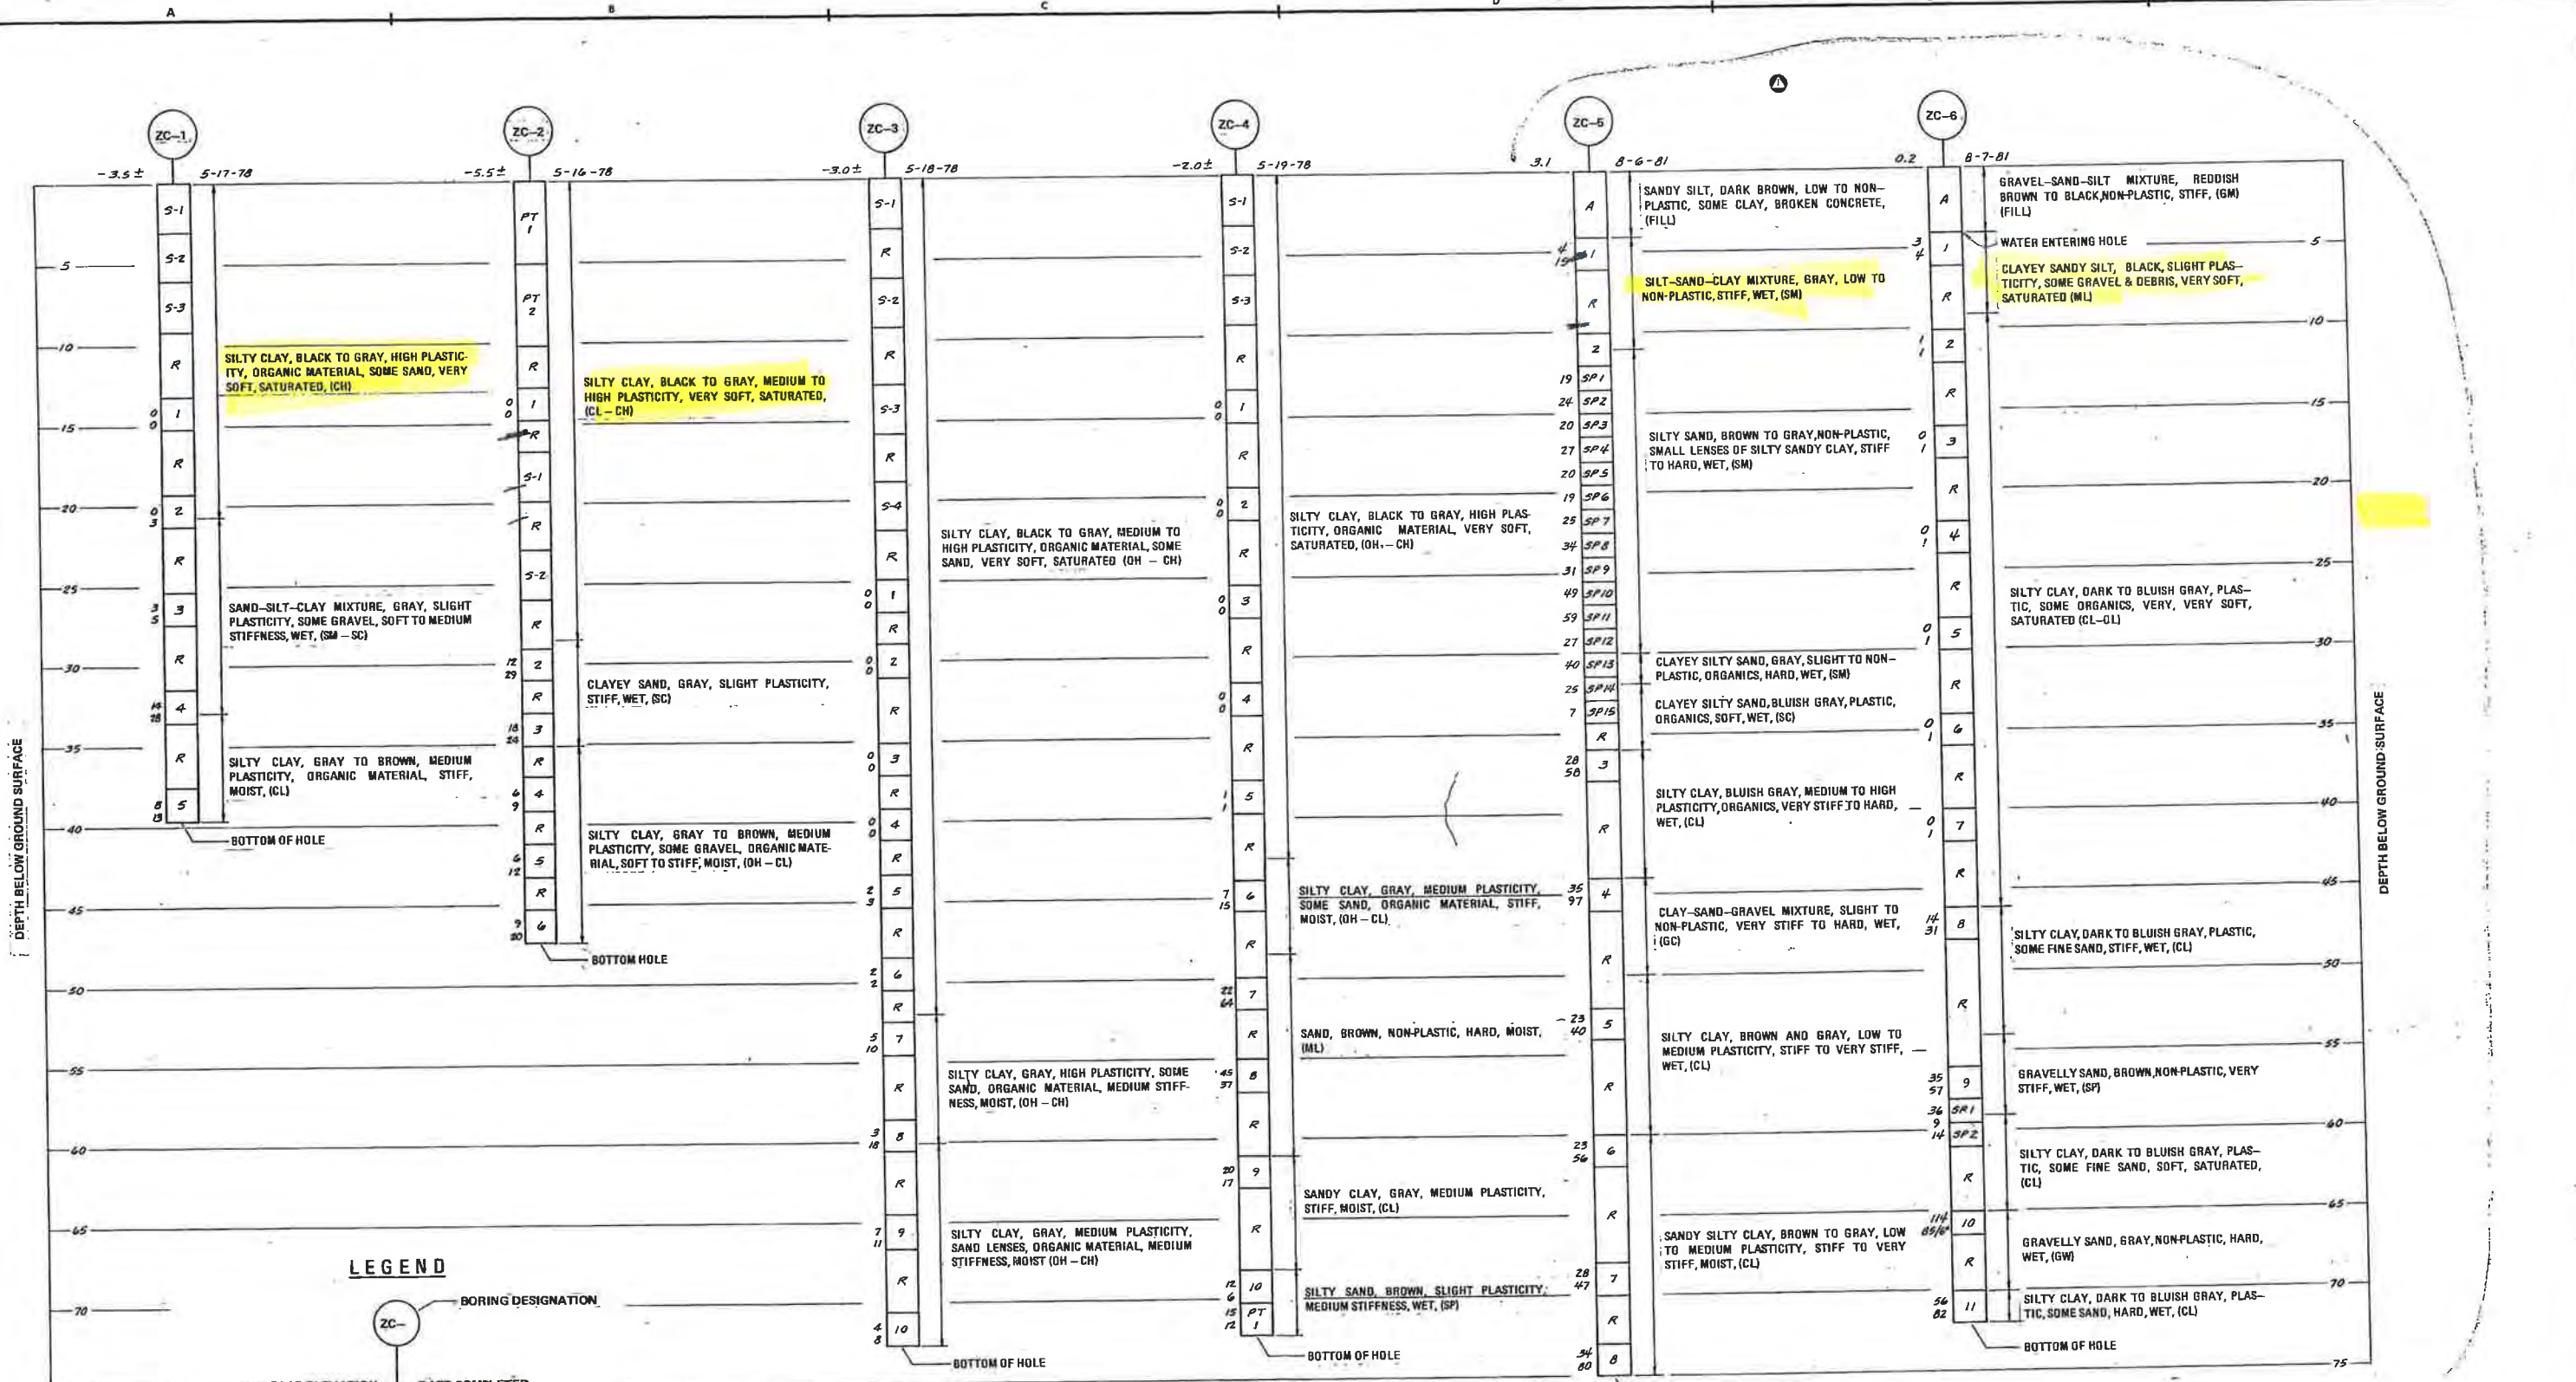
Figure 7A
Alameda-Bay Farm #2 Detailed Soil Profile

7. Alameda Bay Farm 2 Crossing (Ref. Figure 7A): Figure 7A shows boring stick logs along the Alameda-Bay Farm 2 pipeline described below. The pipeline is embedded into soft organic clays and potentially liquefiable sandy soils. Based on the soil descriptions and blow count data provided in the stick logs shown, pipeline vulnerability is considered to be high.
